# **Feasibility Study – Final Report**

Burslem Indoor Market

Queens Theatre

Wedgwood Institute

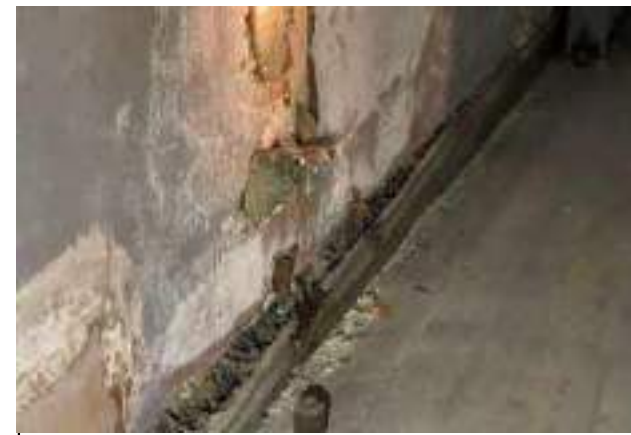
Photo 30 - Dry rot to the timber skirting board and wall above, in the gallery loft.

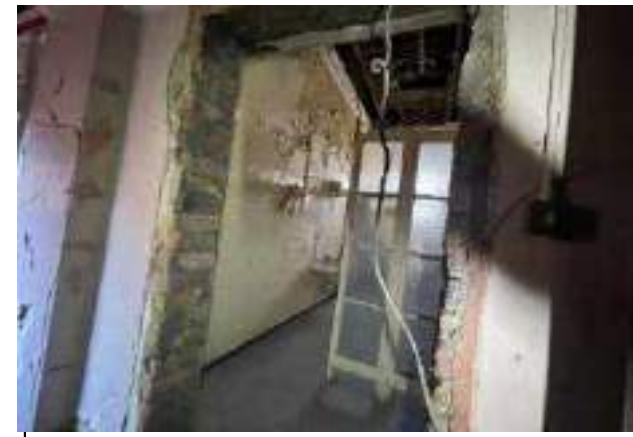
Photo 33 - Bathrooms on the first floor.

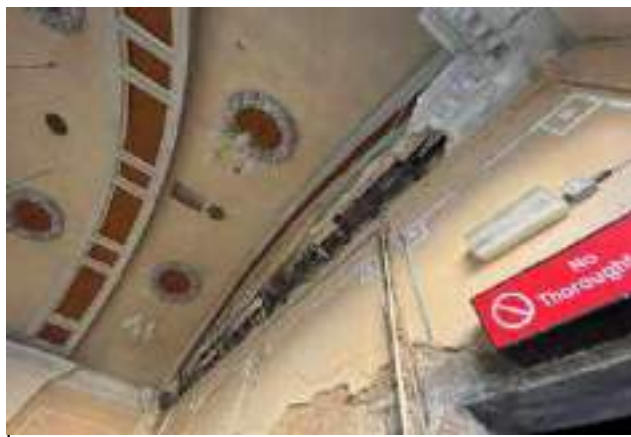
Photo 43 - Ceiling to the small hall where the ornamental plasterwork has fallen.

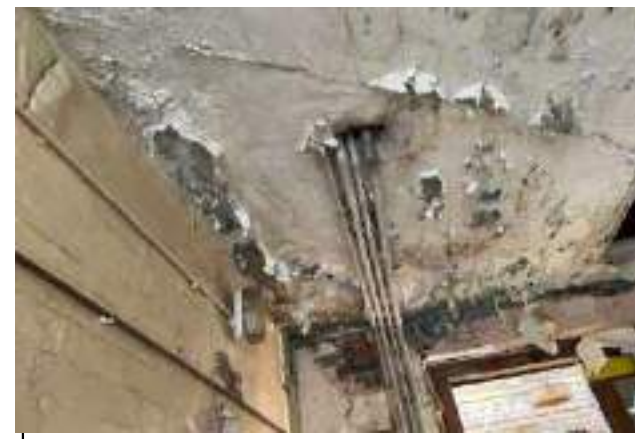
Photo 48 - Typical water damaged ceiling

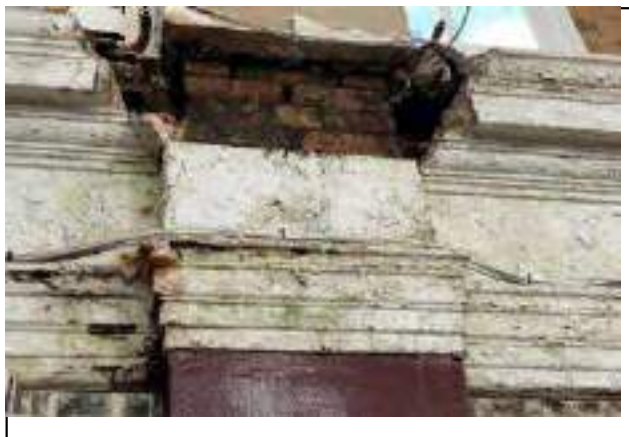
Photo 49 - Exposed brickwork to the internal walls of the ground floor corridor where plaster has fallen.

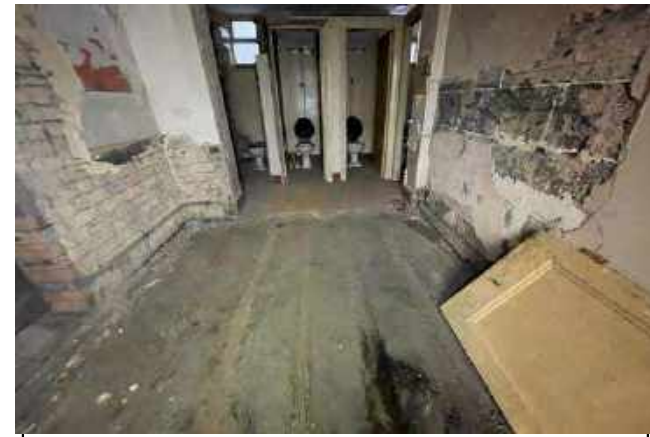
Photo 51 - WC's to the ground floor area in overall disrepair.

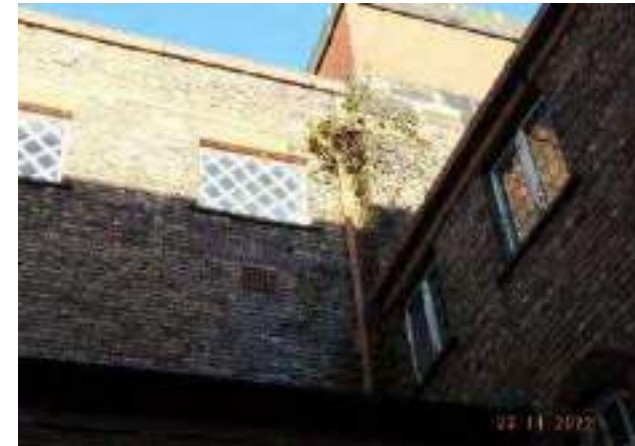
Photo 54 - Vegetation growth to hopper/ stonework.

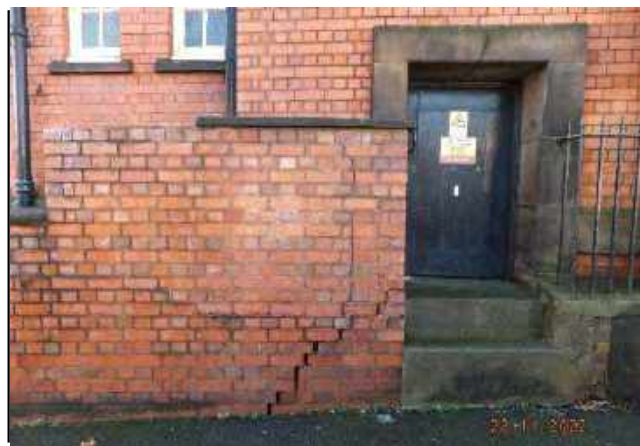
Photo 58 - Stepped cracking to freestanding wall on Price Street.

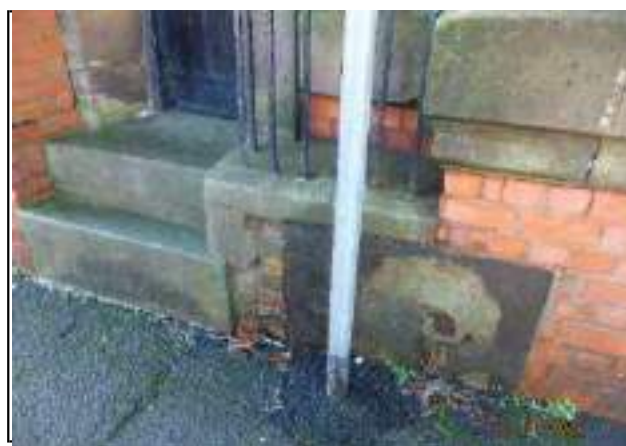
Photo 59 - Damaged cement finish.

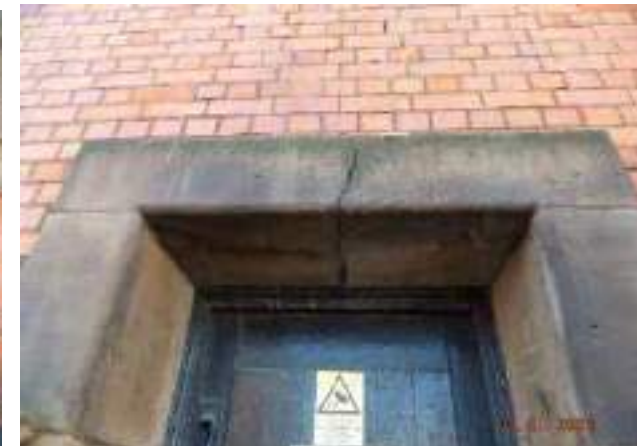
Photo 60 - Cracked lintel to stage entrance door.

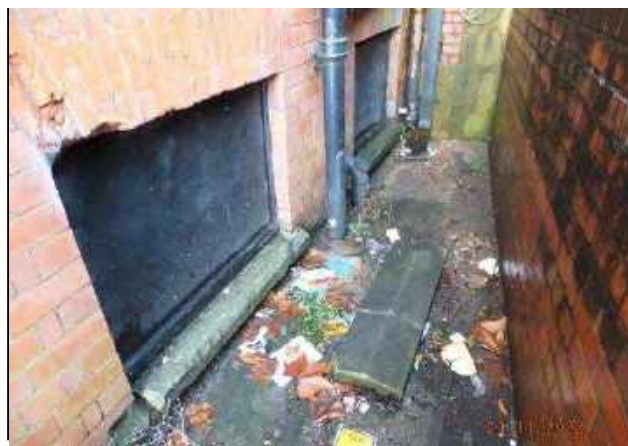
Photo 62 - Windows to basement (behind freestanding wall on Price Street). Damage to flat arch brickwork and missing coping stone.

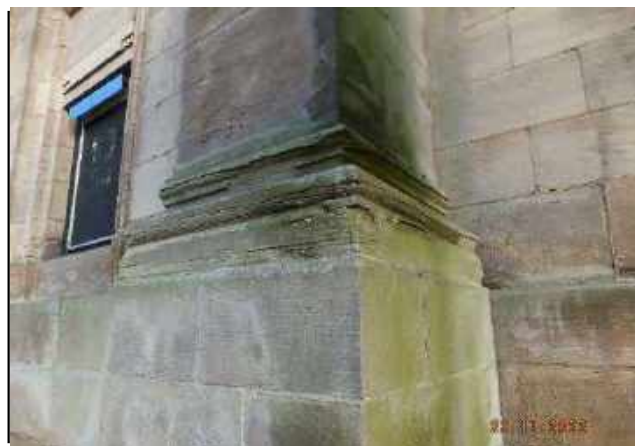
Photo 64 - Algae growth and deterioration of stone due to inadequate water shedding above.

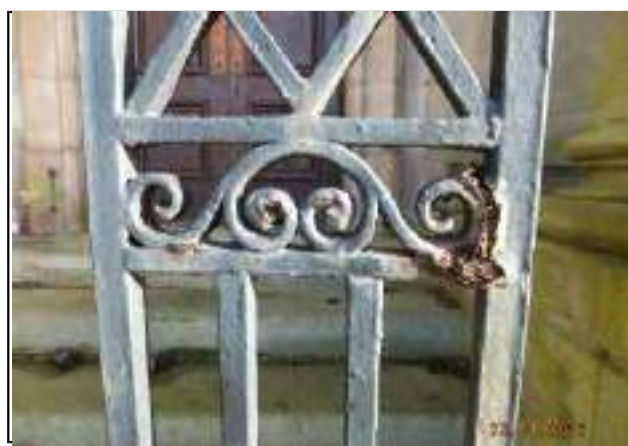
Photo 65 - Corrosion damage to railings.

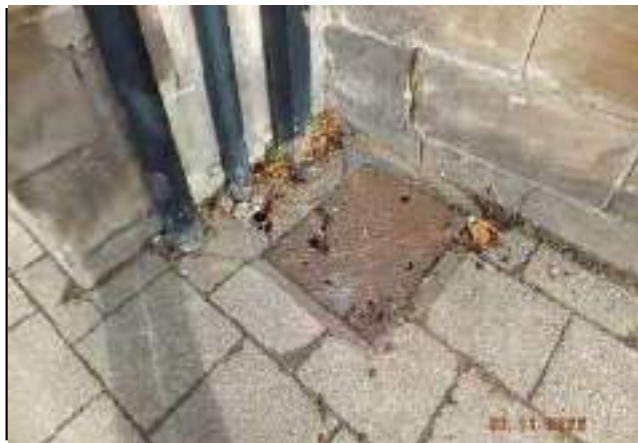
Photo 67 - Damaged manhole to Wedgwood Street.

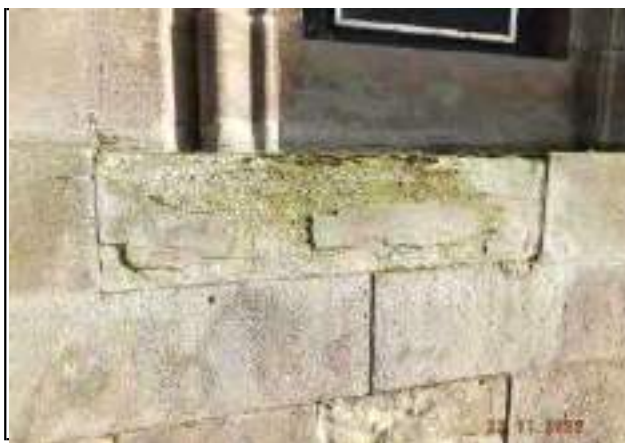
Photo 68 - Example stone deterioration.

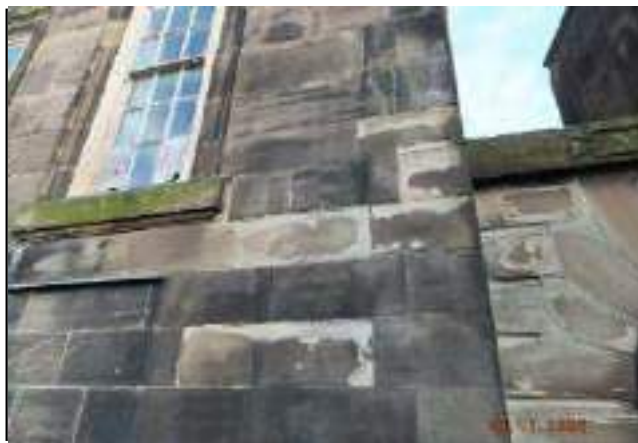
Photo 70 - Example stone deterioration due to staining and cementitious pointing.

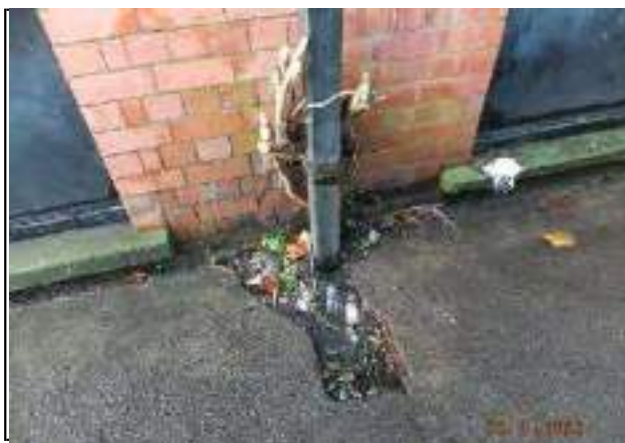
Photo 71 - Example damage to drainage surrounds.

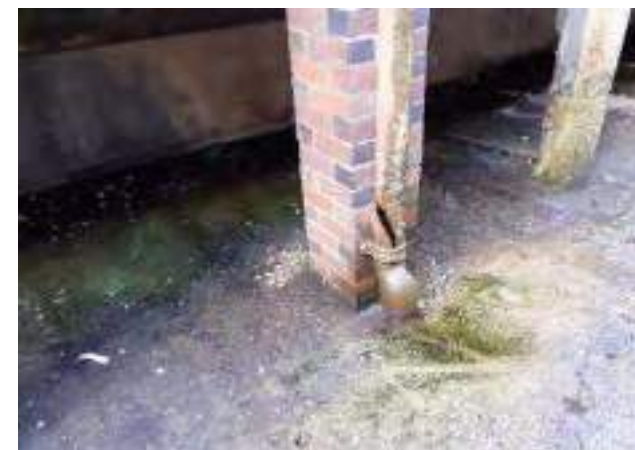
Photo 75 - Inner courtyard ponding and broken downpipe.

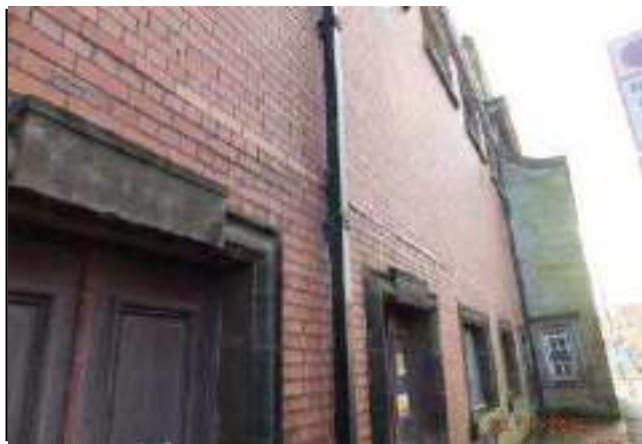
Photo 76 - Displaced lateral brickwork.

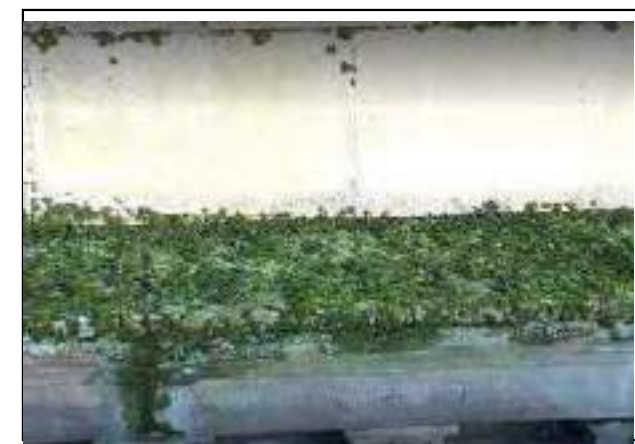
Photo 78 - moss growth to horizontal stone surfaces generally.

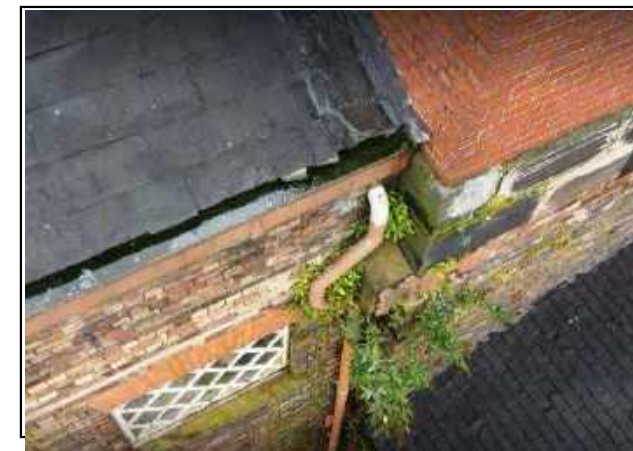
Photo 84 - Poor detail and disrepair to downpipe/ outlet in central courtyard. Note, photo taken from 2021 survey not current.

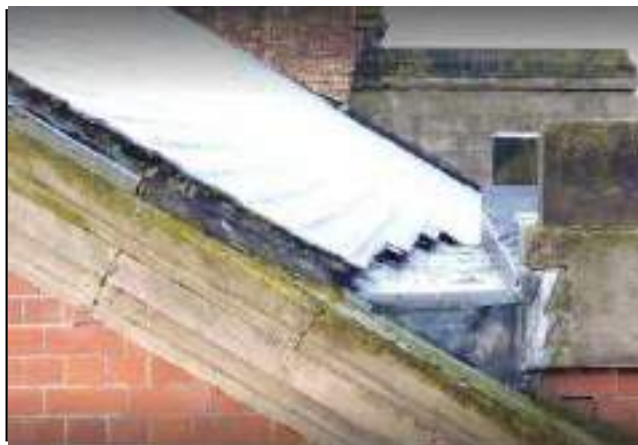
Photo 85 - Example lead lined gutter in satisfactory condition.

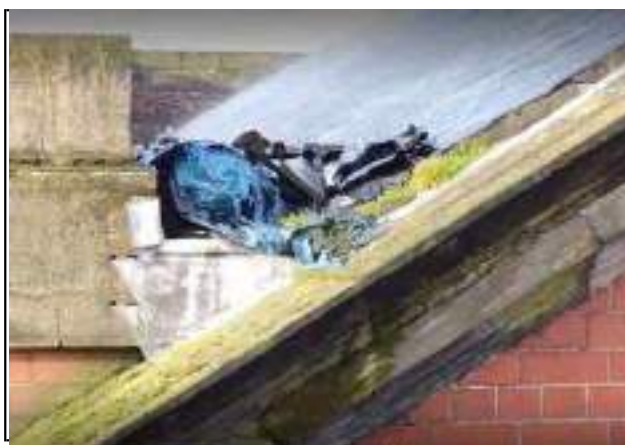
Photo 86 - Debris blocking rainwater discharge on roof.

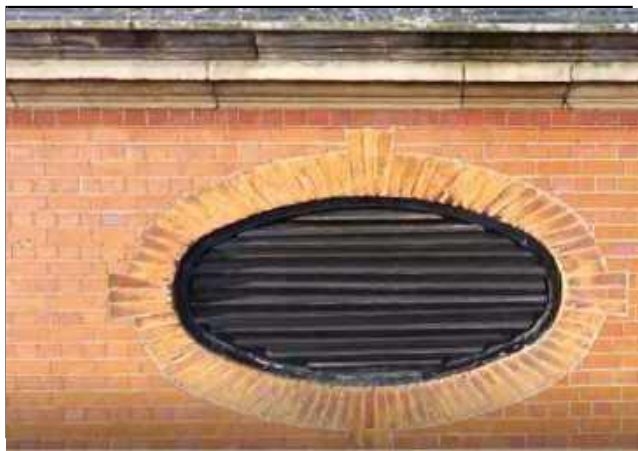
Photo 88 - Spalling to brick surround at high level.

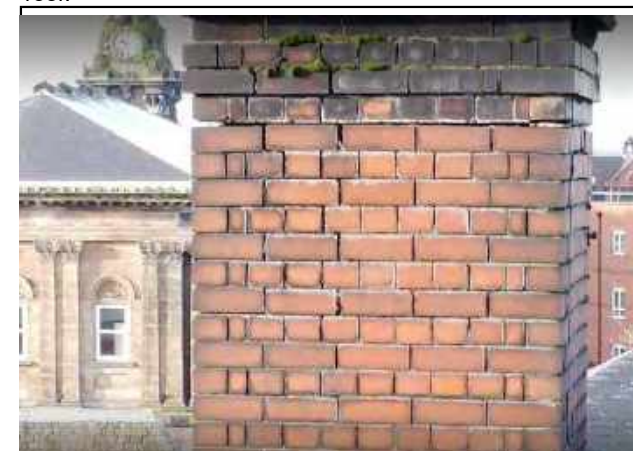
Photo 90 - Large chimney stack to South East displaying open joints and potential instability.

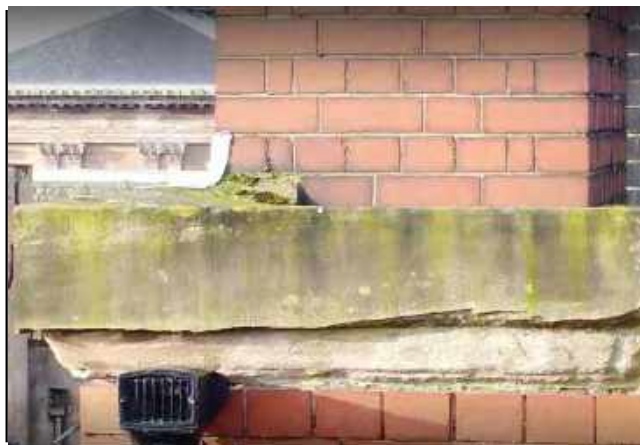
Photo 81 - Deteriorating stone to parapet along Price Street.

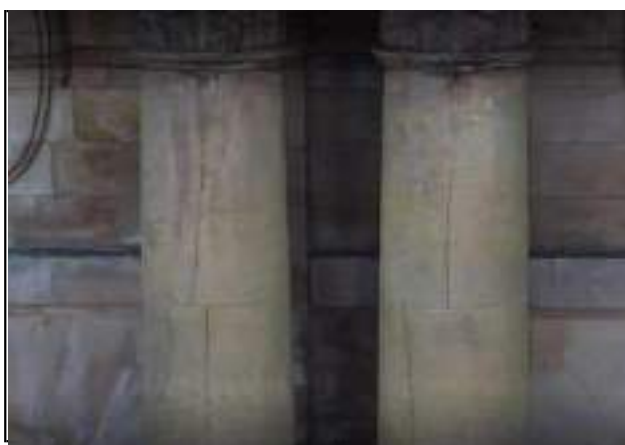
Photo 92 - cracking to stone columns on principal entrance.

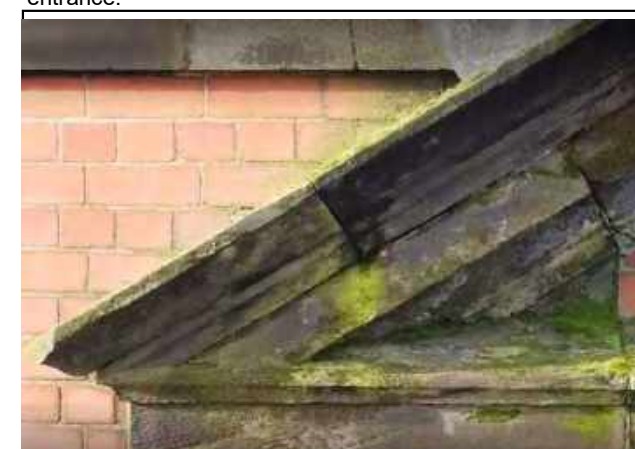
Photo 96 - Stone pediment to elevation above Price Street, stability unknown.
