# The Villas Conservation Area Appraisal

*February 2007*

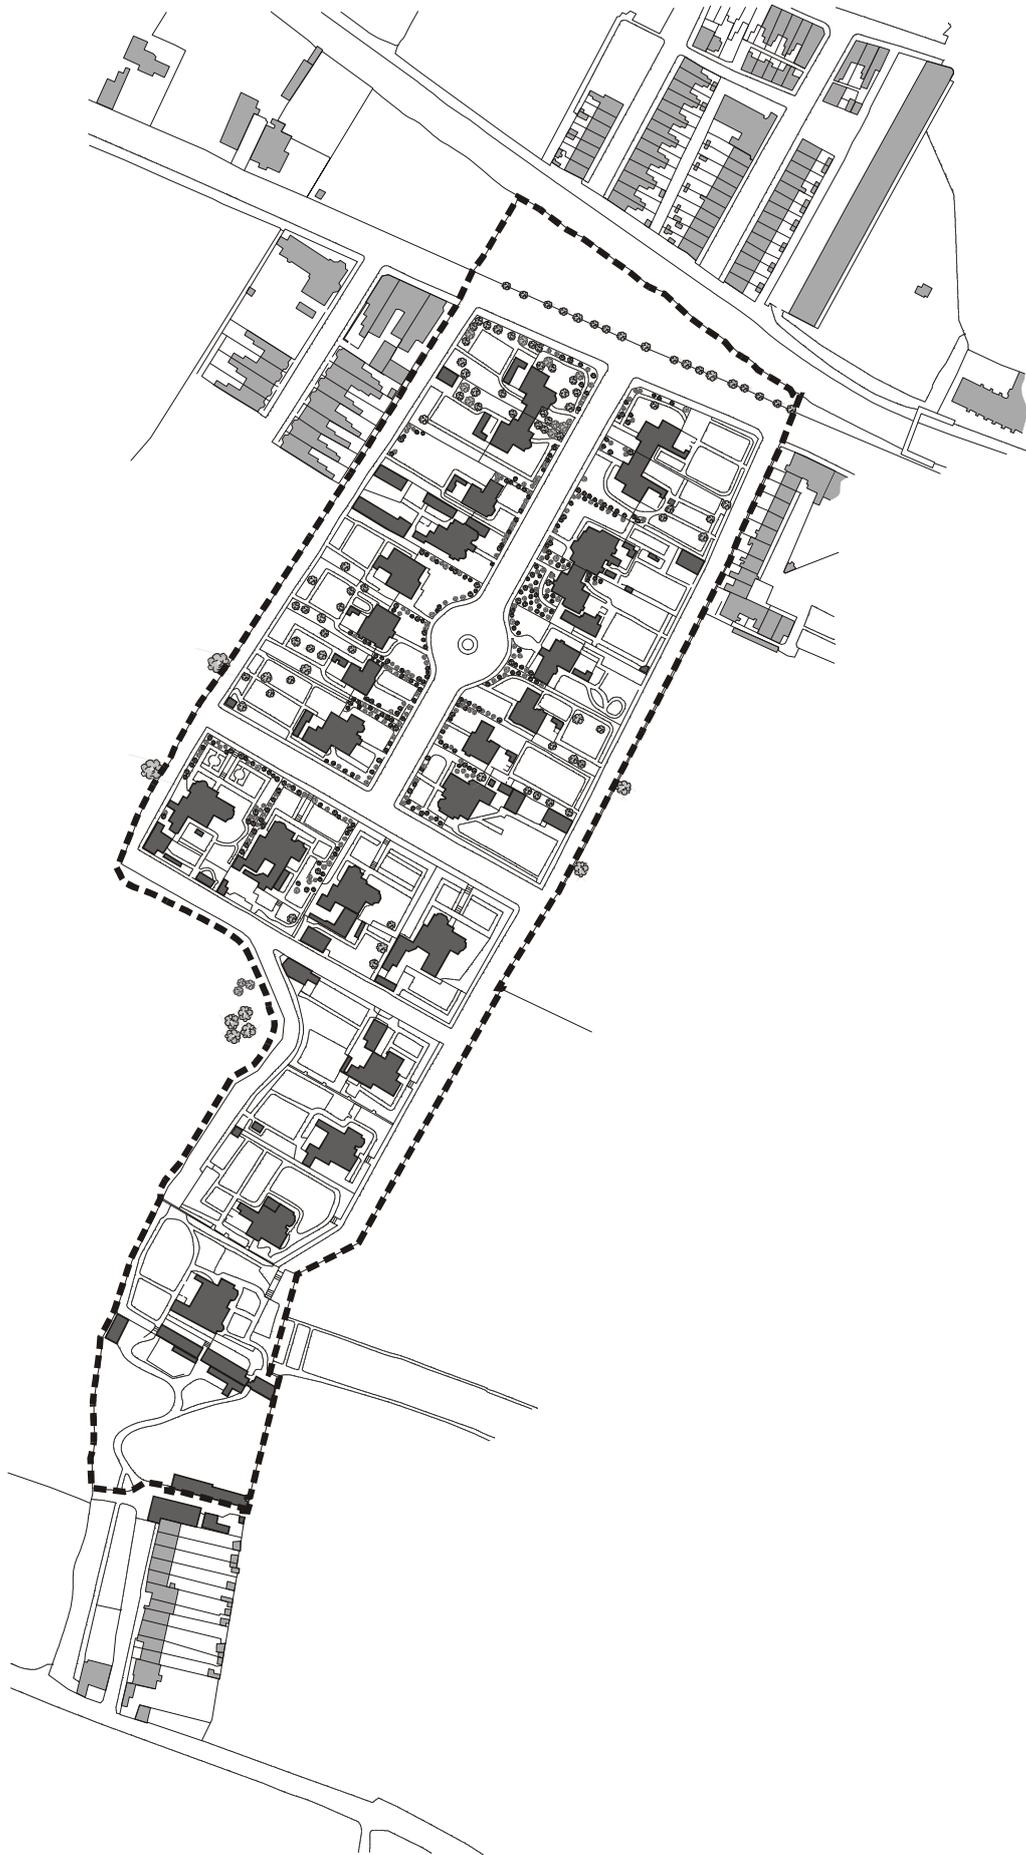
FIGURE 1: *Digitised version of George Lynam's Map (1848)*

- 
- 3.4 The map above, an digitised version of George Lynam's map of 1848 shows the land chosen for the development (outlined). The site was then in open fields on the Turnpike road from the Black Lion Inn at Trent Vale to the town of Stoke and less than a mile from the railway station.

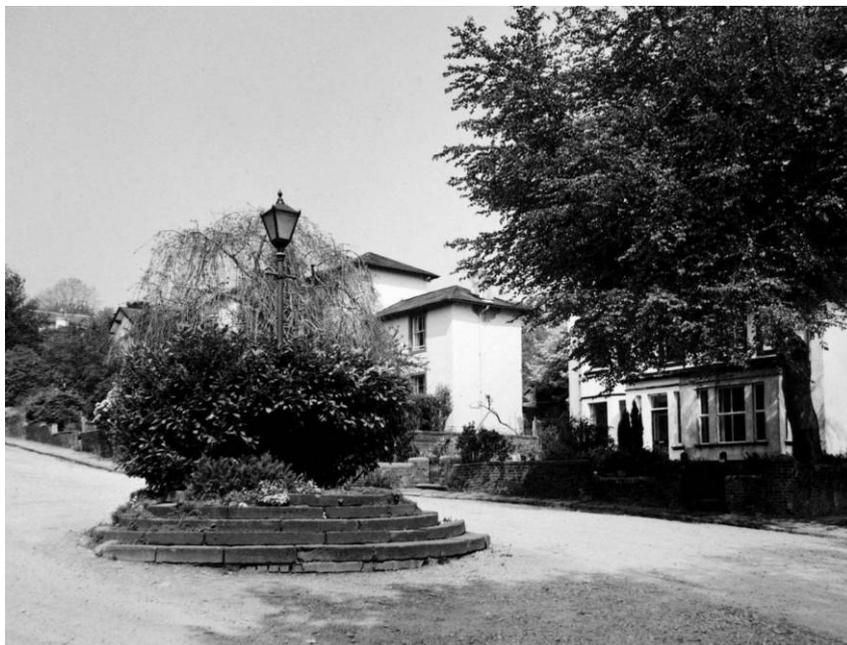
**FIGURE 3:** *Central lamp standard and turning circle (1984)*

4.12 The Conservation Area is set out formally; the plots for the dwellings are drawn symmetrically to each side of a central spine. The spine is punctuated by a turning circle in the form of a raised landscaped bed with a central lamp standard. The lamp is not original and no longer possesses an appropriate lamp or shade. An article in the Daily Mail dated 12 July 1956 includes a photograph of the original lamp on an impressive stone base, which survives but is in poor condition.

- 4.33 The central turning circle and lamp standard is an important architectural device for the setting of the buildings. It is the focal point on entry, enforced by the lack of a similar feature at the centre of the higher terrace. Its appearance and condition has a marked effect upon the perception of the place. Photographs showing the central feature with no planting or controlled planting give a much more formal atmosphere.

- 8.9 Consideration should be given to reintroducing appropriate lamp standards to the conservation area, with special emphasis on the central feature where a “feature” lamp could be provided.

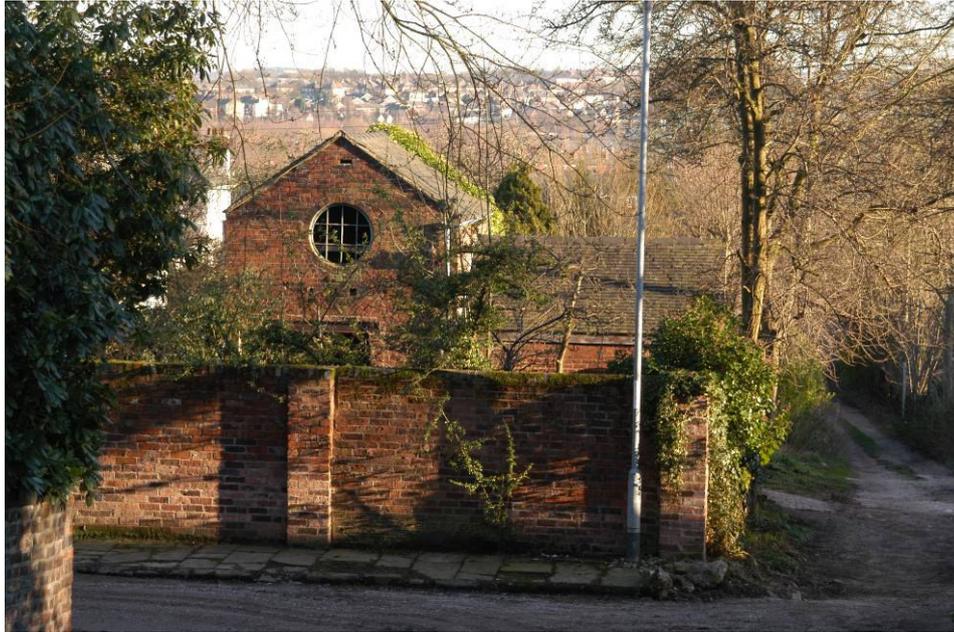
**FIGURE 5:** *Outbuildings*

- The view from the entrance towards the upper terrace
- The view from the terrace towards no. 12
- The views from the service roads of the coach houses, including impressive gate piers to the rear of no.21.

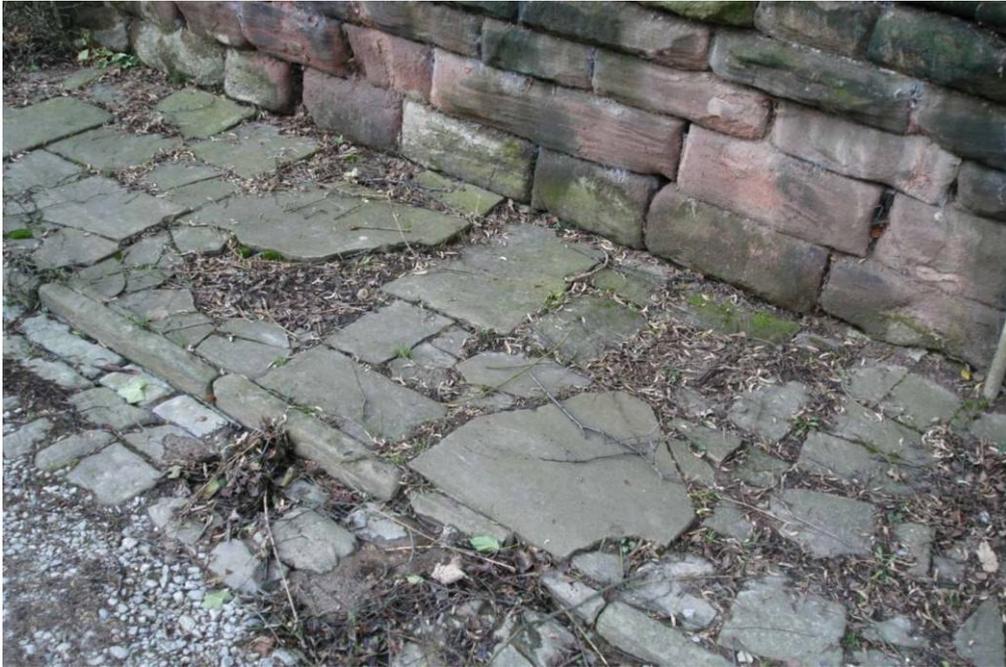
**FIGURE 8:** *Sandstone wall and york stone pavements adjacent to no. 9*

Brickwork is reserved for the garden walls, Coach-houses and some laundry buildings. The walls to the front gardens originally carried railings which pierced York stone capping. The minutes of the Stokeville Building Society record that the bricks were made on site from the "dirt" which had to be moved during the landscaping works. The bond is generally English, with some English Garden Wall.

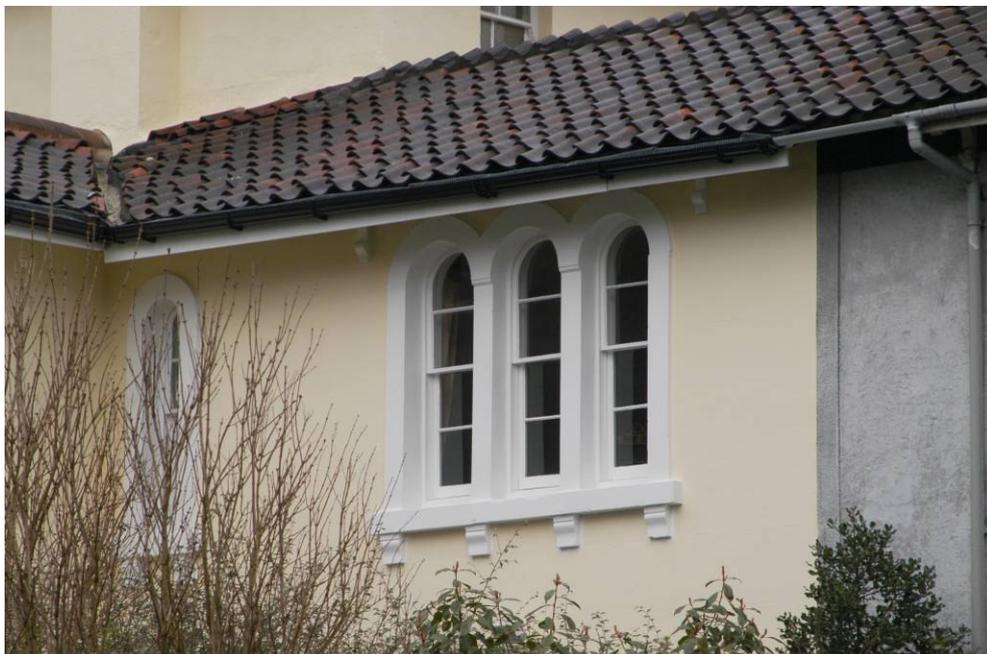
**FIGURE 9:** *Stone details*

The window and door dressings, window bays and entrance porch details are constructed from a pale sandstone, possibly local. This has not weathered well and without exception is now painted with many layers of oil paint. York stone is used for the paving, gutters, kerb stones and steps to the central lamp standard. York stone is also used to form the capping for entrance gate piers, garden walls and garden steps.

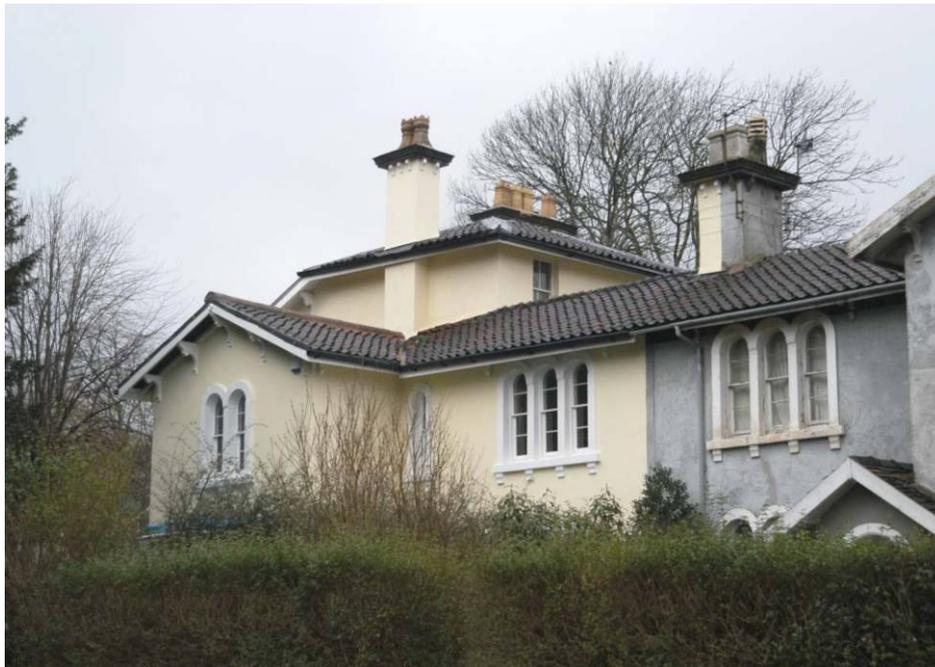
**FIGURE10: Roofs**

All roofs were originally covered in clay pantiles, a strong visual characteristic associated with the Italianate style of the 1840's. Few remain today and there are now many variations in material; replacement roofs include concrete tiles and welsh slate.

The shallow pitched roofs with their overhanging and bracketed eaves are a common unifying feature of the buildings in the conservation area. The roof surfaces are not a dominant characteristic of the area because the pitches are so shallow and the sightlines constrained within the site itself. It is the impact of the eaves and brackets which play the dominant role. Views from adjacent roads (especially at the north end) into the site give a stronger emphasis to the roof-scape.

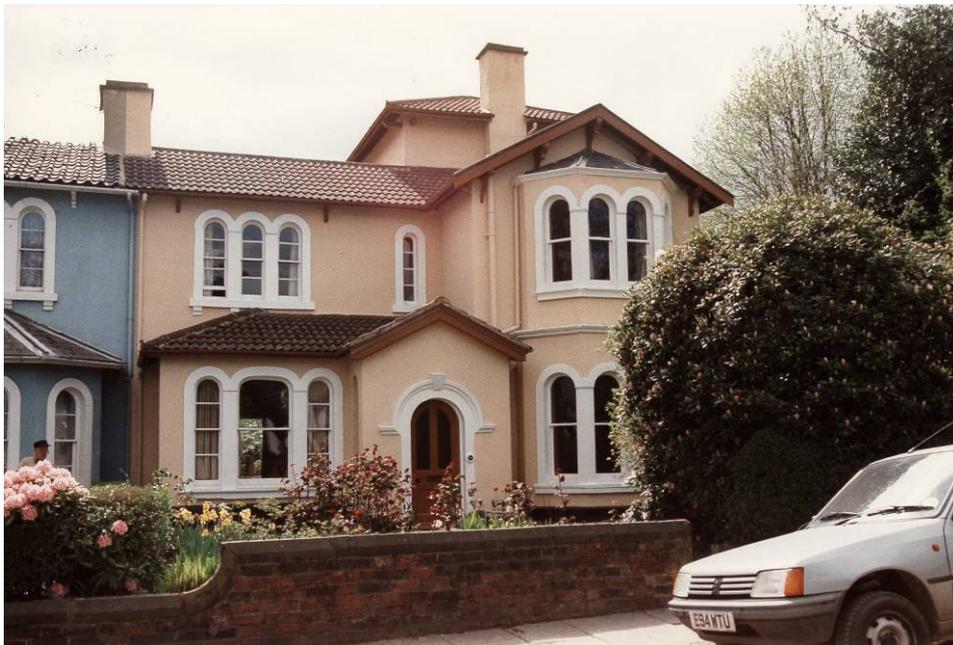
**Figure 11:** *Windows*

Across the Area sash windows remain the most common window type providing a vertical emphasis to facades. A few broader casements do however occur as either components of original designs or as later alterations on a number of properties. Windows are single or paired; composite or tripartite arrangements separated by ornamental mullions or balusters in stone. Bay windows are a common feature on

the ground floors of most of the houses, these doubled up at first floor level in two or three instances but look unconvincing. Arrangements vary, though repetition within the facades maintains a sense of regularity. It is common for windows to carry a heavy rectangular stone cill and lintel though some are framed completely by a raised stone band, both arch and square headed. There is an evident hierarchy in design cost and size, the principal rooms having the largest and most intricate designs. The original sashes do not have horns, the most impressive have margin lights. These are not further embellished by the use of different glass, although there are examples of both stained and painted glass in front doors and to windows in rooms or spaces that overlook the service areas. The most common form of replacement is an Edwardian casement window but unfortunately there are also late 20<sup>th</sup> century alterations which represent a clear loss of detail and character.

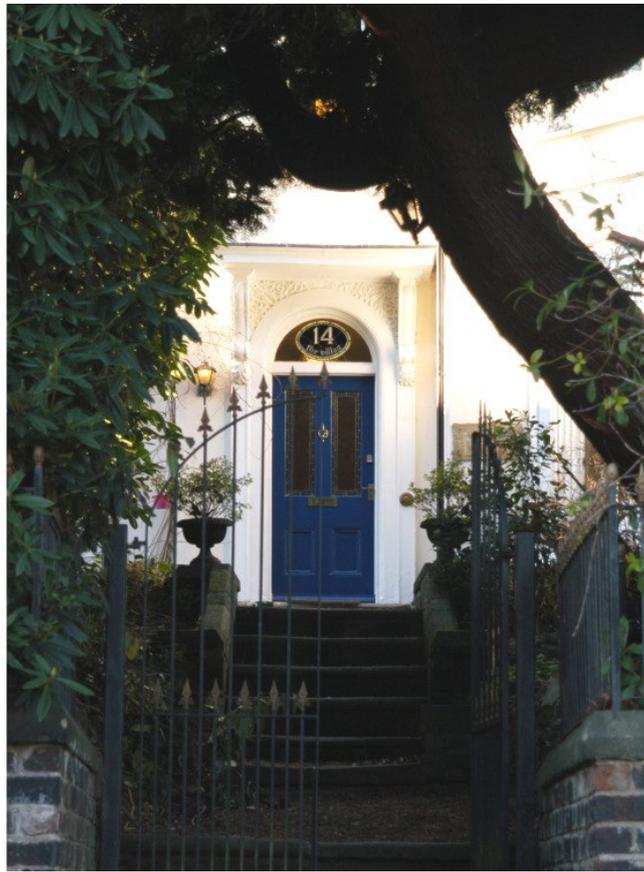
**FIGURE 12:** *Porches, doors*

The entrance to individual villas varies a great deal. In some compositions the entrance door is well recessed inside a projecting porch, which then becomes the most important feature of the ground floor. Porches provide opportunity for Minton tiled pavements and (possibly later) wall tiling to dado height. Other houses have front doors are simply fitted to the side of a projecting bay and do not in themselves feature on the front elevation; these have simple projecting hoods to protect the visitor.

Few original or unaltered front doors survive, though most houses retain altered doors that have been adapted to accommodate larger panes of glass in the upper panels.

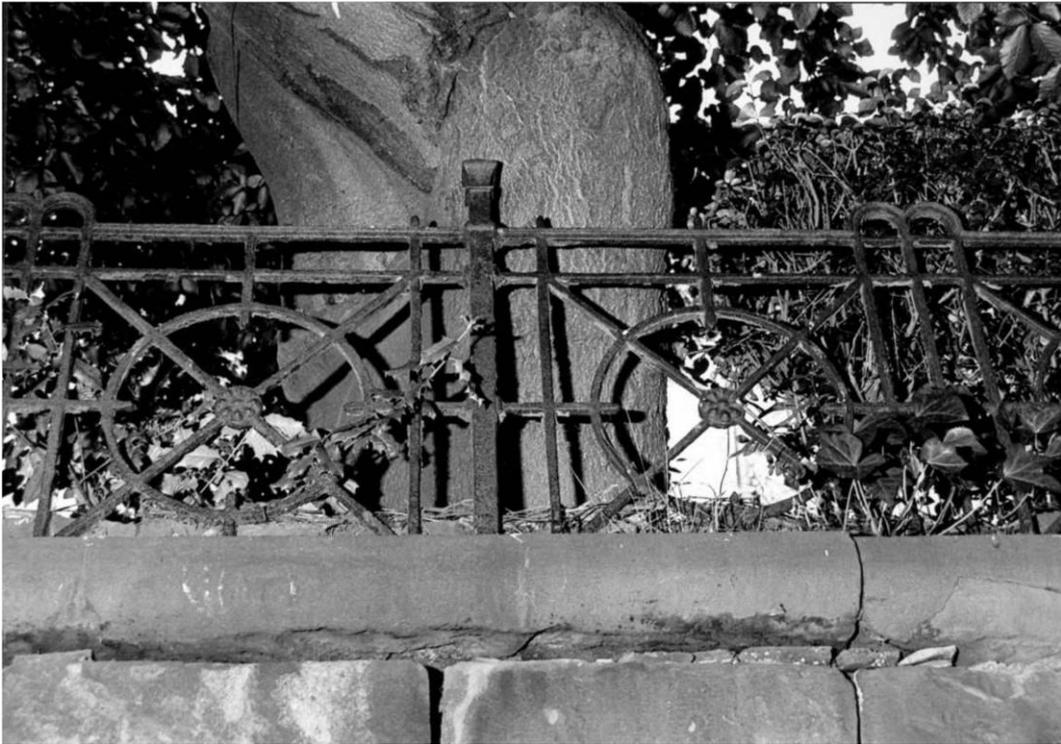
**FIGURE 13:** *Railings*

In all cases private space to the front and rear of properties was historically enclosed by brick walls, though in many cases to the rear these have been breached, replaced or swept away without provision of alternative following redevelopment or simple decay. Railings were a historic feature of the properties at the front and sides. Photographic evidence exists of original railings to no. 14 The Villas, although it is unclear from inspecting the property if remnants survive under the vegetation. The design was based on repeated square sections into which were placed elliptical spoked wheels. “Stokeville” was unusual not only because it was built as a middle class estate with a consistent architectural style designed by an architect as a “set piece,” but also because it was built as an enclosed estate – a gated community. This was the first of its type in North Staffordshire and emphasised – as would do today- the exclusive nature of the development. Photographic evidence shows the gates as viewed from London Road in 1919. There was a pair of carriage gates, with stone pillars, flanked by two smaller pedestrian gates opening onto the pavements. These were of a simple design, the railings topped with arrow heads. The service roads were also gated at London Road but access to the rear service road was in fact a public right of way, from Penkhull to London Road. This is clearly shown on the 1848 map, although it was part of a much earlier footpath to Boothem. The rear of the site was not enclosed until the late 1920’s when the land to the rear was developed for housing which removed the path entirely. Photographic evidence provided by Edwardian postcards, confirmed by site inspection shows that the railings to the front walls were formed by sets of 5 or 7 simple iron spikes of 3 or 4mm diameter interspersed with larger 50mm square sectioned posts. All uprights united with one horizontal bar. Railings to the party fence walls running

perpendicular to these have wider spaced square sectioned posts only. These are more likely to have had railings similar to no. 14 shown below.

- 8.5 Restoration of lost railings and gates could be an informed conservation project or grant scheme, as photographic evidence survives showing the original designs.

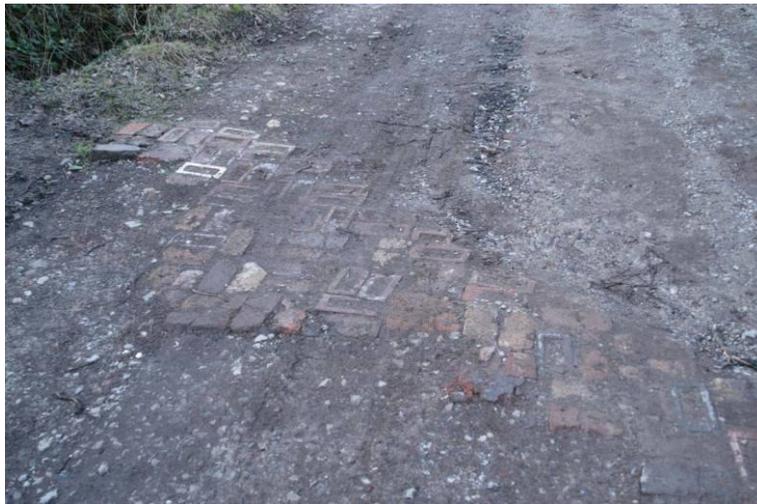
FIGURE 15: *Historic street surfaces*

- Gutter, pavement and kerbing in York stone have survived - but are in an appalling start of repair.
- There are surviving kerbs in the service road to the north.
- The original road surface may have been topped with gravel, but the existing surface is compacted earth and hardcore now lacking any bound surface to shed the rain.

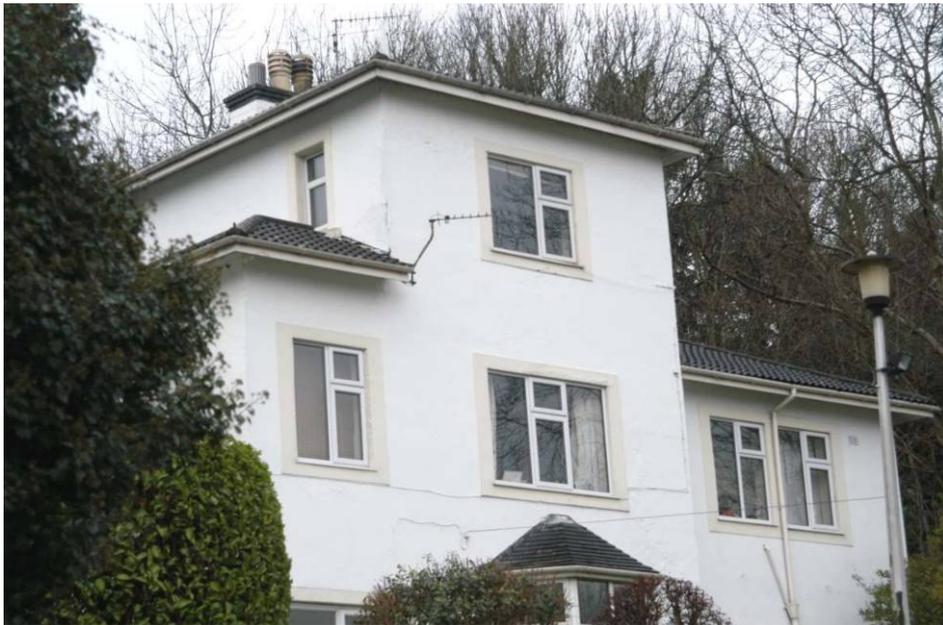
**FIGURE 17:** *Harmful modifications.*

- Loss of entrance gates and insensitive enclosure at the entrance now gives a poor impression
- Off-road parking in the central area has become congested
- Replacement windows and doors, particularly those made of PVCu. These are often of varied design within terraces, spoiling their harmony, while plastic windows are intrinsically harmful to the appearance and fabric of historic buildings.

- 
- Loss of original gates and railings to fronts of properties
  - Loss of original boundary walls
  - The poorly designed extension and alterations to nos. 1 and 24 The Villas disfigure the buildings and spoil the approach from London Rd.
  - Poor signage at entrance and poor replacement lamp standards of a variety of designs within the estate, especially at focal points such as the centre of the terrace and at the centre of the turning circle.
  - The loss or replacement of original chimney stacks
  - The loss or replacement of original roofing tiles
  - Poor condition of road surface, pavements, gutters and boundary walls especially those to the rear
  - Poor condition of original outbuildings

- 8.4 Work needs to be done to improve the entrance to the estate. No. 1 and 24 both suffer from large inappropriate extensions which can be modified to improve their appearance. Landscaping could be beneficial here. The cinder wall opposite the entrance would benefit from a central feature.
