# Dresden Conservation Area Appraisal

*March 2008*

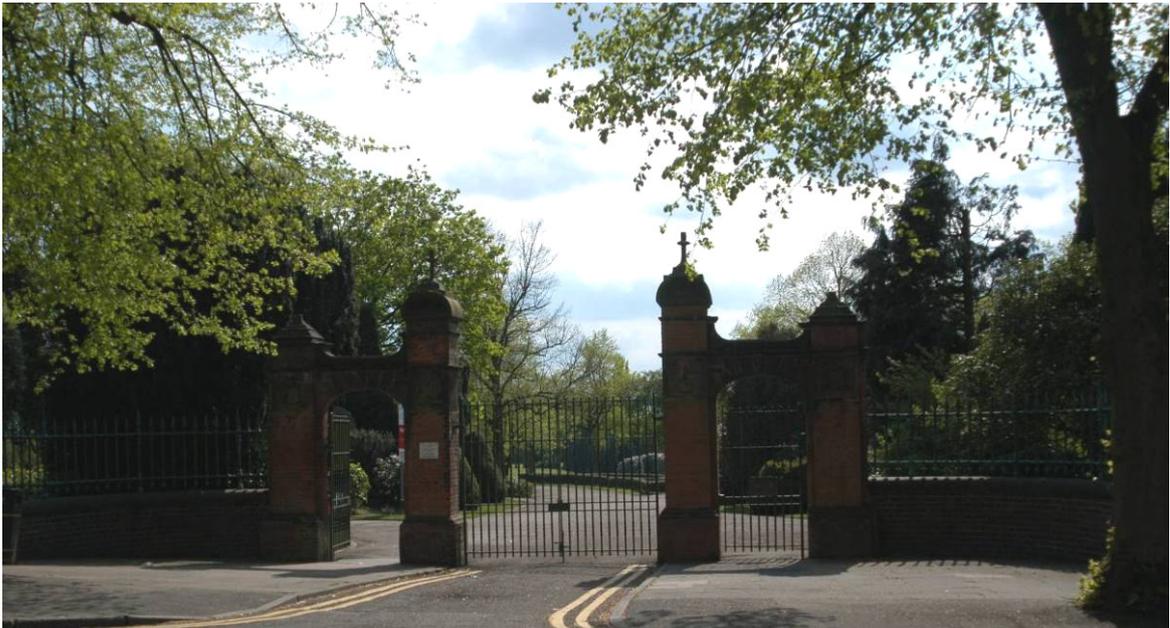
**FIGURE 4:** *Showing the intimate relationship between the estate and the park*

- The whole area is dominated by greenery and in particular large mature trees. The park has a large expanse of green space which extends out to the tree lined Queens Park Avenue.
- From inside the park through the lines of large trees and rhododendrons, the houses of Approach 2 and 4 are partially visible.

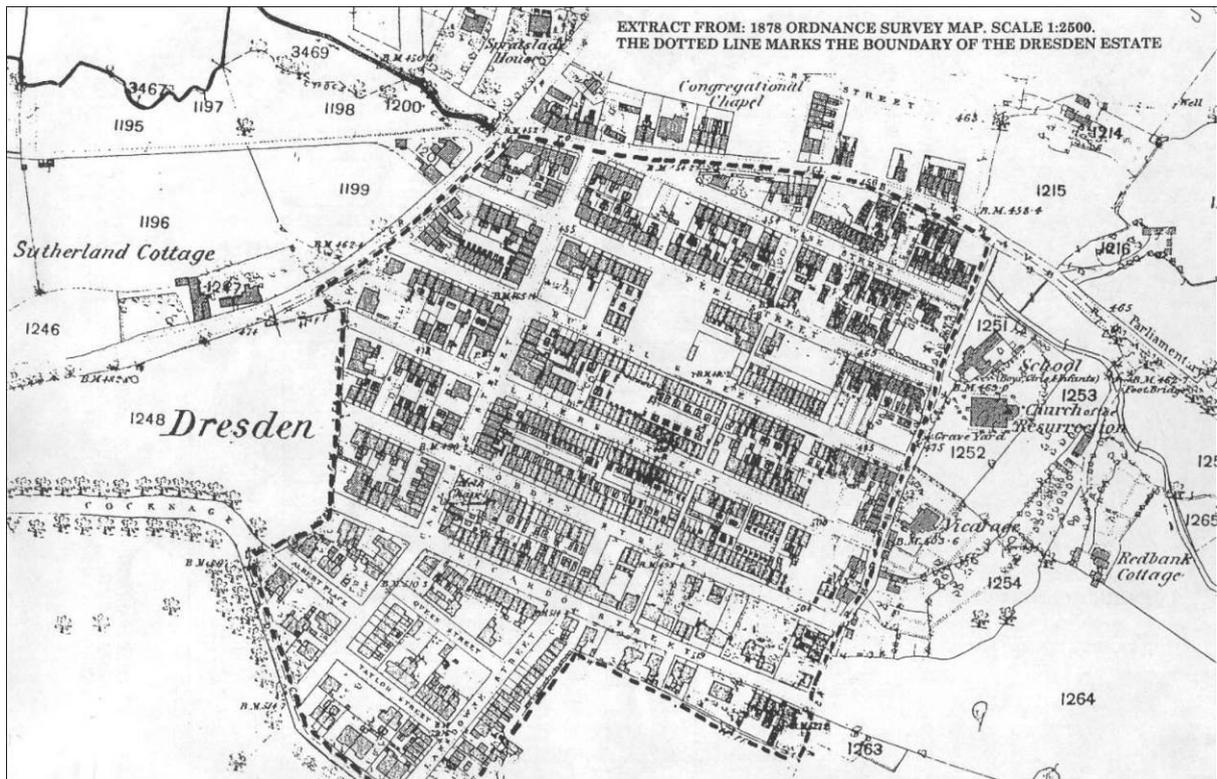
**FIGURE 9:** Map of the estate in 1878  
[http://www.thepotteries.org/maps/1878\\_dresden.htm](http://www.thepotteries.org/maps/1878_dresden.htm)

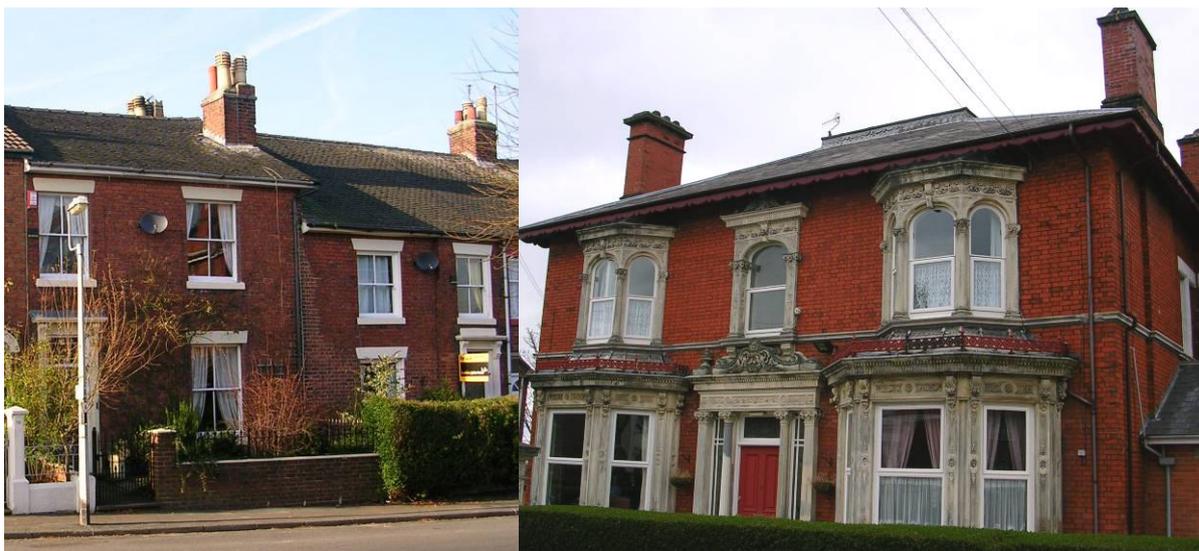
**FIGURE 10:** *Contrasting detailing within the Conservation Area whilst still retaining a similarity of style*

The Conservation Area is stylistically very mixed. Whilst the buildings cover two distinct periods, the styles vary considerably due to the nature of the development. Houses range from the elaborately decorated Dresden House to smaller plain brick terraced houses. The two periods can be defined as properties built when the estate was created in the 1800's, and the infill development which started in the 1970's. Due to the nature of the development the terraces are not workers' houses but rather genteel well proportioned small terraces.

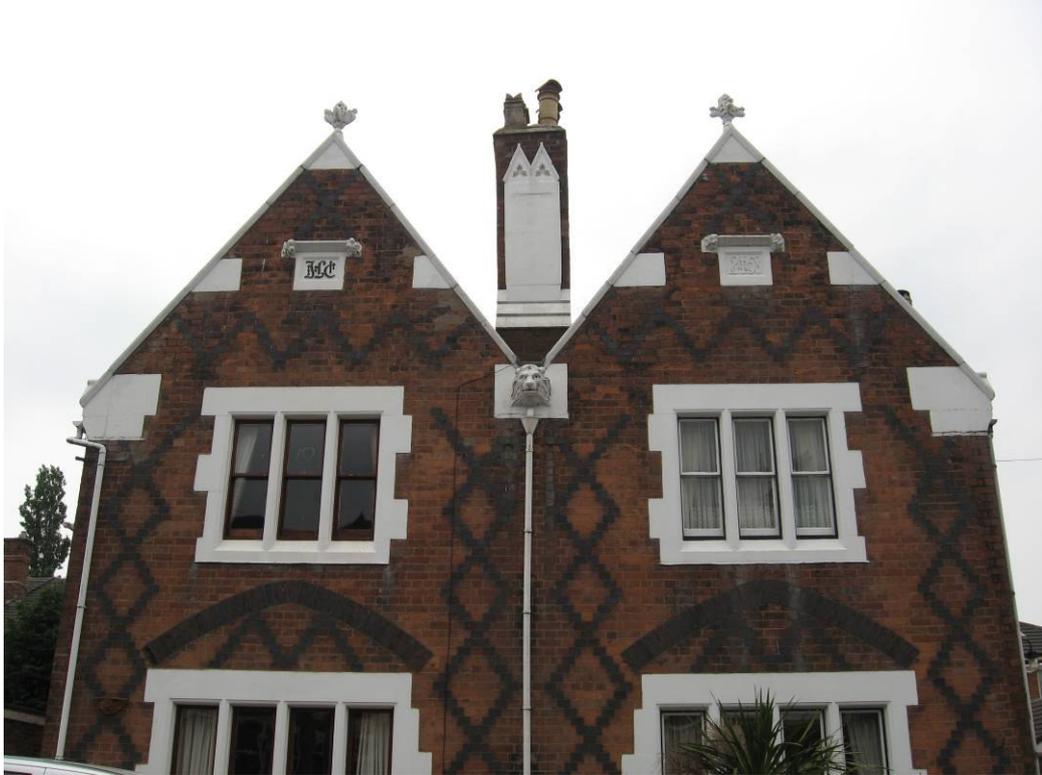
**FIGURE 11:** *Diaper brickwork and stone window surrounds*

Many of the houses within the Conservation Area have no brick detailing and have very simple plain lines. Brick eaves details are plain throughout the Conservation Area with the exception of some of the more ornate houses such as 53 Ricardo Street and 27 Queens Park Avenue. In Rowland Street many of the original houses have decorative diaperwork in Staffordshire blue brick with relieving four centred arches also accentuated by use of diaperwork.

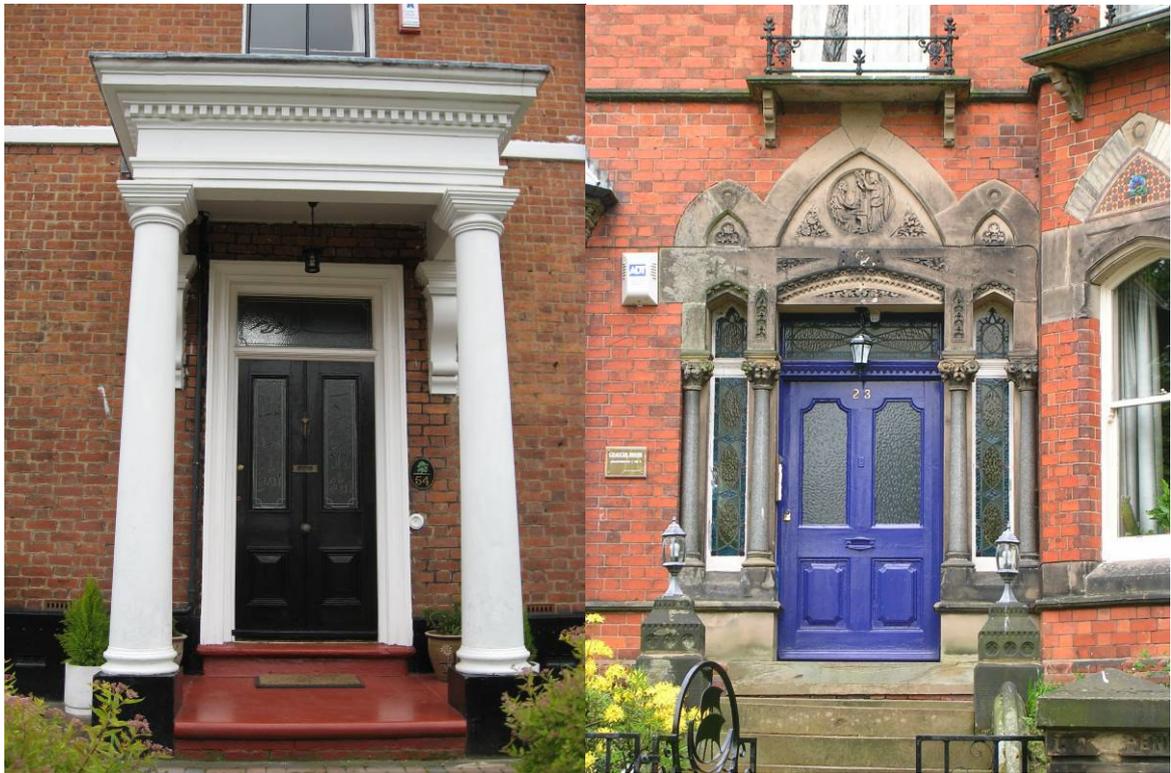
**FIGURE 12:** *Showing two very different styles of stone detailing showing the mixture of styles throughout the Conservation Area*

A majority of the buildings in the Conservation Area are brick but many have plain rendered gable ends. Some buildings lost their character by being completely rendered such as 72 and 74 Carlisle Street. Tile hanging is also visible on the gable of no 15 Queens Park Road.

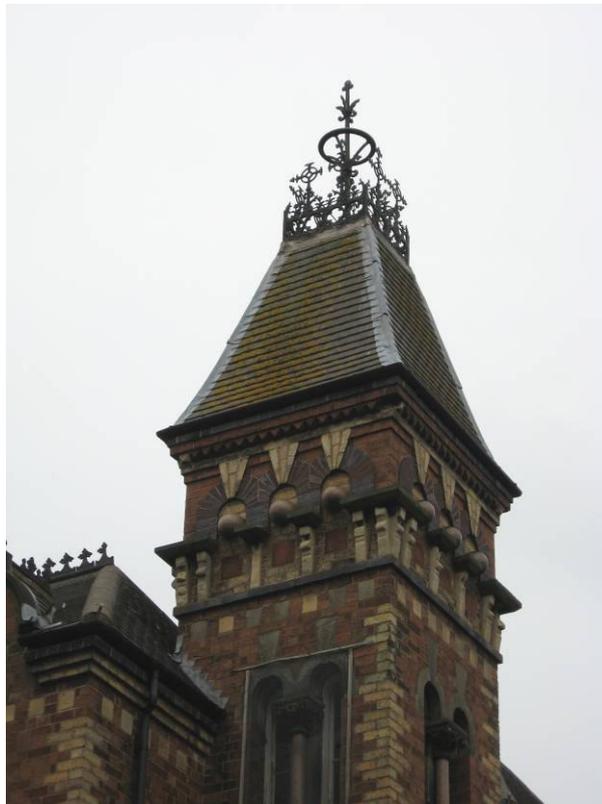
**FIGURE 13:** *Roofs: The tower of the Tower House showing the complex detailing*

Most roofs carry local dark blue-purple tiles. A few of the houses within the Conservation Area have been re-roofed in a concrete tile. The exception to these is those few houses that retain their slate roofs such as 11 Mercer Street, 23 Queens Park Avenue and 69 Ricardo Street. A majority of the houses within the Conservation Area have simple gable roofs without embellishments. 39 Cocknage Road has a double span gable roof, as does the Tower House (no 53 Ricardo Street) which also has the addition of a tower with a square truncated spire with detailed decorative ironwork at its top. There are a few decorated ridge details within the Conservation Area, particularly along Queen Park Avenue. Deep eaves with eaves details decorated in stone, brick or timber boarding are common throughout the area. Chimneys play a strong part in the character of the area with most housing having tall traditional chimneys, some with decorative detailing such as the chimneys at 23 and 27 Queens Park Avenue.

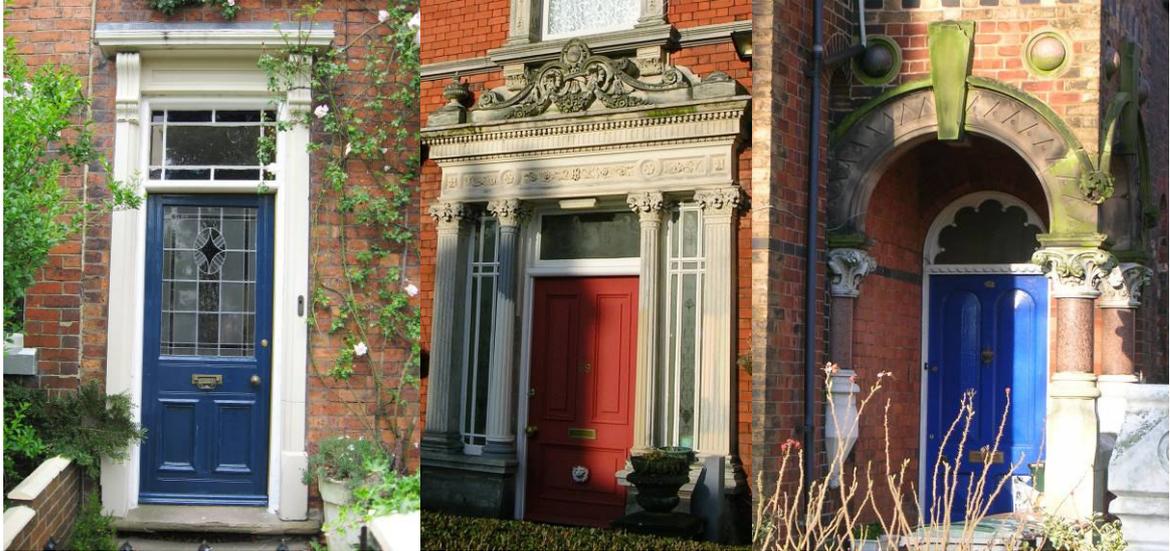
**FIGURE 14:** *Examples of unaltered or original front doors*

Few original or unaltered front doors survive although some particularly fine examples can be seen on Queens Park Avenue and Ricardo Street. Doors are an important feature of the Conservation Area as they are generally on the front elevation of the properties.

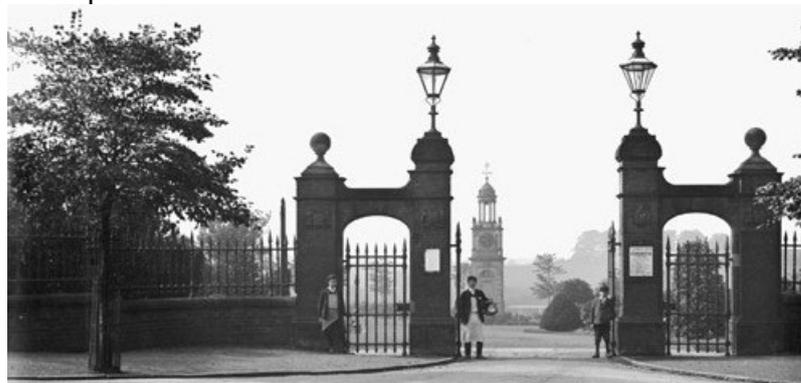
**FIGURE 15:** *Historic photo c1920 Queens Park Gates*

- Several constructional details are worthy of note including the park gates, which have sadly lost their lamps.

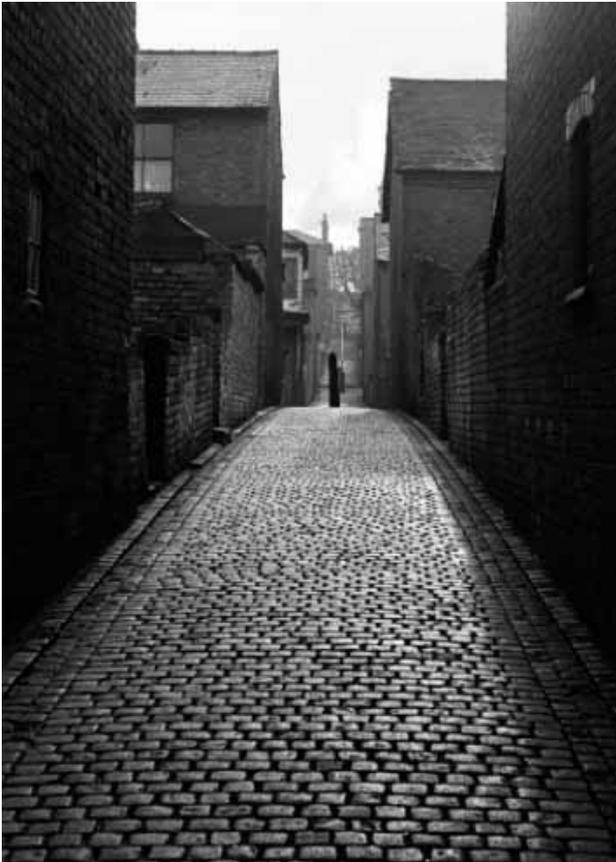
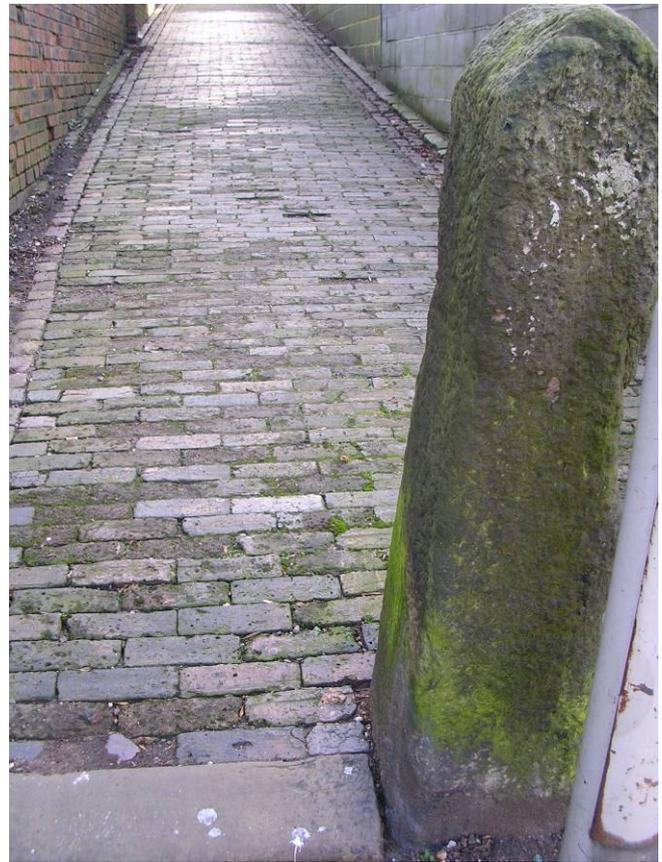
**FIGURE 16:** *The alleyway in 1967 and today retaining its street furniture*

- Original street, pavement and kerbing materials have been almost entirely replaced with tarmac or concrete slabs across the Conservation Area. The alleyway between Cobden Street and Ricardo Street and one of the entrances to a house in Queen Park Avenue are laid out in blue brick and retain an historic surface.
- The lack of street furniture in the Conservation Area enhances its open and uncluttered feel. Very little original street furniture has survived.

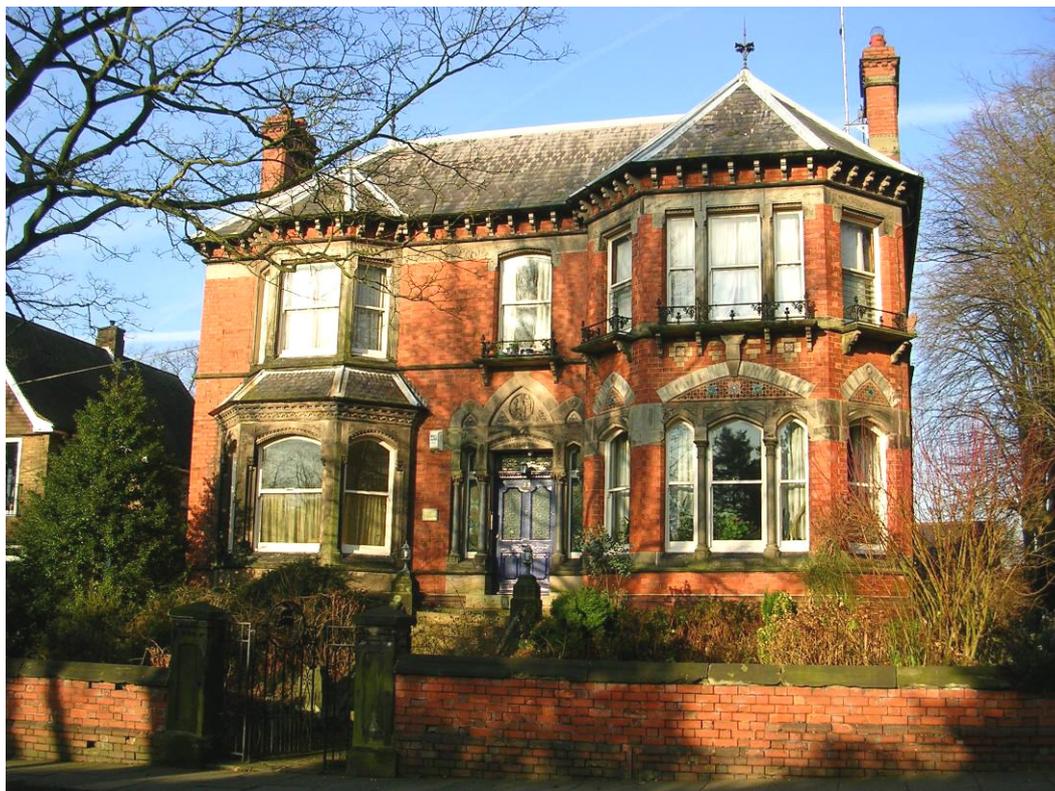
**FIGURE 17:** *Chaucer House (No 23), Queens Park Avenue*

- *Chaucer House (No 23), Queens Park Avenue:* A large detached dwelling with an impressive street frontage, with two full height canted bays on either side of the front door. Decorated door and window arches to ground floor and decorated cills to first floor with a plain slate roof. One of the most visible and prominent buildings along Approach 4.

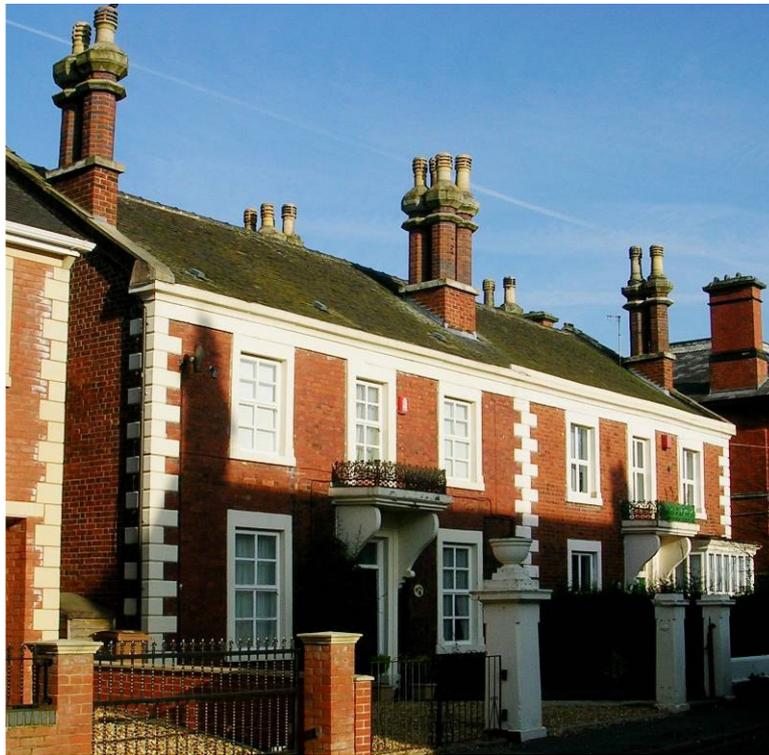
**FIGURE 19:** *Nos 65 and 67 Ricardo Street showing the tall chimneys*

- *54 Ricardo Street:* a large detached villa residence opposite to Eldon House. Built in a plan style it still retains its large chimneys, sash windows and elegant porch supported on two columns. The garden to the side has been built on but a reminder of where the garden was is visible in the full height side bay windows.
- *Nos 65 and 67 Ricardo Street:* Two similar semi detached houses which, despite losing some of their original features, retain their character. Built in brick with projecting dress stone quoins and stone eaves and copings. The two properties both have projecting porch with decorated metalwork as a top detail and also retain all 6 tall chimneys with stone detailing.

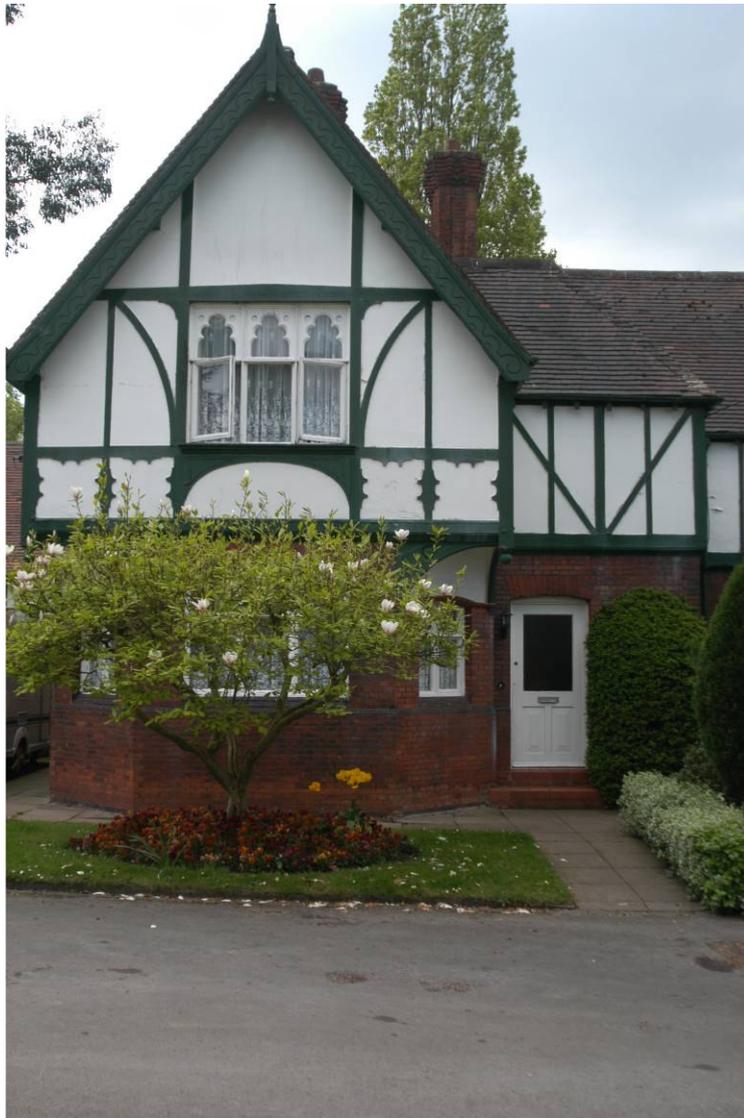
**FIGURE 20:** *The North lodge*

- *The Park Lodges:* The park has two lodges adjacent to both gates. Both are brick, built but the East lodge has a tile hung upper storey and the North lodge is rendered with timber detailing the first storey.

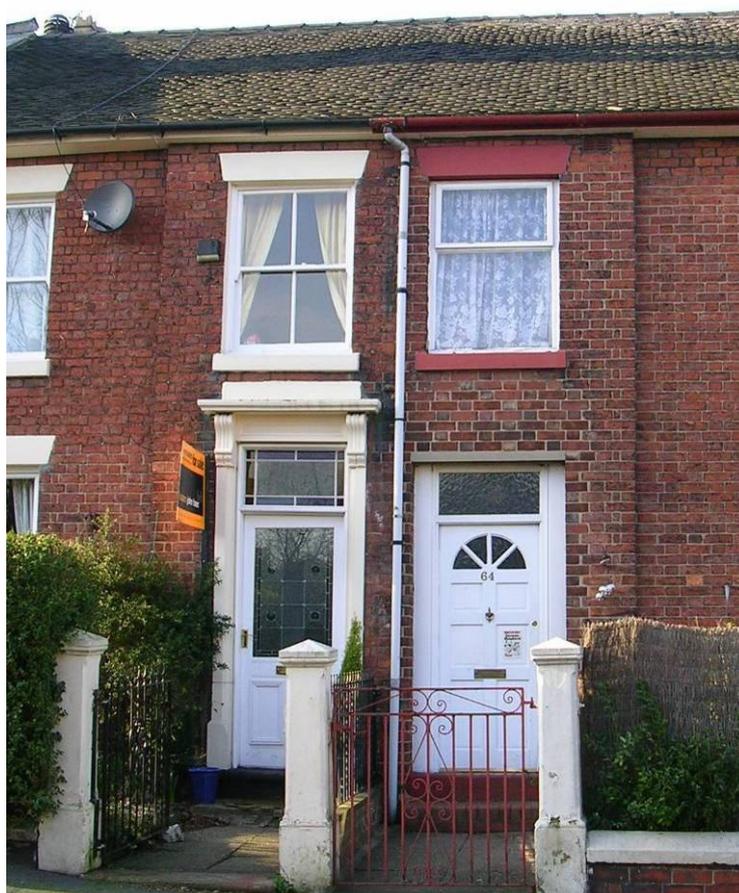
- There are a few buildings of negative character within the Conservation Area. The later infill buildings such as those built in the 1970's and after certainly do not have a positive impact on the Conservation Area, and in fact detract from the character and scale of the area.
- There are buildings of little or no character within the Conservation Area including the two large blocks of flats in Queens Park Avenue which are incongruous with the scale and character of the area.
- Replacement windows and doors, particularly those made of PVCu. These are often of varied design within terraces or semi-detached properties, negating their harmony, while plastic windows are intrinsically harmful to the appearance and fabric of historic buildings.
- The depot in the South East corner of the park is in need of improvement and in particular screening from the park.

**FIGURE 21:** *Harmful modifications. Removal of timber detailing, sash windows and timber doors and replacement with inappropriate uPVC*

- 6.1 Replacement windows and doors, particularly those made of PVCu, can seriously harm the character of the Conservation Area. There is currently no Article 4(2) Direction which covers windows and doors in the Conservation Area.
- 6.2 Careful consideration should be given to further proposals relating to infill development as it can damage the character of the area and alter the special layout of the original estate, detracting from the Conservation Area's character.
- 6.3 Maintenance of the park is vital to the upkeep and character of the area.
- 6.4 The park's lodge house on Queens Park Avenue is currently vacant. This building is situated in a prominent position next to one the park entrances.

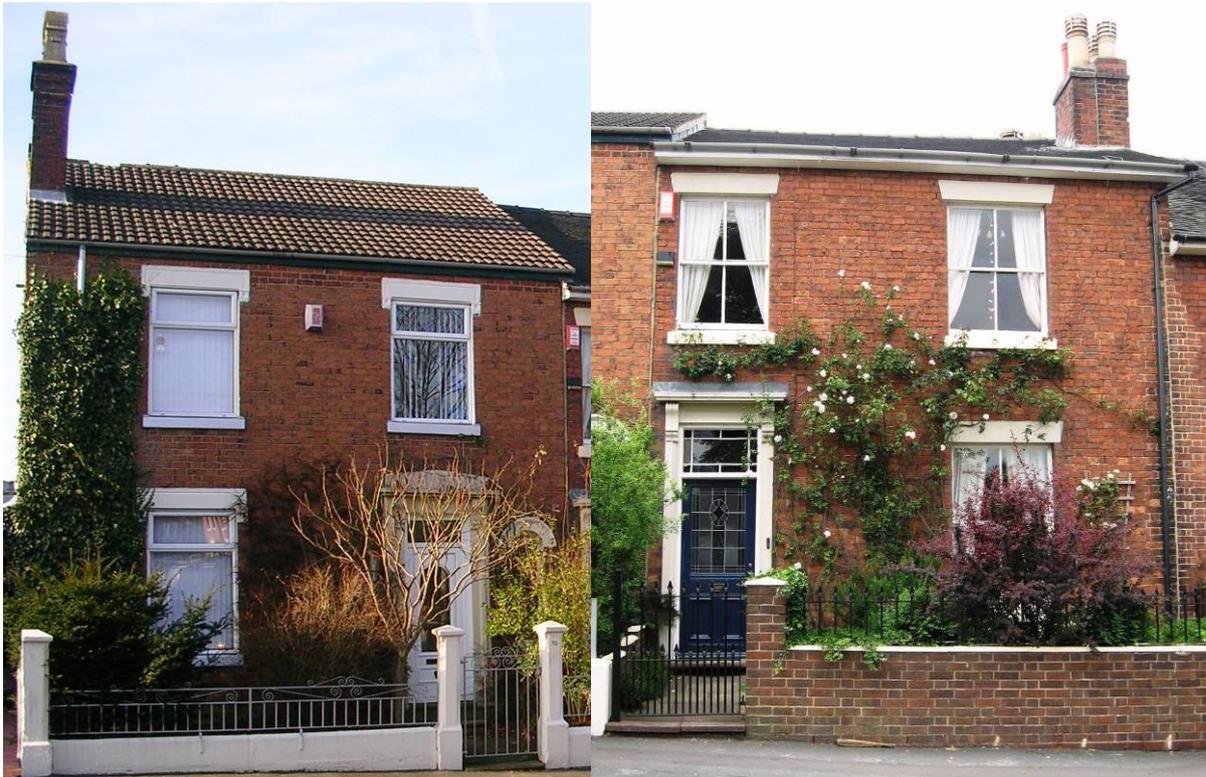
**FIGURE 22:** *Example of inappropriate changes and how this alters the character of a house*

- 8.1 Boundaries Boundaries in each case are suggested by natural breaks in townscape character or historical developmental patterns and relationships. Current boundaries are appropriate and therefore no boundary revisions are proposed.
- 8.2 The survival of many original features including windows and boundary walls is a crucial aspect of the special interest of the Conservation Area and demands the consideration of Article 4(2) designations to prevent insensitive modifications. Provision of generic guidance to householders on sensitive home improvement options should be considered whether or not a new Article 4 designation is approved.
