# **Feasibility Study – Final Report**

Burslem Indoor Market

Queens Theatre

Wedgwood Institute

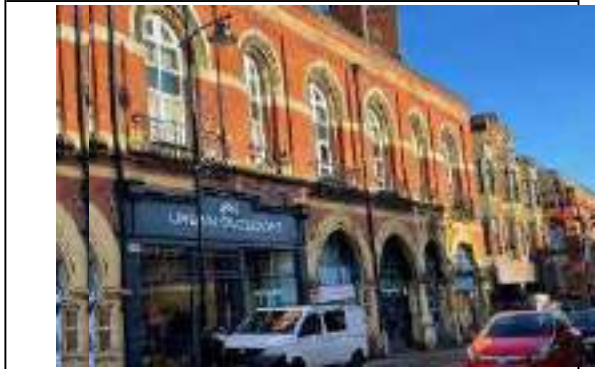
Photo 1 - Front elevation, Queen Street.

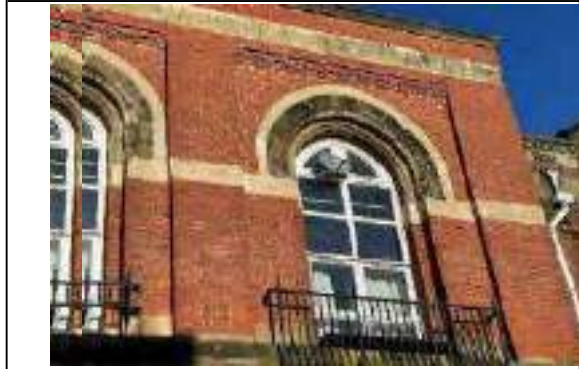
Photo 2 - Second floor windows, and stonework window surrounds showing signs of erosion.

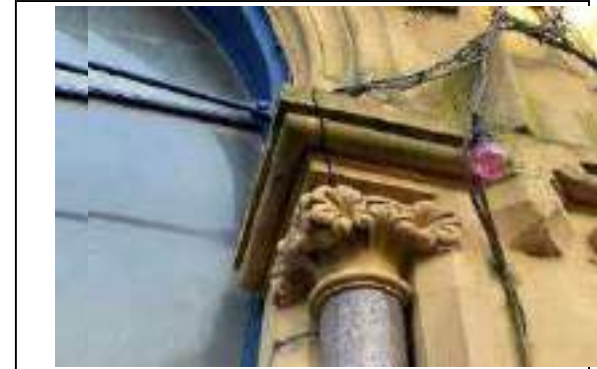
Photo 3 - Crack noted to the front elevation stonework surround of the door.

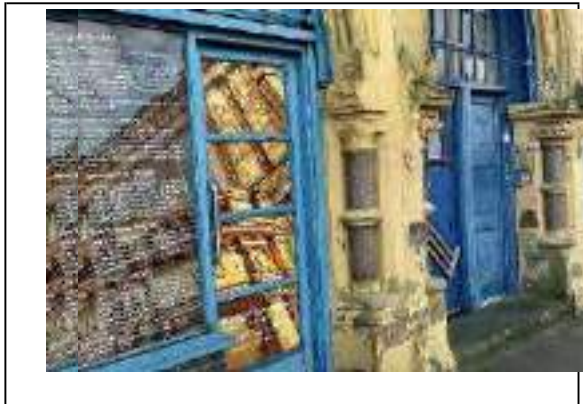
Photo 4 - Front elevation shop front and entrance.

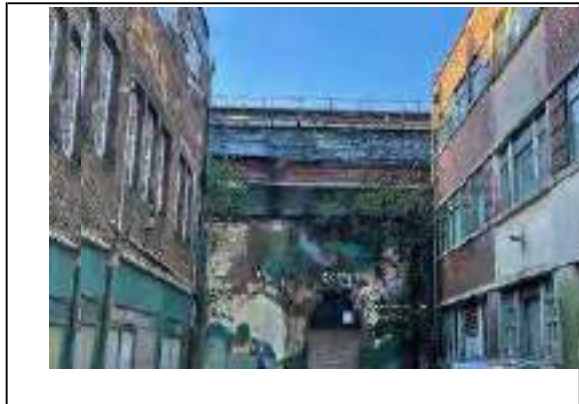
Photo 5 - Keates Street entrance, flaking paintwork, damaged brick faces, and defective tiling to the roof.

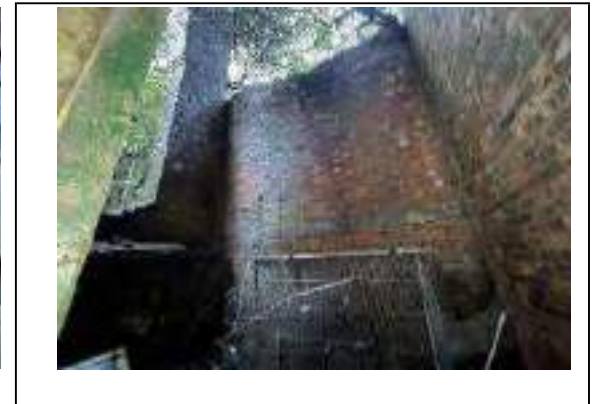
Photo 6 - External wall of the market, East elevation, located within the adjoining property on Keates Street. Showing signs of structural movement.

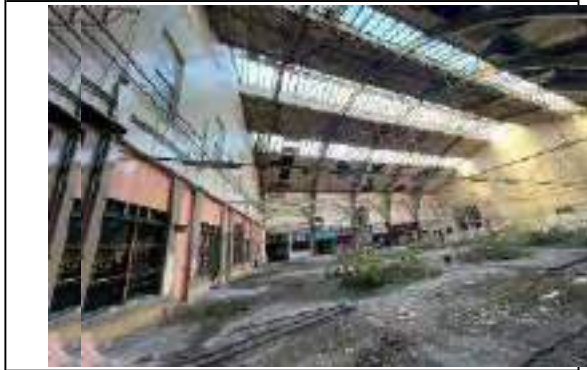
Photo 7 - Internal market area, vegetation overgrowth to the central area of the hall. Perimeter units general overview.

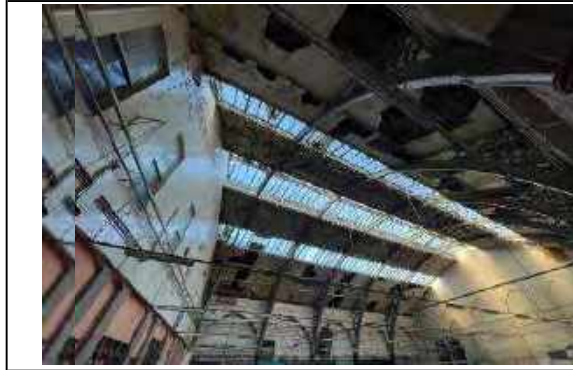
Photo 8 - Overview of the Market hall roof, cast iron, glass and lath and plaster, in poor condition.

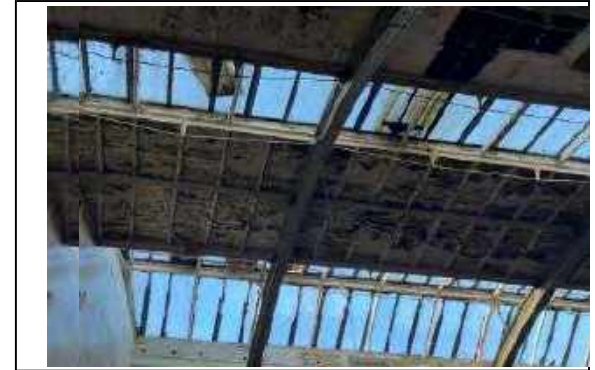
Photo 9 - Closer view of the market hall roof.

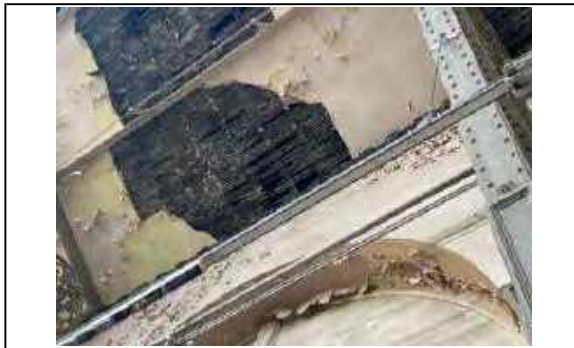
Photo 10 - Lath and plaster ceiling suffering significant decay.

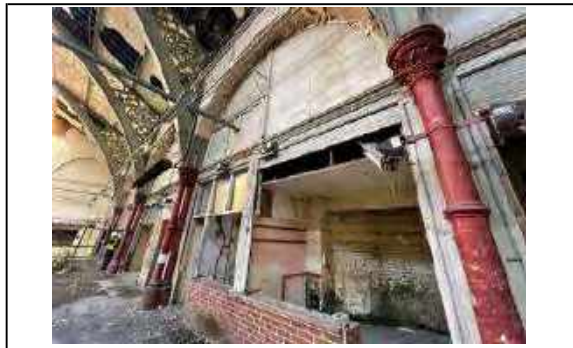
Photo 11 - Example of the unit spaces to the perimeter of the market hall.

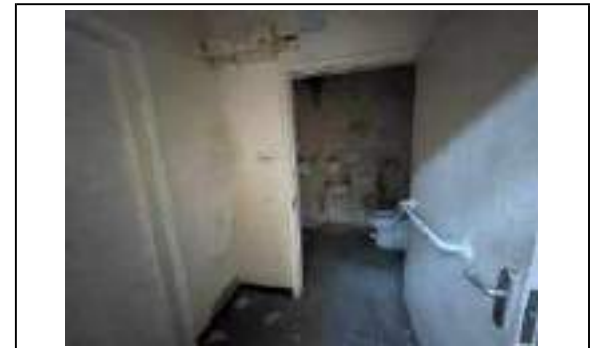
Photo 12 - Accessible toilet.

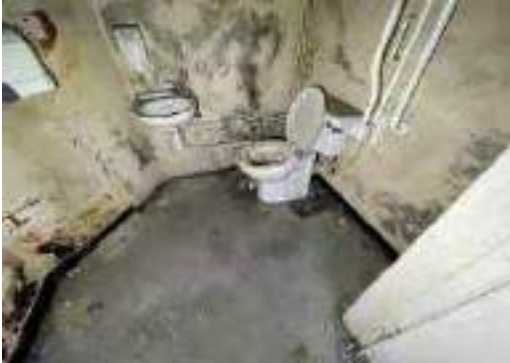
Photo 13 - Significant mould and defective finishes observed to the accessible toilet.

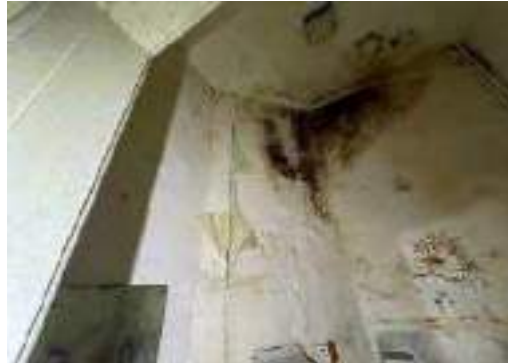
Photo 14 - Mould to the ceiling and walls of the toilets.

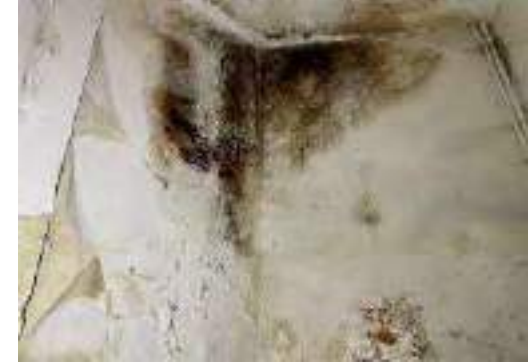
Photo 15 - Mould to the ceiling and walls of the toilets.

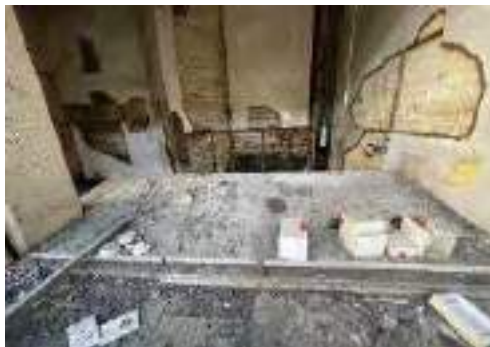
Photo 16 - Aged and defective finishes to the plastered walls of the units.

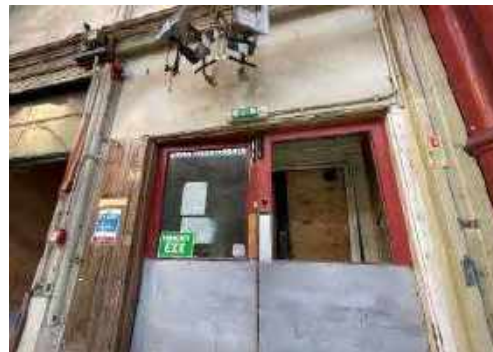
Photo 17 - Keates street access point via double leaf timber doors with vision panels.

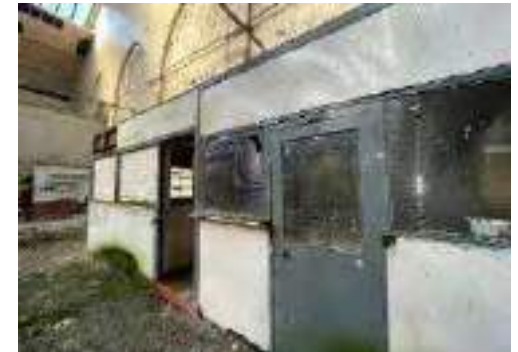
Photo 18 - Partitioned unit to the rear of the market hall, consisting of terracotta tiled flooring.

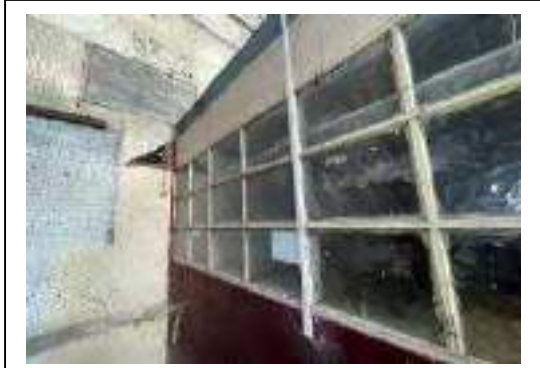
Photo 19 - Vision panels to one of the units.

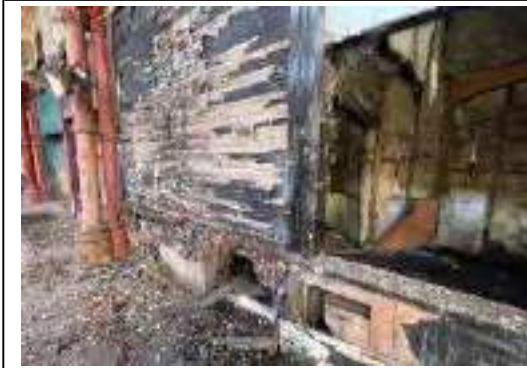
Photo 20 - Timber decay and overall disrepair of another unit.

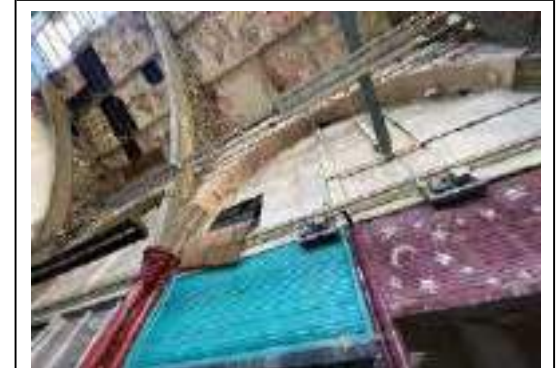
Photo 21 - Rolling shutters to the units.

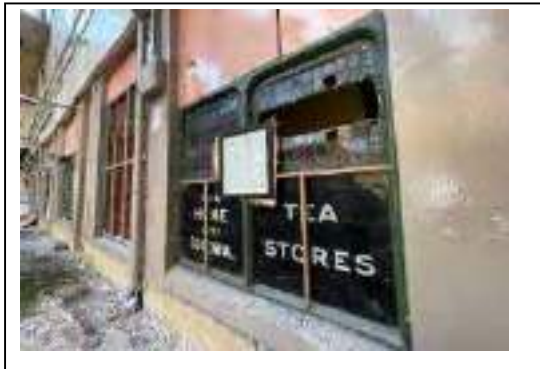
Photo 22 - Etched glass internal windows damaged.

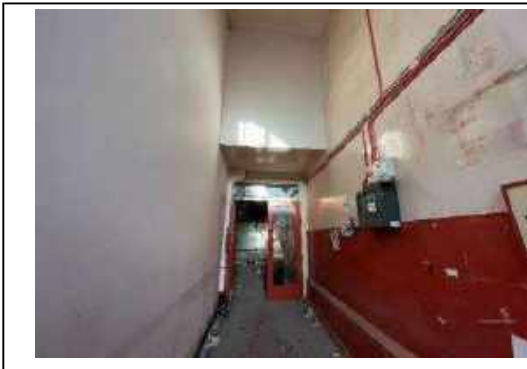
Photo 23- Overview of the corridor to the front entrance from Queen Street.

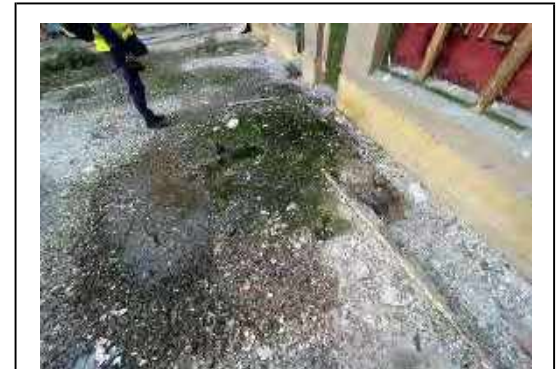
Photo 24 - Section of structurally unsound flooring.

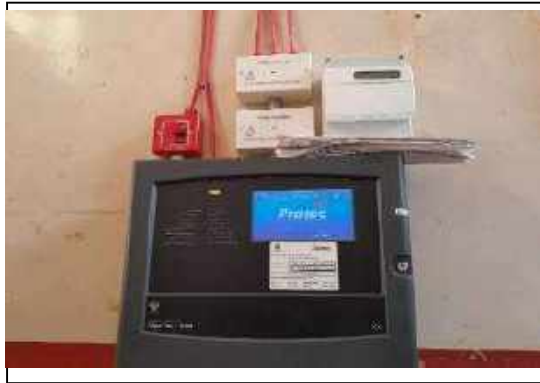
Photo 25 - Fire Alarm Panel

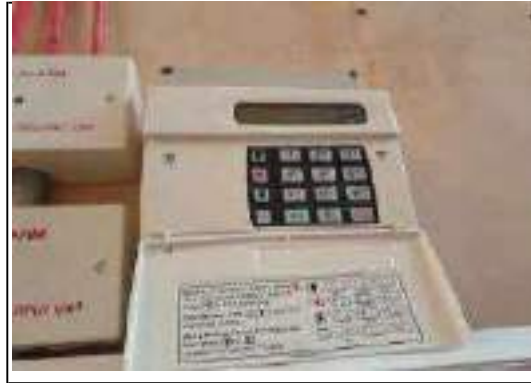
Photo 26 - Intruder Alarm Keypad

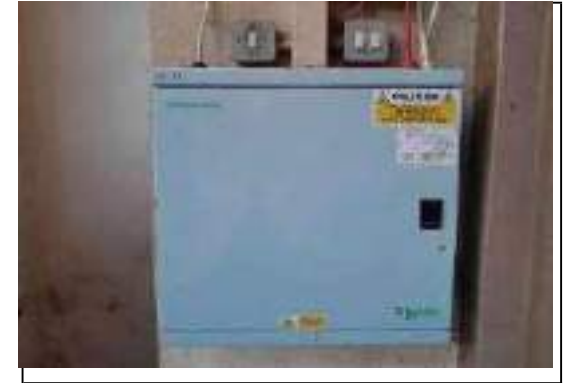
Photo 27 - Distribution Board

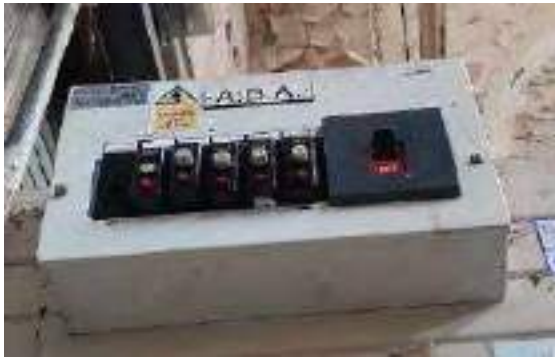
Photo 28 - Retail outlet Consumer Unit

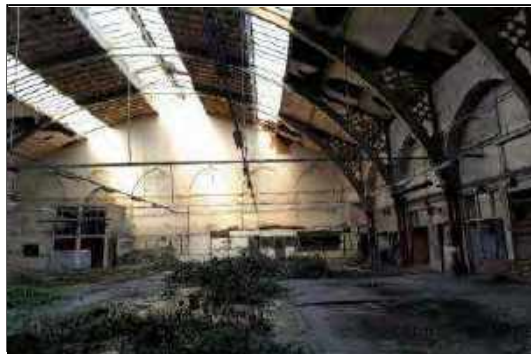
Photo - 29 Market lighting arrangement

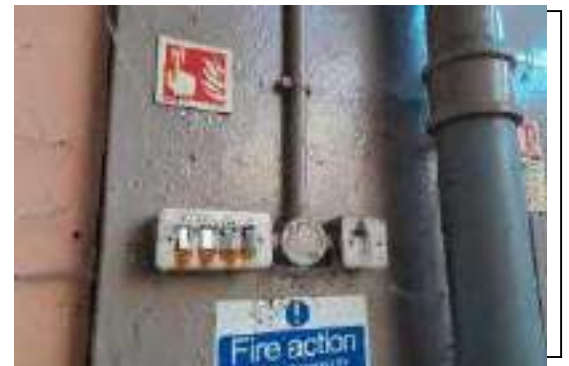
Photo 30 - Corroded light switches

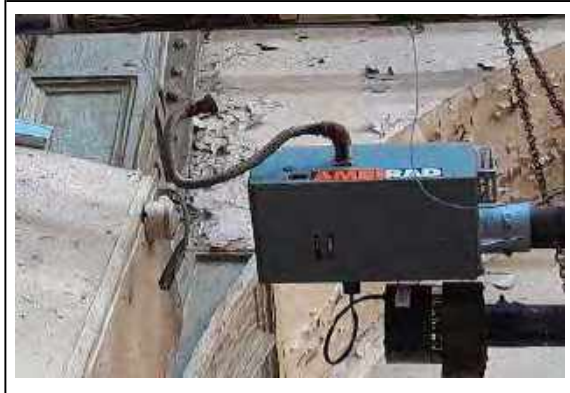
Photo 31 - Radiant tube gas burner disconnected from gas supply.

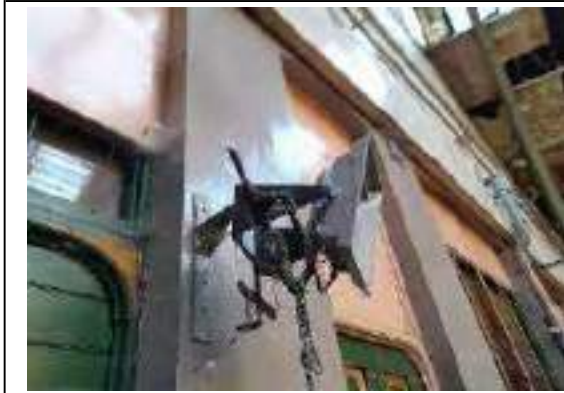
Photo 32 - Radiant plaque gas heater, disconnected from gas supply.

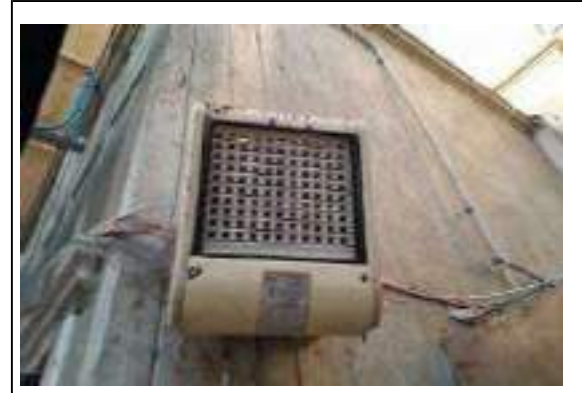
Photo 33 - Radiant plaque gas heater, disconnected from gas supply

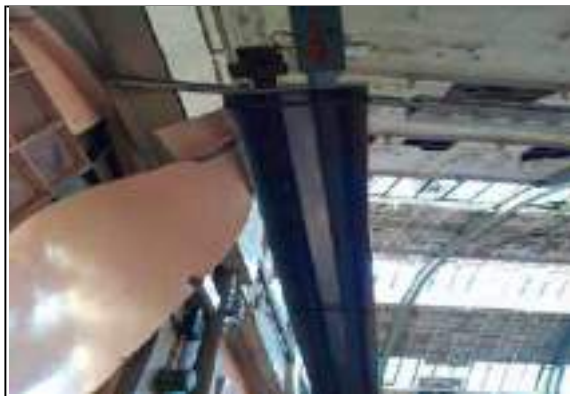
Photo 34 - Gas fired radiant tube heater

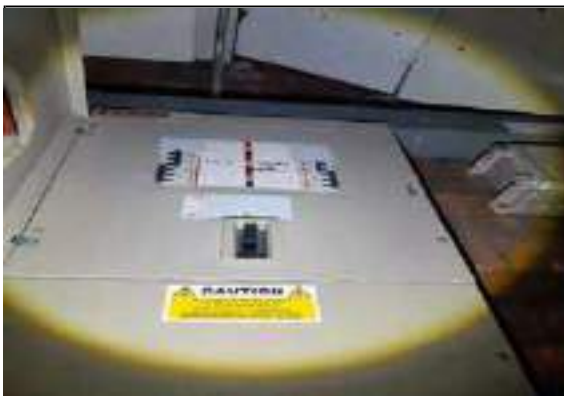
Photo 35 - Main distribution board

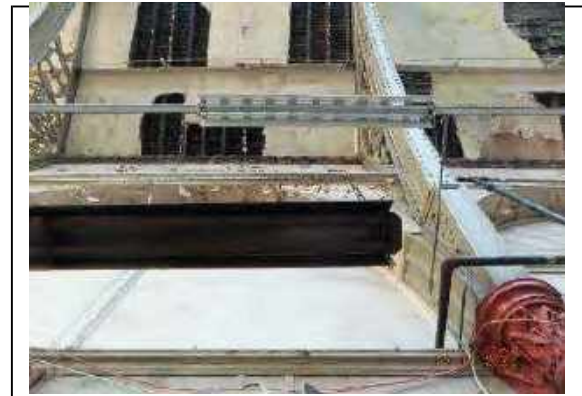
Photo 36 - Lighting

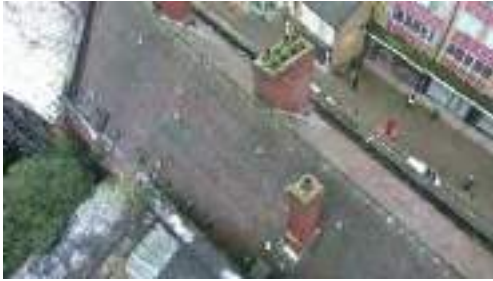
Photo 37 - Chimney and pitched roofs above the flats.

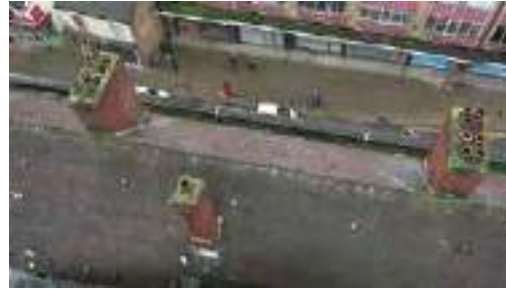
Photo 38 - Chimneys in poor condition.

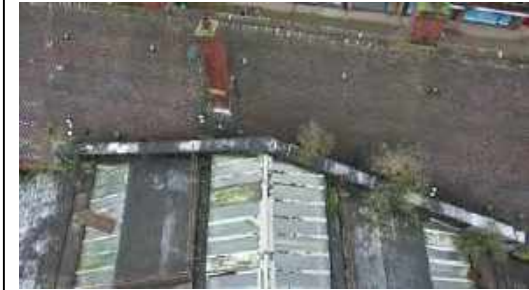
Photo 39 - Junction of the flats and market hall.

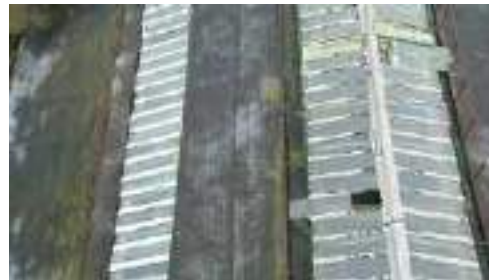
Photo 41 - Slipped glass panels.

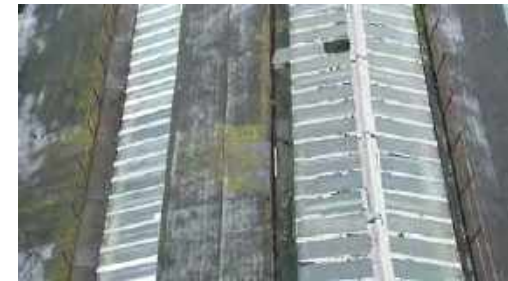
Photo 42 - Market Hall roof overview.

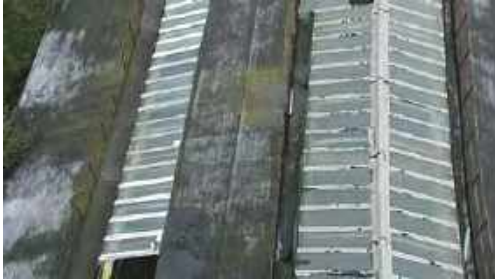
Photo 43 - Glazed roof to market hall.

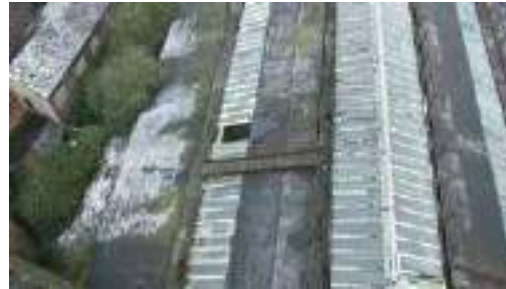
Photo 44 - Roof in overall disrepair.

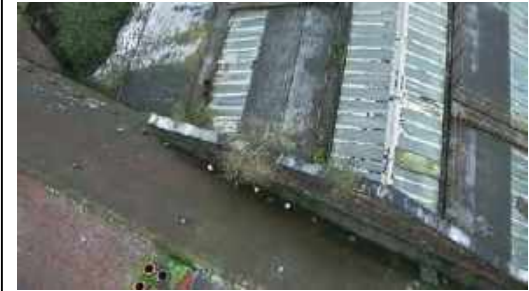
Photo 45 - Vegetation growth to the junction of roofing.

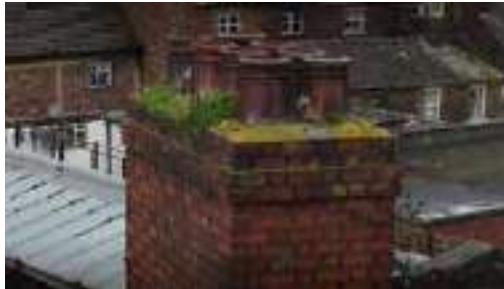
Photo 46 - Vegetation growth to the chimney pots.

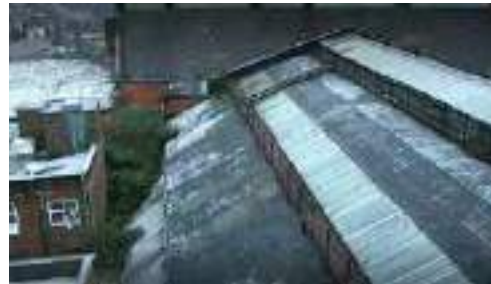
Photo 47- Overview of the roof.

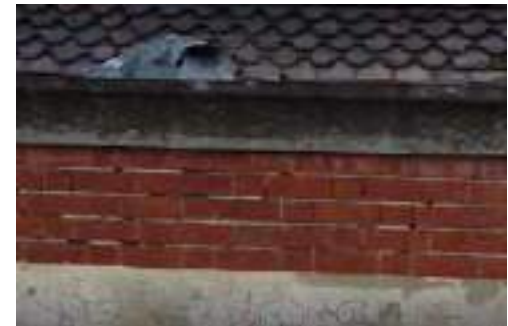
Photo 48 - Repointing needed to the front elevation.

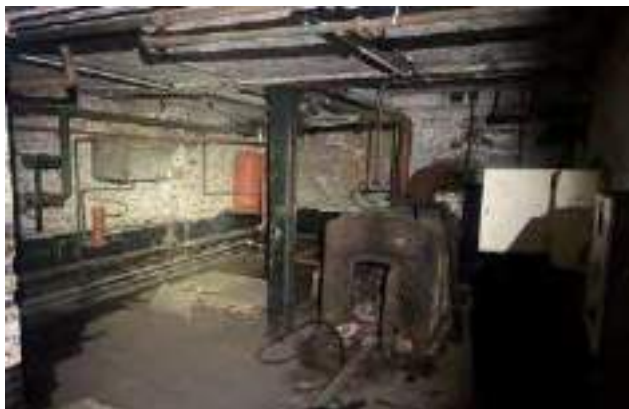
Photo 1 - Existing Heating plantroom

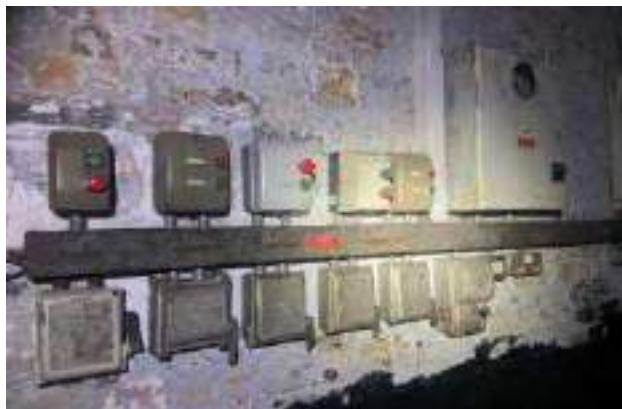
Photo 2 - Electrical switchgear and basic heating control panel

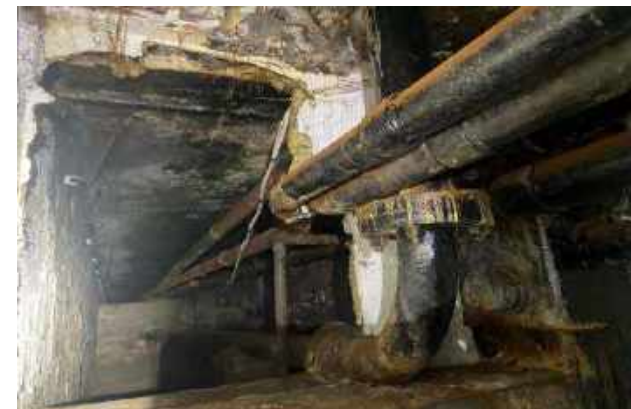
Photo 3 - Existing LTHW pipework

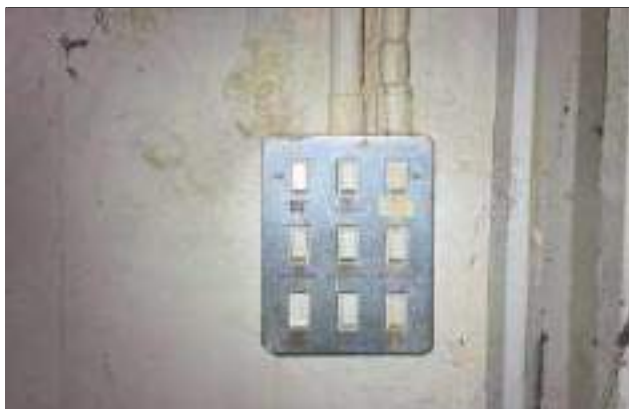
Photo 4 - Multi-gang lightswitch - typical dated construction and finish

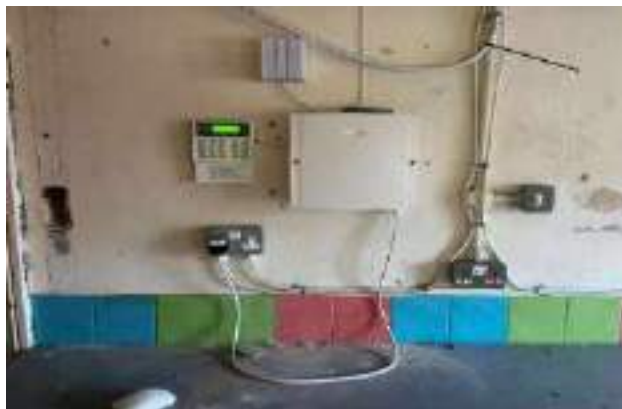
Photo 5 - Temporary intruder alarm system

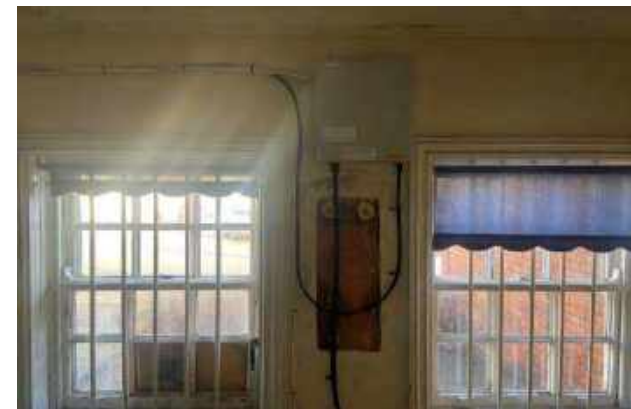
Photo 6 - Temporary LV distribution board

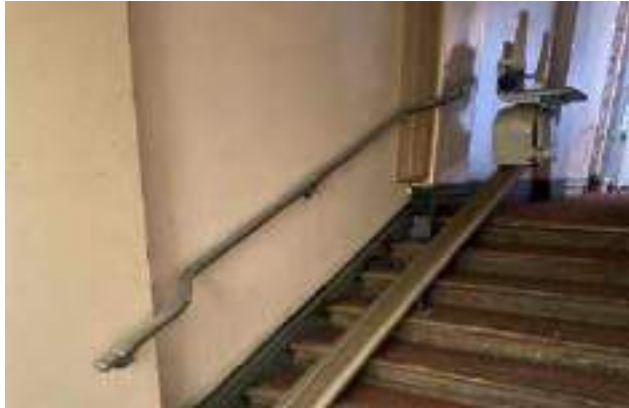
Photo 7 - Existing stairlift

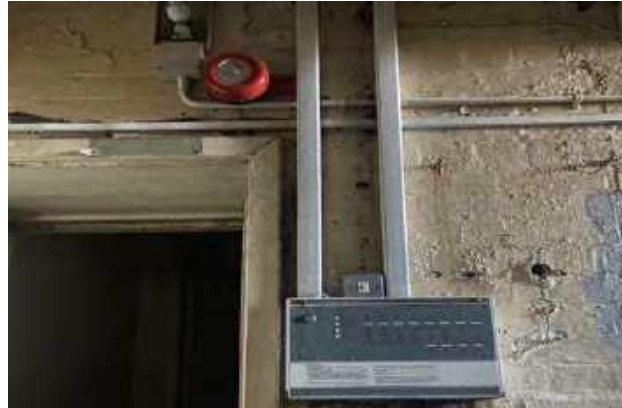
Photo 8 - Redundant fire alarm panel

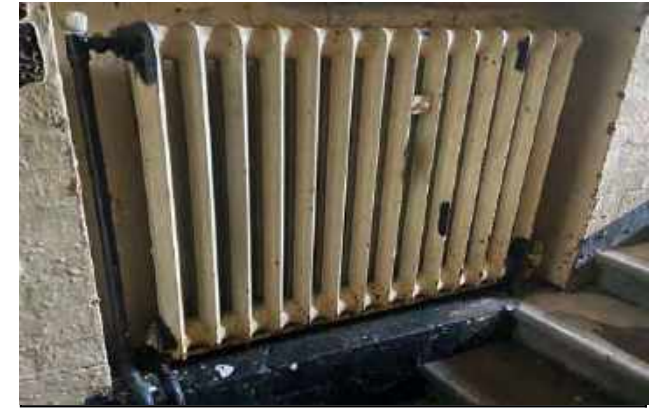
Photo 9 - Typical corridor area steel column radiator

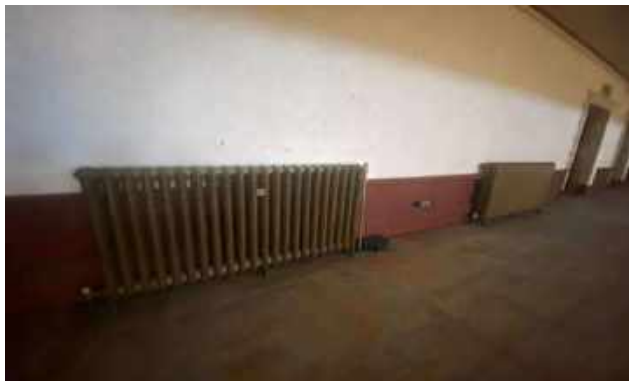
Photo 10 - Typical auditorium area steel column radiator

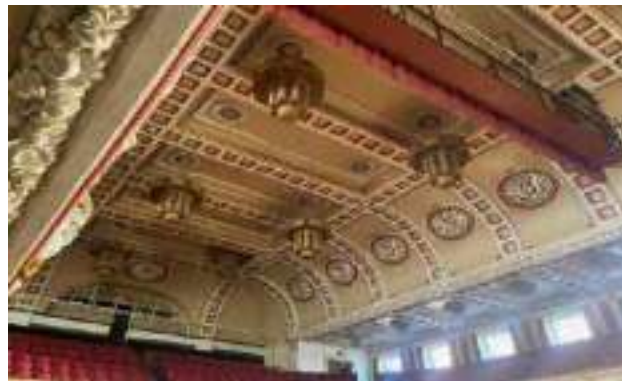
Photo 11 - Auditorium lighting

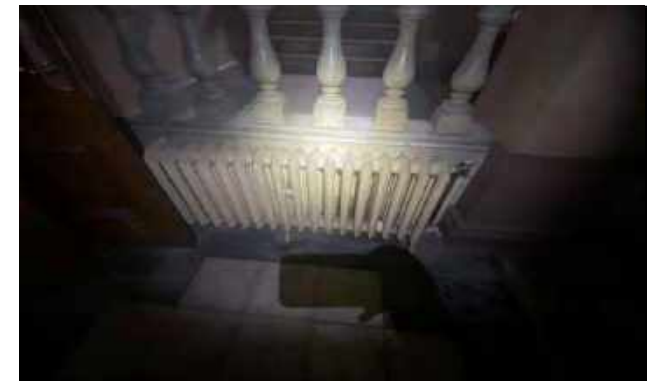
Photo 12 - Typical lobby area steel column radiator

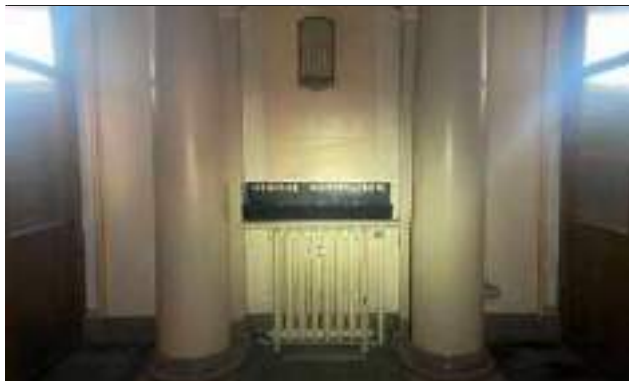
Photo 13 - Typical lobby area steel column radiator

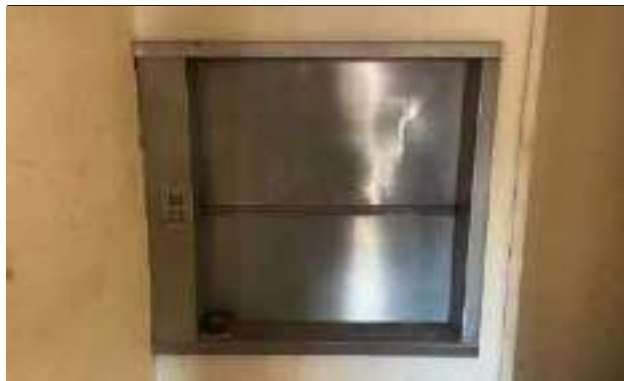
Photo 14 - Redundant dumbwaiter (1 of 2)

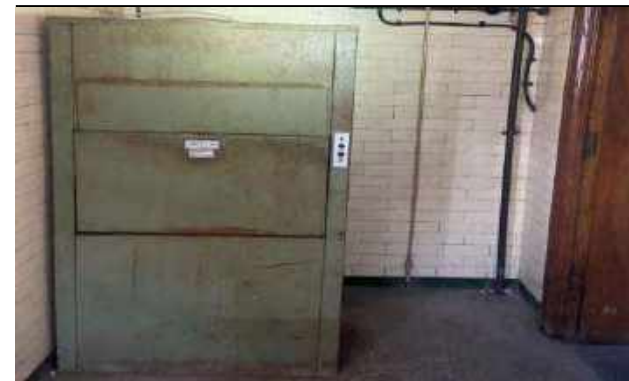
Photo 15 - Redundant dumbwaiter (2 of 2)

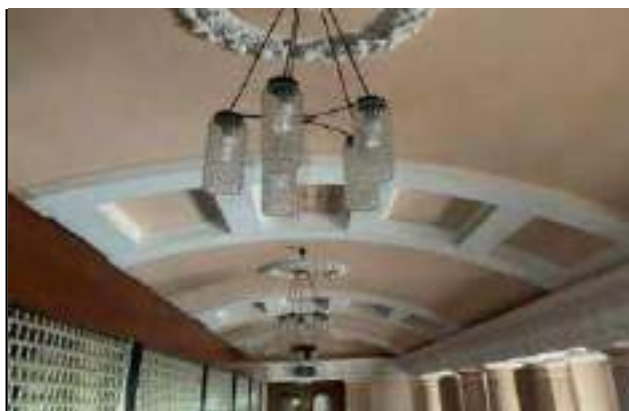
Photo 16 - First floor lobby lighting

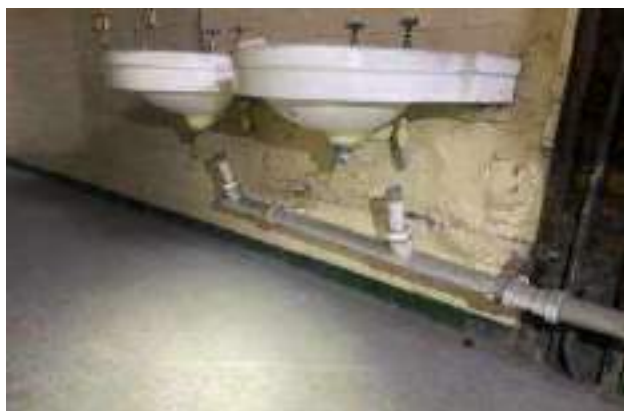
Photo 17 - Existing open-ended waste pipework, and existing lead domestic hot and cold water pipework

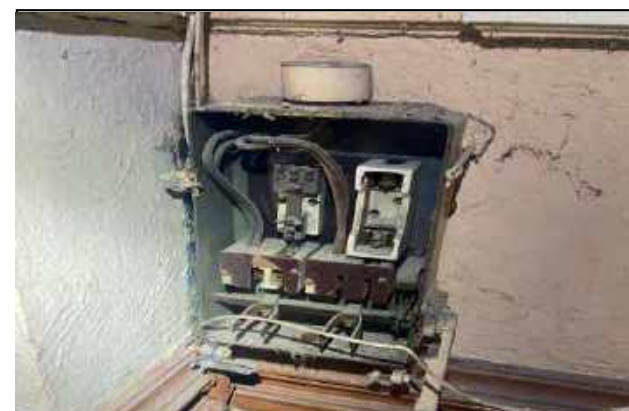
Photo 18 - Existing fusegear

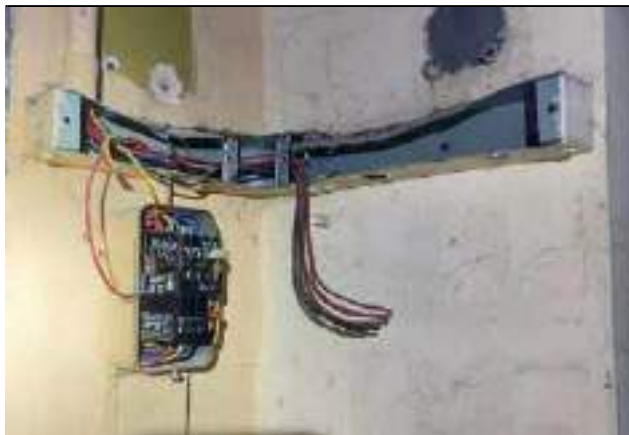
Photo 19 - Existing redundant wiring installation and fusegear

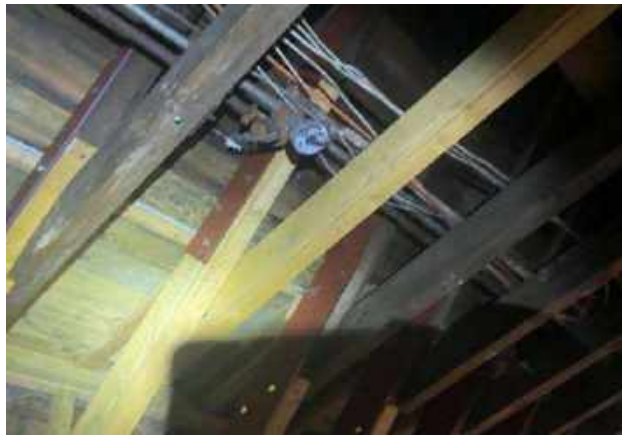
Photo 20 - Existing wiring installation

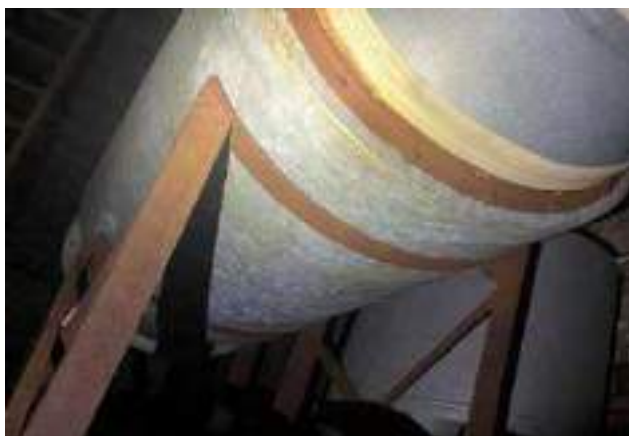
Photo 22 - Existing auditorium ventilation ductwork in roof void

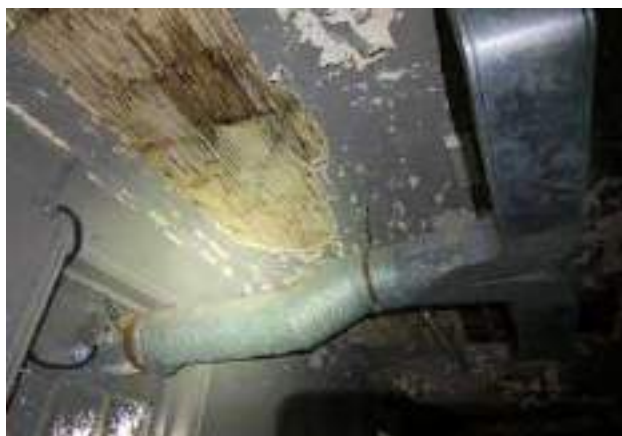
Photo 23 - Existing stage control area ventilation

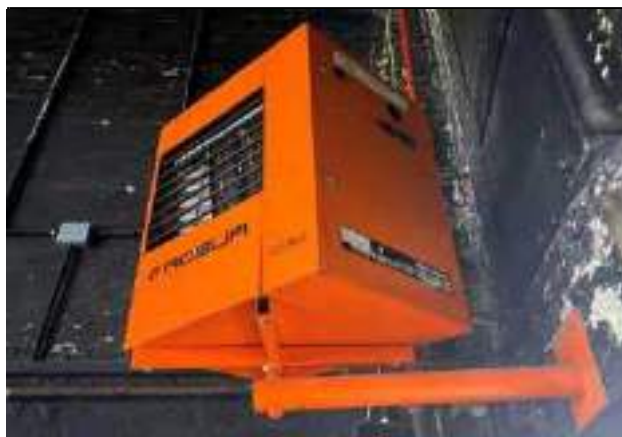
Photo 26 - Gas fired space heater in stage area

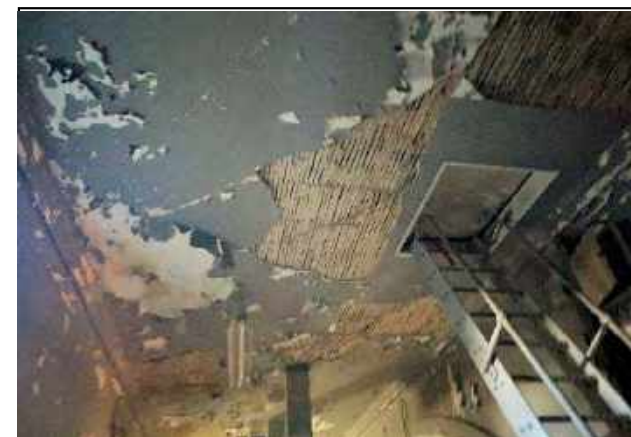
Photo 27 - View of roof access ladder and dilapidated ceiling within lighting control gallery

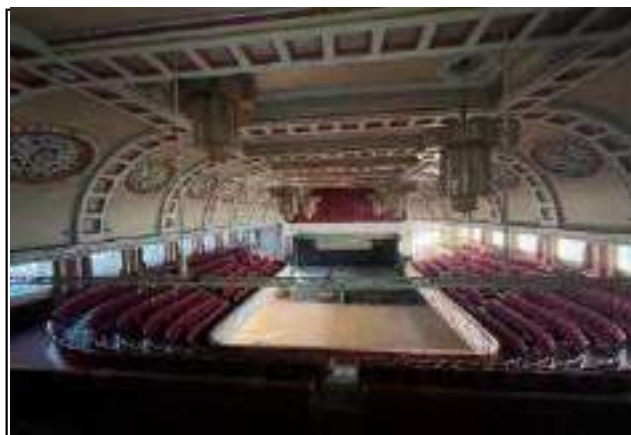
Photo 28 - Main hall viewed from loft area.

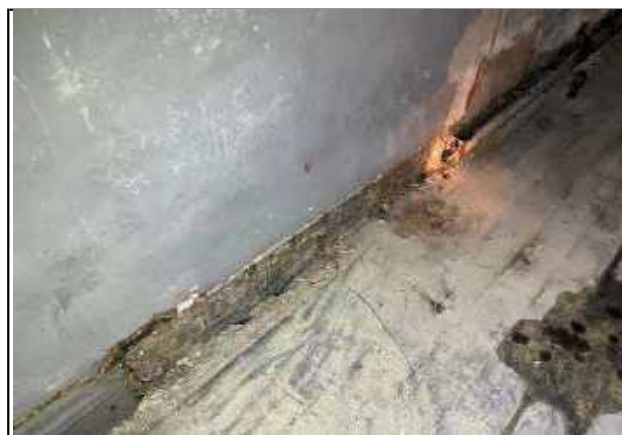
Photo 29 - Dry rot to the timber skirting board in the gallery loft.

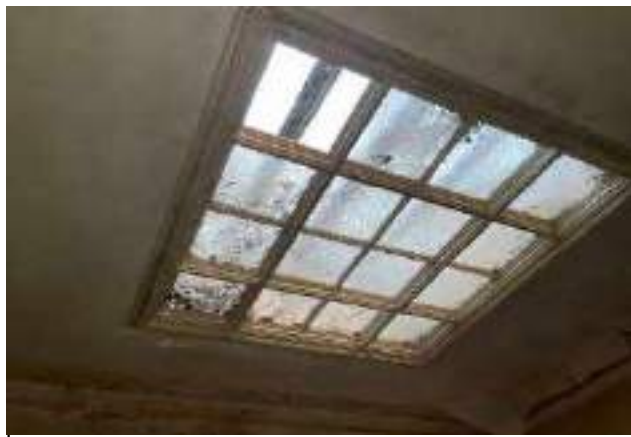
Photo 31 - Skylight to the top floor, beside the loft space and gallery lobby.

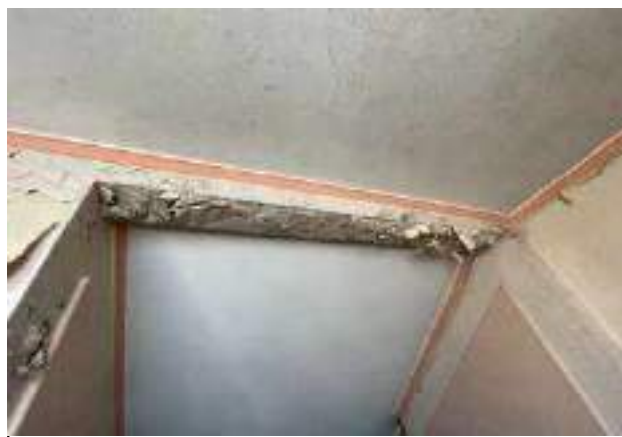
Photo 32 - Example of defective plaster throughout.

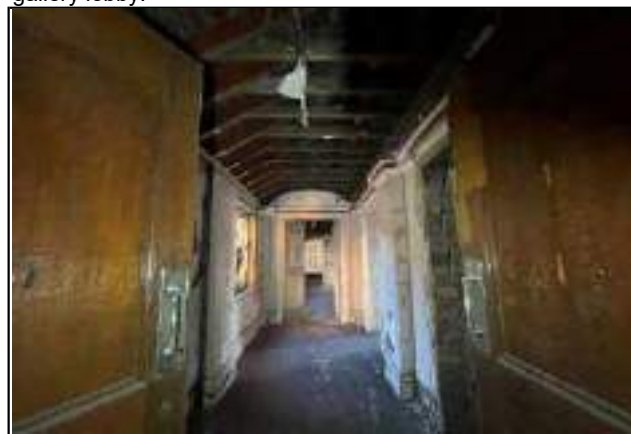
Photo 34 - Corridor area to the first floor.

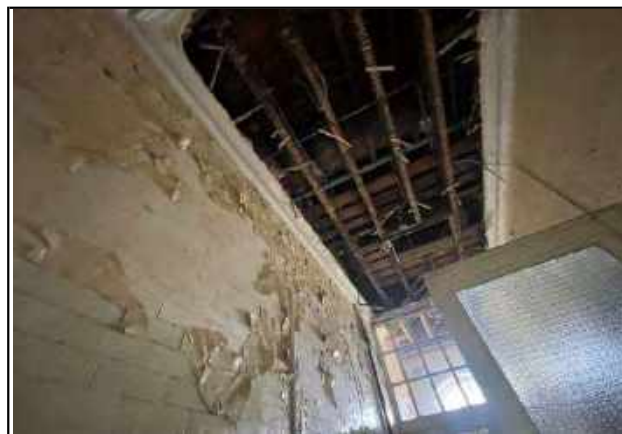
Photo 35 - Ceiling of the bathroom to the first floor.

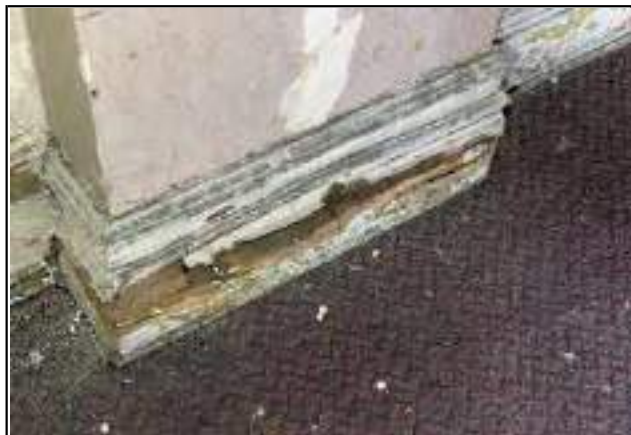
Photo 37 - Cuboidal cracking to the corridor skirting board signifying dry rot.

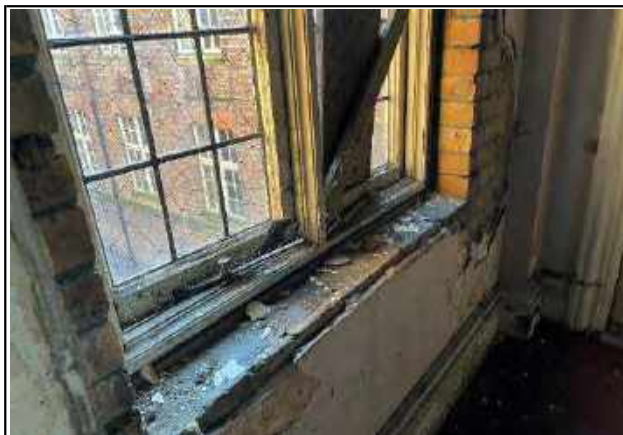
Photo 38 - Exposed brickwork to the window cill of the small hall on the first floor.

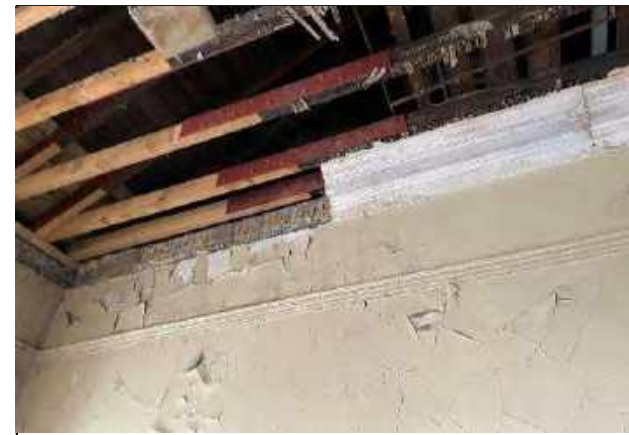
Photo 39 - Past example of splicing to the timber trusses within the roof voids of the first floor.

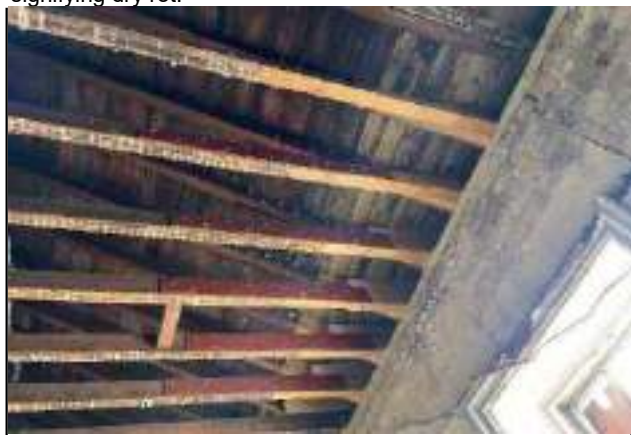
Photo 40 - Example of the timber splicing to the roof trusses of the first floor within the office space.

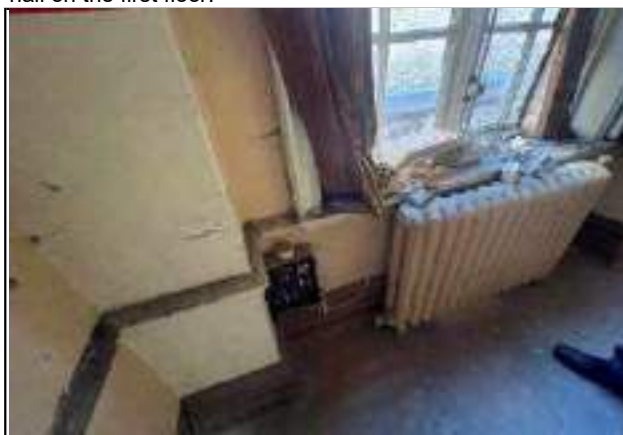
Photo 41 - Further examples of fallen ornamental plasterwork from the ceiling of the small hall.

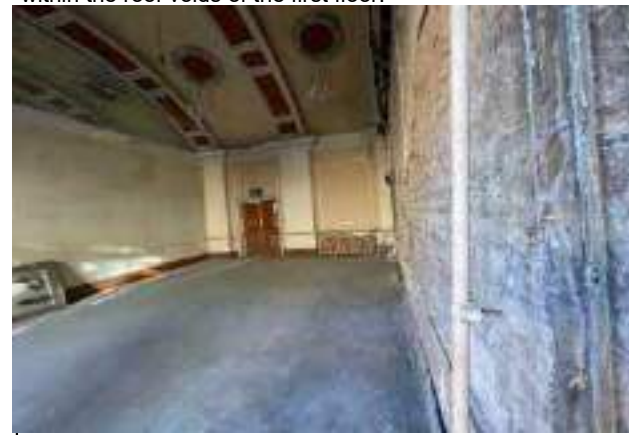
Photo 42 - Overview of the small hall section.

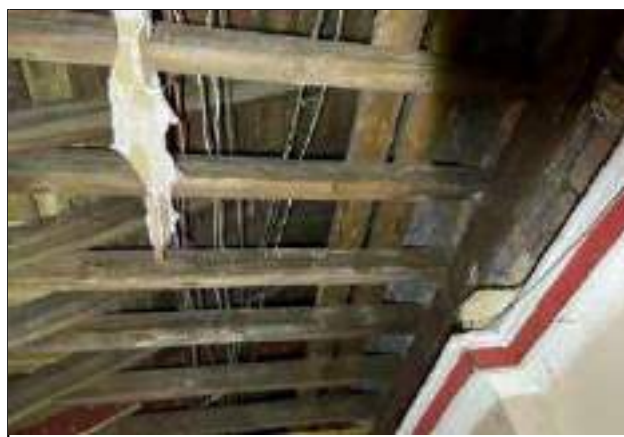
Photo 44 - Exposed timber trusses of the first floor corridor.

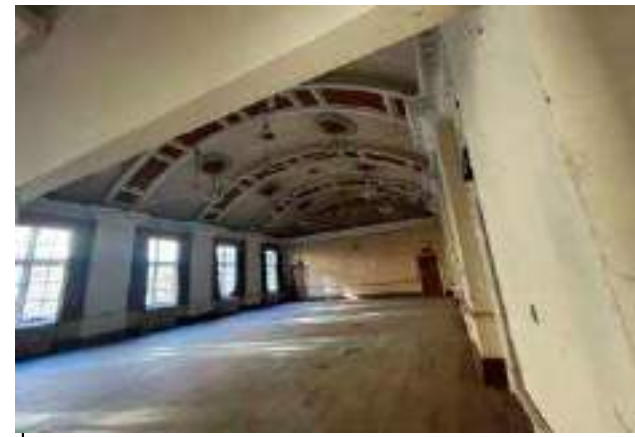
Photo 45 - Overview of the larger section of the small hall on the first floor.

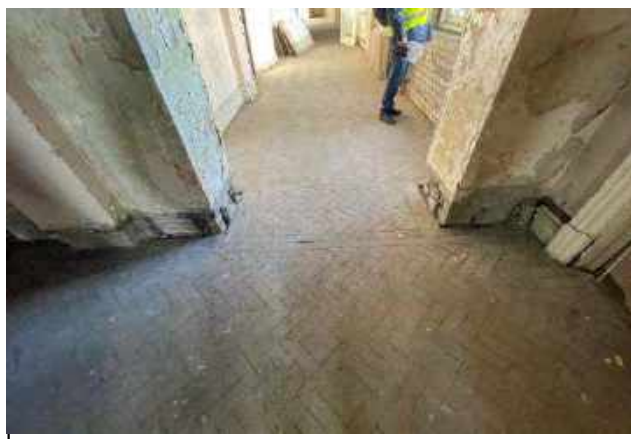
Photo 46 - Parquet flooring to the corridor area of the first floor.

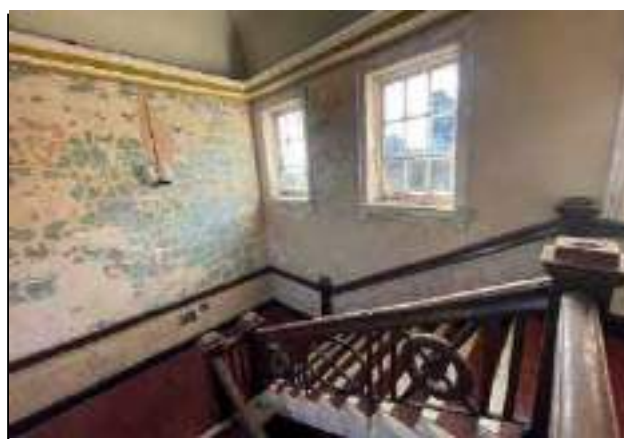
Photo 47 - Feature staircase with the oak balustrade.

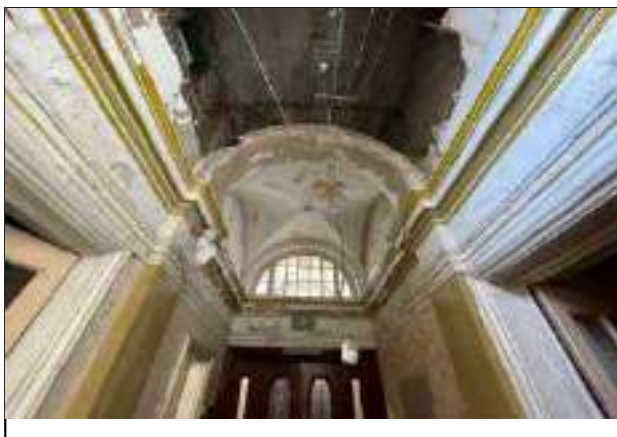
Photo 50 - Missing ceiling to the ground floor corridor area.

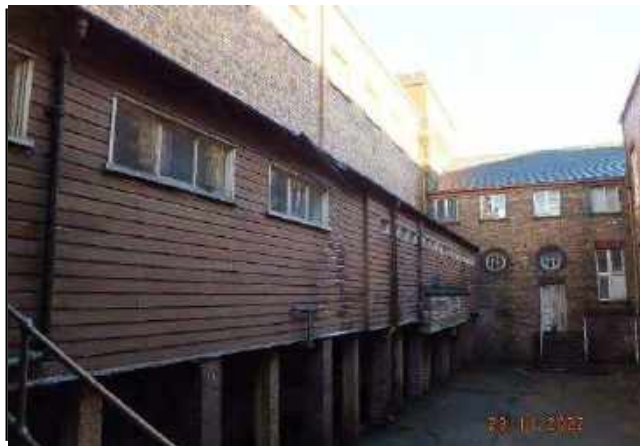
Photo 52 - Inner courtyard showing raised shiplap clad walkway (looking East).

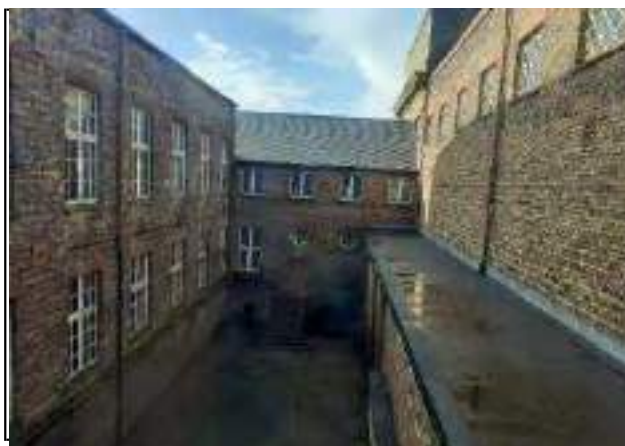
Photo 53 - Inner courtyard view looking West.

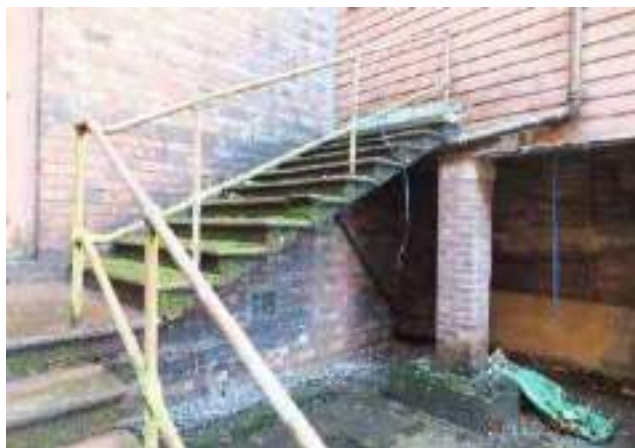
Photo 55 - External concrete staircase.

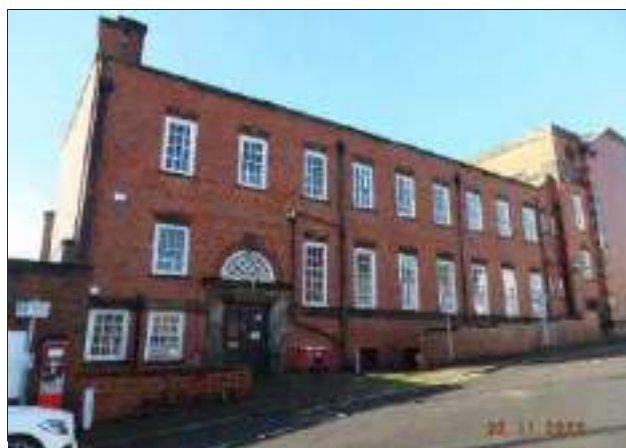
Photo 56 - East elevation.

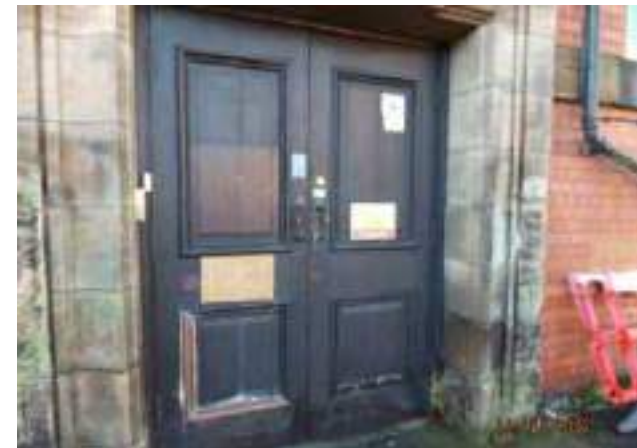
Photo 57 - twin leaf external entrance doors to Price Street.

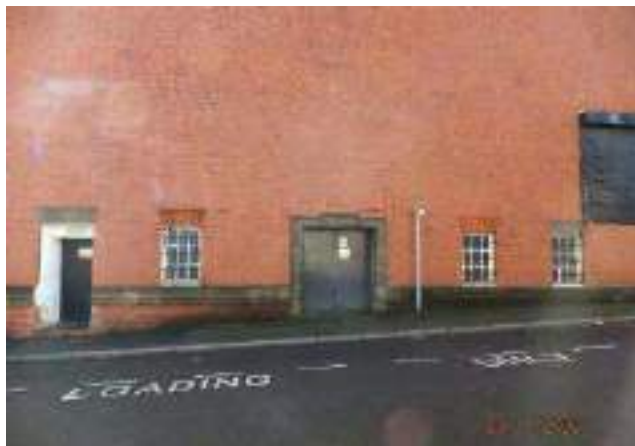
Photo 61 - East elevation of Theatre.
