# **Feasibility Study – Final Report**

Burslem Indoor Market

Queens Theatre

Wedgwood Institute

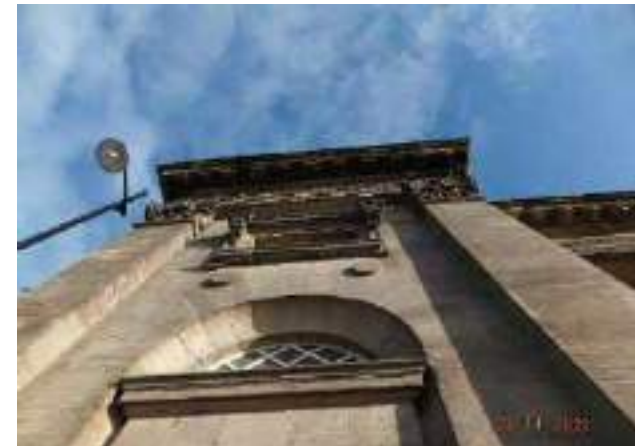
Photo 63 - View of projecting stone elements looking up from Wedgwood Street pavement.

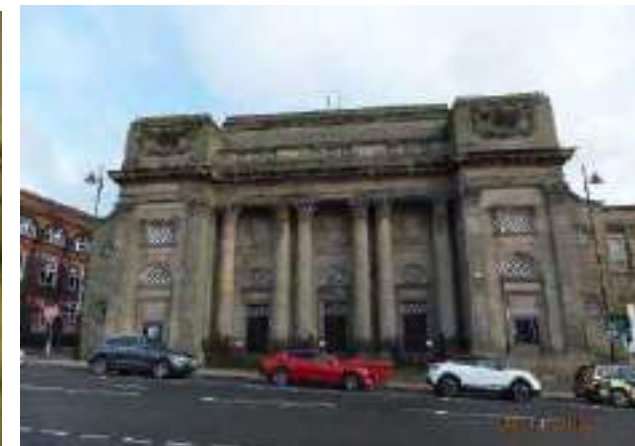
Photo 66 - Main Theatre frontage to Wedgwood Street.

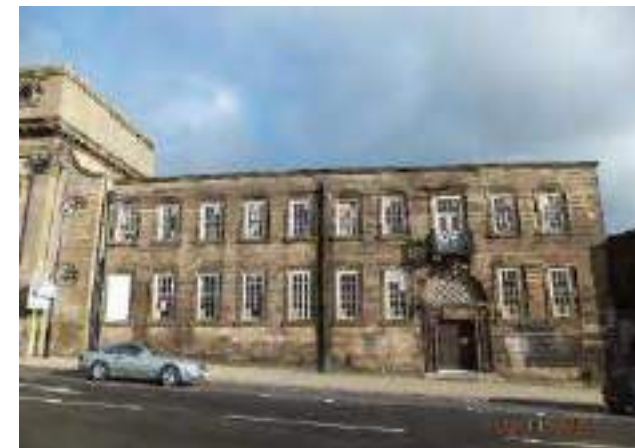
Photo 69 - Range extending South from main Theatre building on Wedgwood Street.

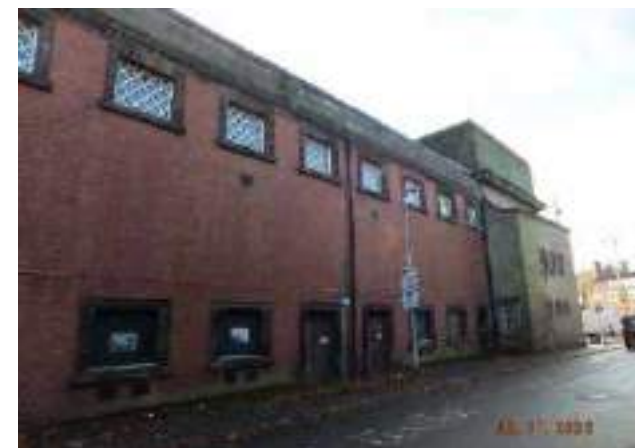
Photo 72 - General view of North elevation.

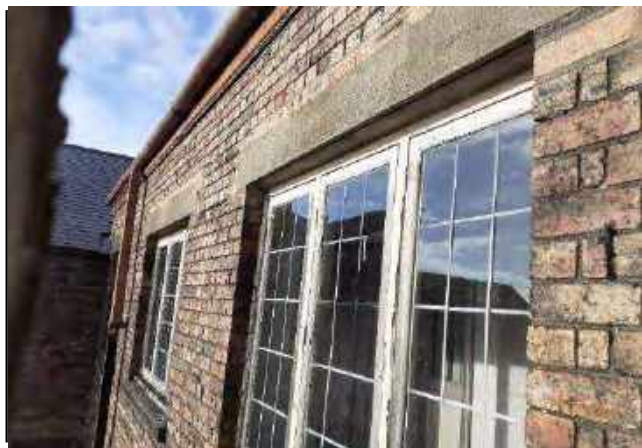
Photo 73 - Example imitation leaded light.

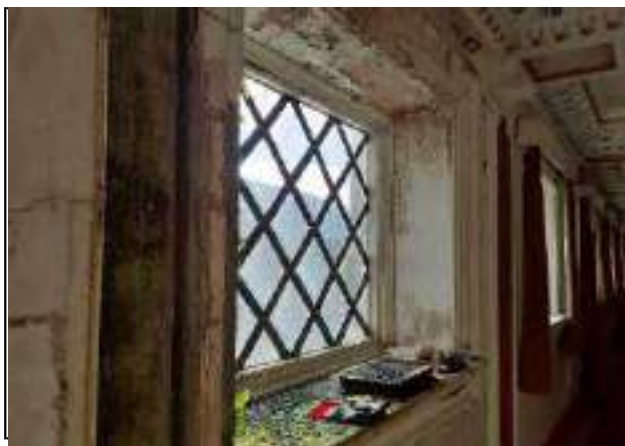
Photo 74 - Example cast iron lattice fixed window.

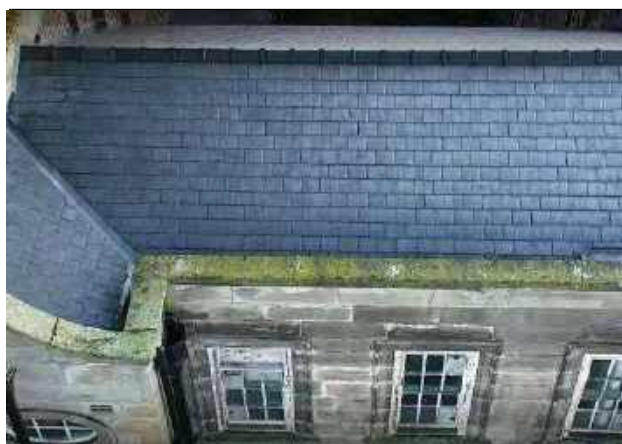
Photo 77 - slate roof to Princes Hall along Wedgwood Street.

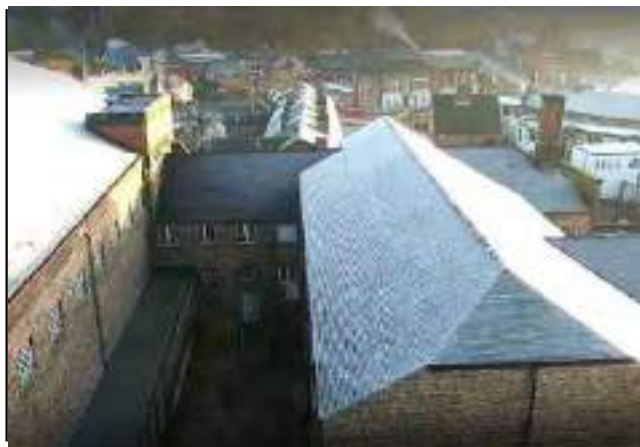
Photo 79 - general view looking East over inner courtyard.

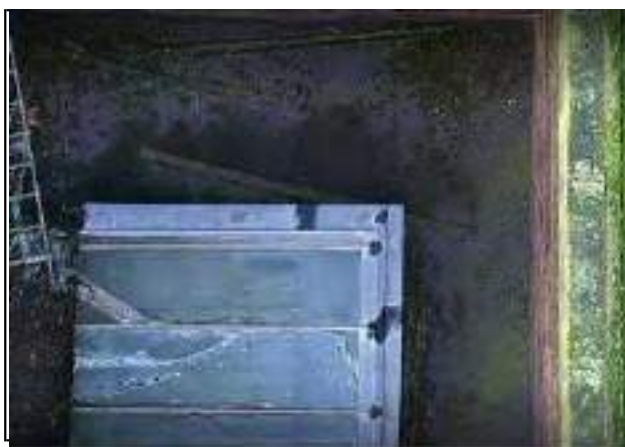
Photo 80 - Flat roof to main Theatre.

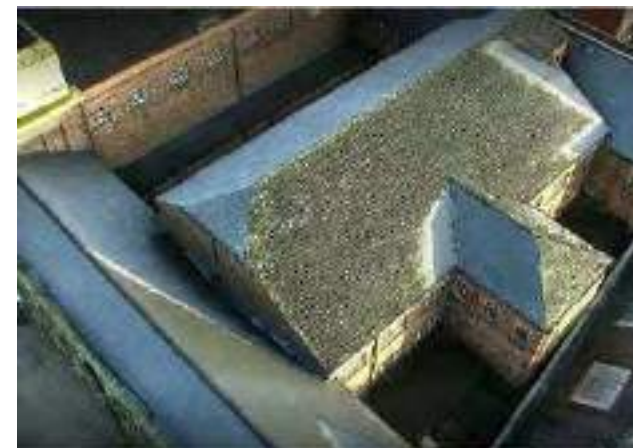
Photo 81 - general view of central roof areas.

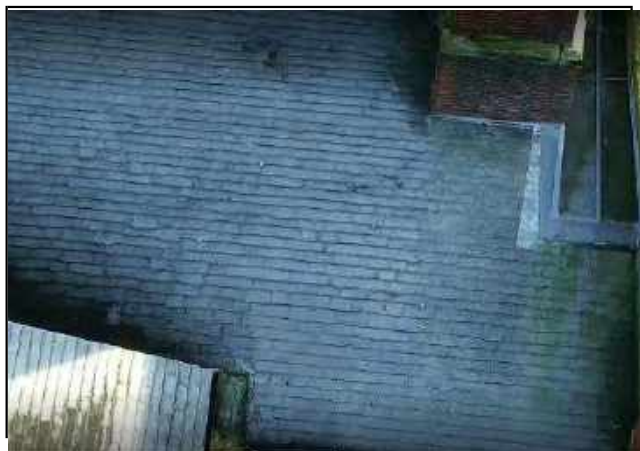
Photo 82 - Slipped slates to Princes Hall Western roof pitch along Price St.

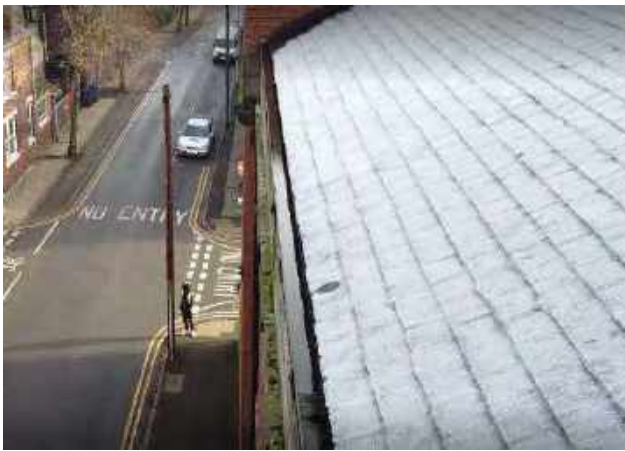
Photo 83 - Example trough gutter showing standing water (frozen).

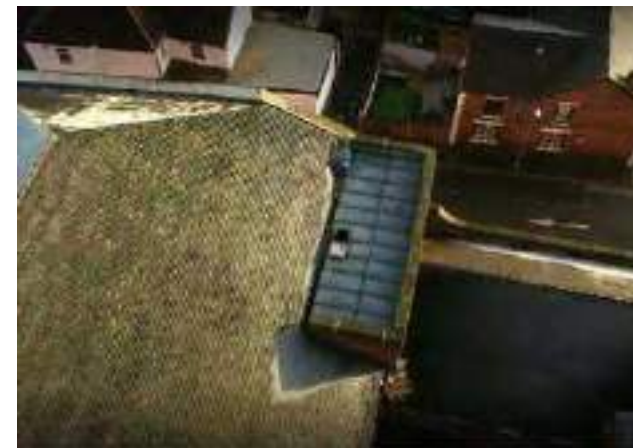
Photo 87 - Lead flat roof with removed vent cap to Theatre roof.

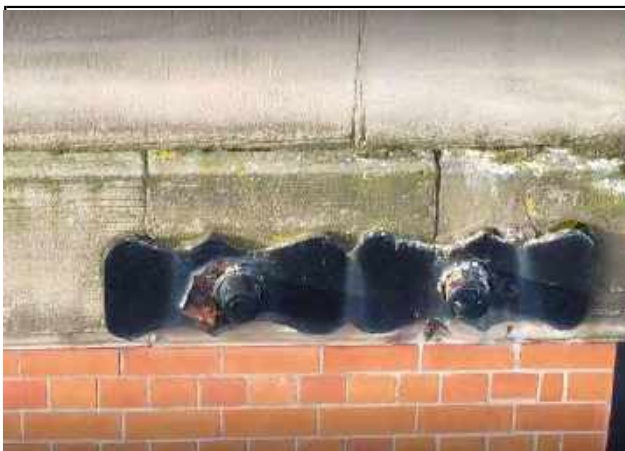
Photo 89 - Example lateral restraint plates.

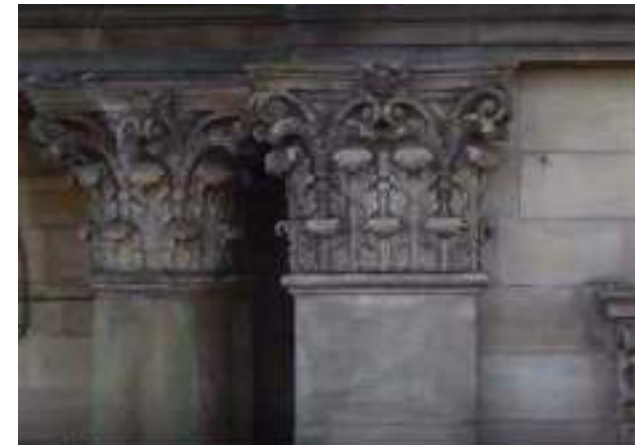
Photo 93 - Corinthian stone detail to columns at Principal entrance.

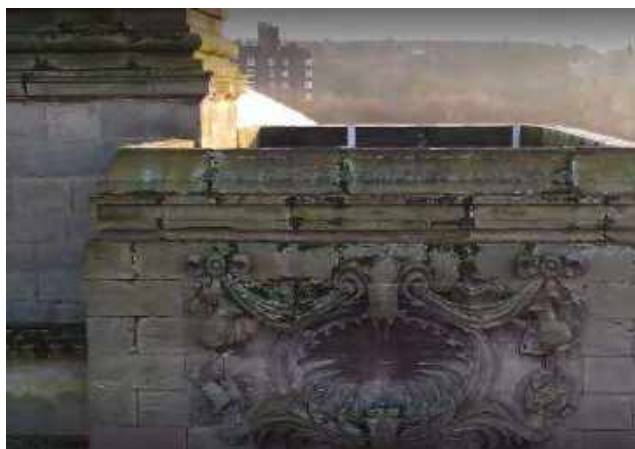
Photo 94 - stone detail flanking main entrance.

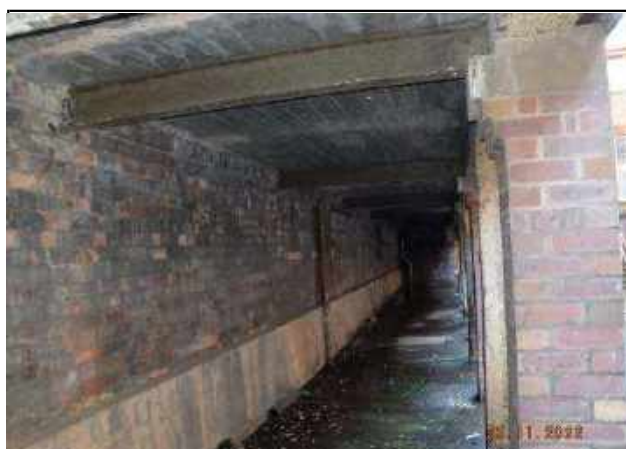
Photo 95 - Undercroft of walkway to central courtyard.

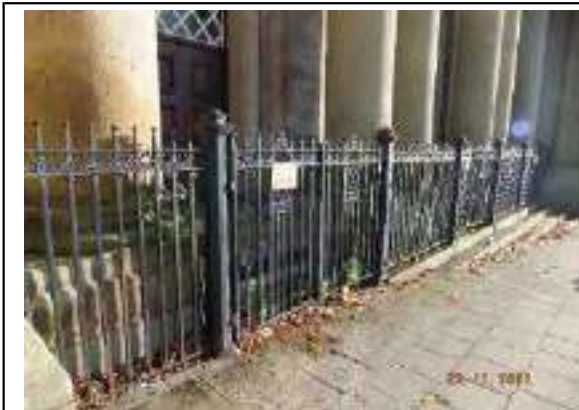
Photo 97 - external railings to Principal entrance.

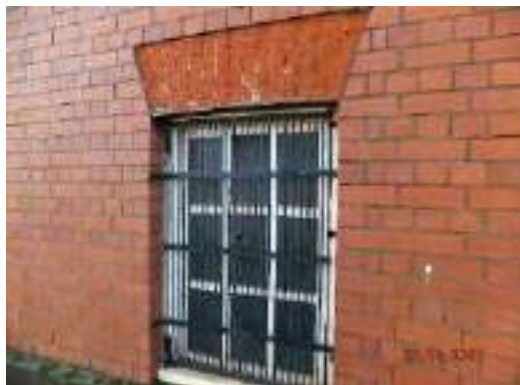
Photo 98 - window to East elevation along Price Street - mock stone finish to brick flat arch has been lost.

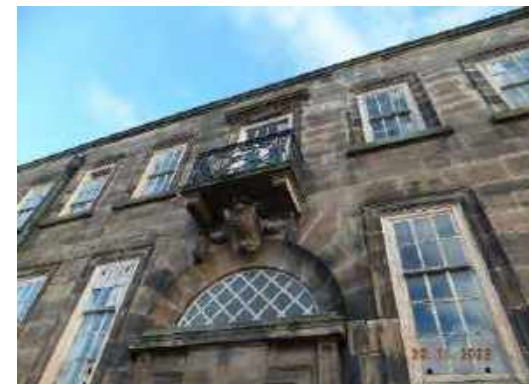
Photo 99 - windows to Princes Hall Wedgwood Street elevation.

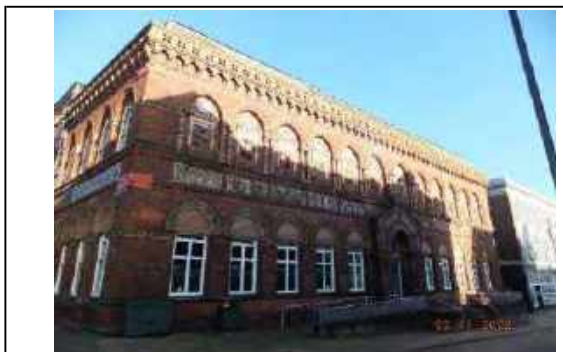
Photo 1 - Principal front elevation (South).

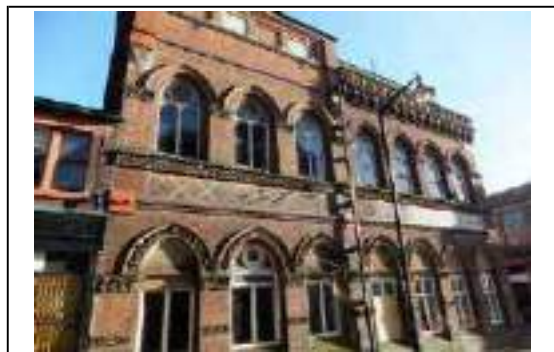
Photo 2 - West elevation showing technical school (added 1892).

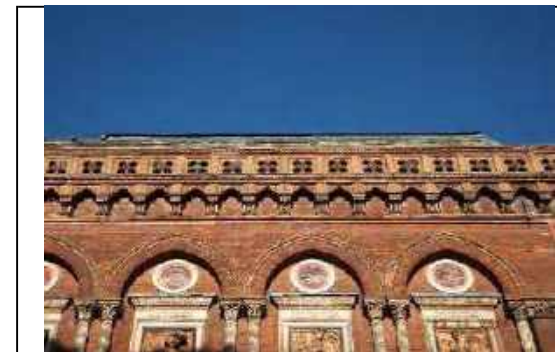
Photo 3 - decorative terracotta arcading and frieze detail.

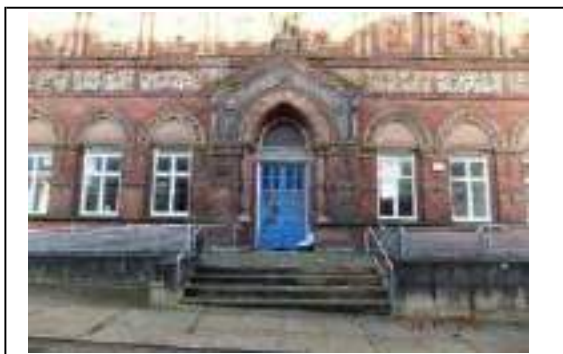
Photo 4 -Main entrance doors and step/ ramp access.

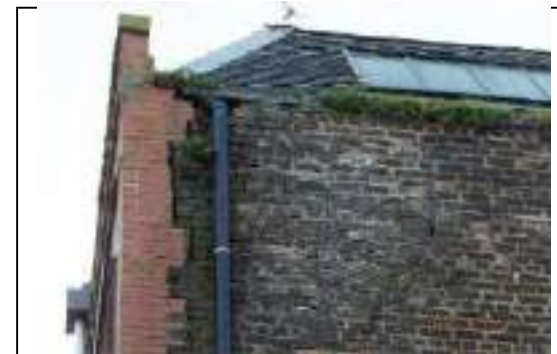
Photo 6 - Brick junction opening up between East façade at parapet level and North elevation. Rainwater disposal system blocked by vegetation.

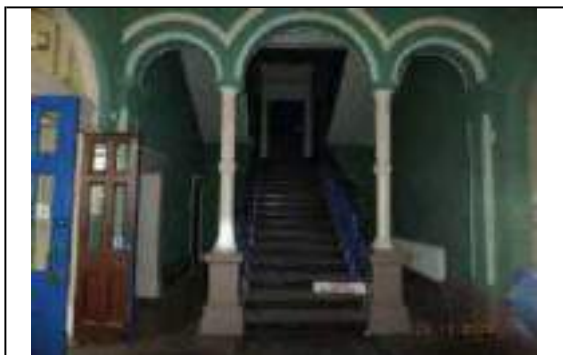
Photo 7 - Principal staircase opposite main entrance.

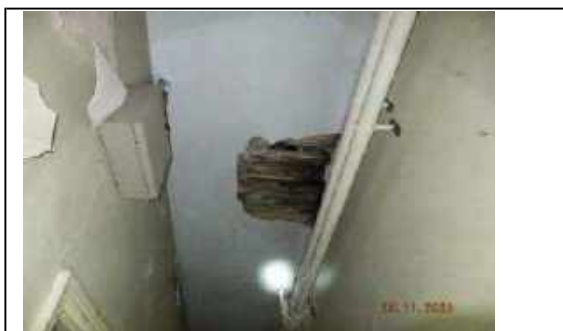
Photo 10 - Example of damaged lath & plaster ceiling to RG.12

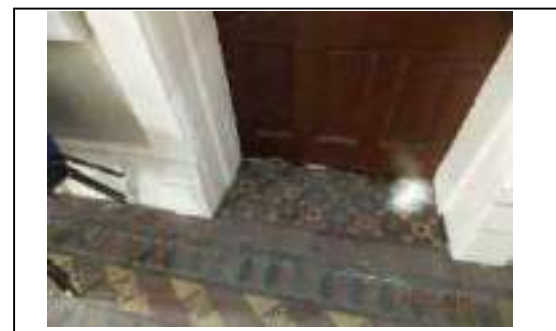
Photo 12 - Dry rot fruiting body emerging from RG.19 into RG.15

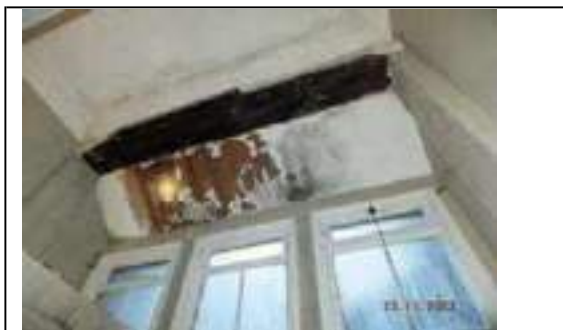
Photo 13 - Active water ingress to RG.19, timber saturated.

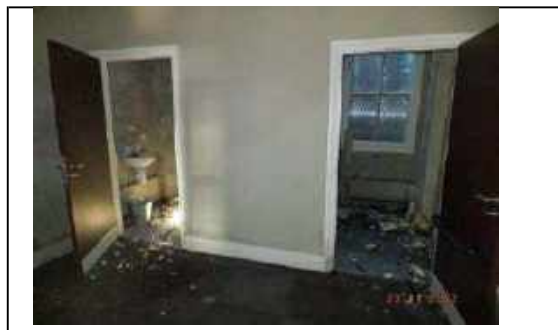
Photo 14 - RG.19 Damage to sanitary facilities due to leak. Dry rot observed to RHS skirting level.

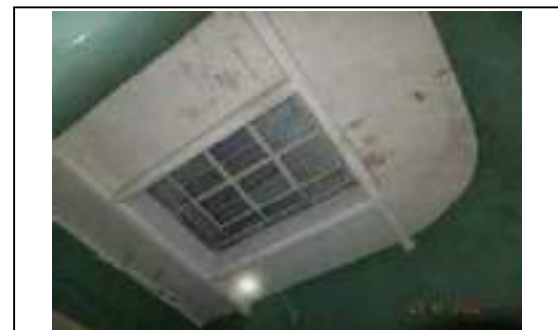
Photo 15 - Skylight above principal staircase.

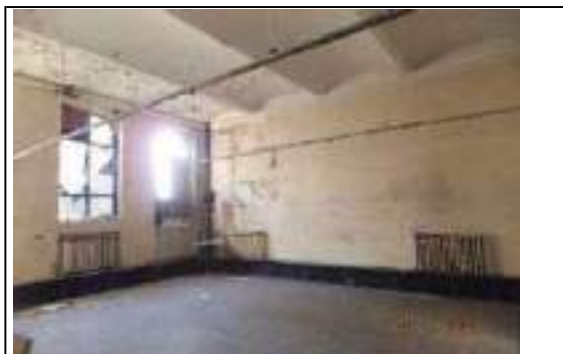
Photo 16 - RF.40 (meeting room). Jack arches visible to second floor.

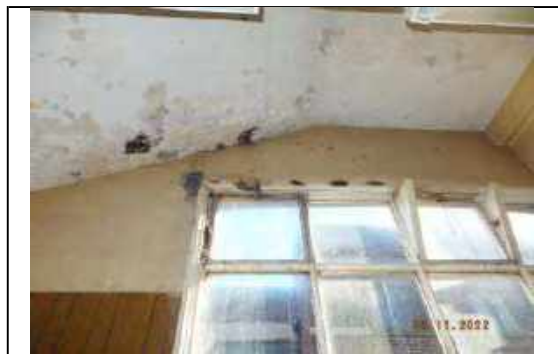
Photo 17 - RF.36 (student room). Water ingress and associated damage.

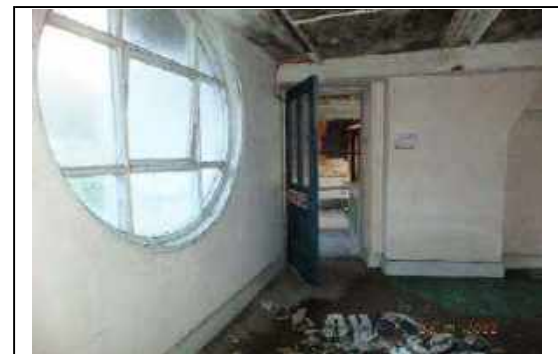
Photo 18 - View through RF37 (no further access). Collapsed lath & plaster ceiling and damage to floor below.

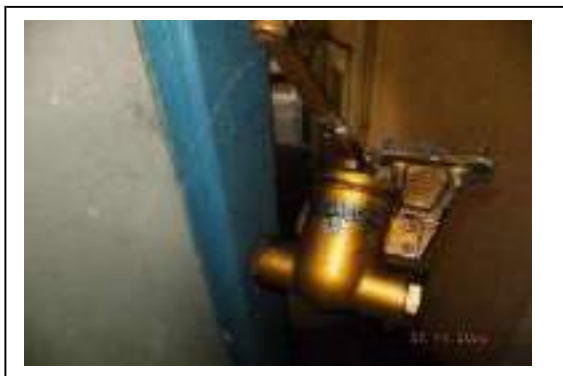
Photo 19 - Example of early 20th Century door closers observed in the building. These should be retained where possible and overhauled by a specialist.

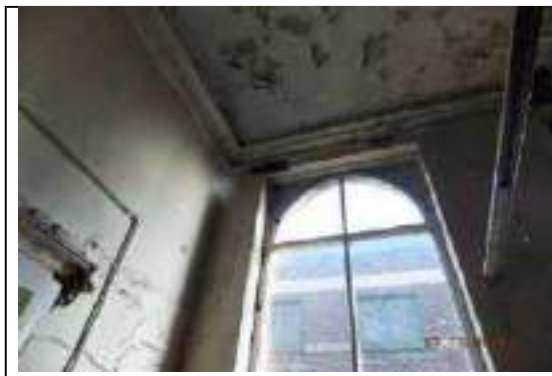
Photo 20 - Evidence of previous investigation/ repair to steel lintels in RF.40.

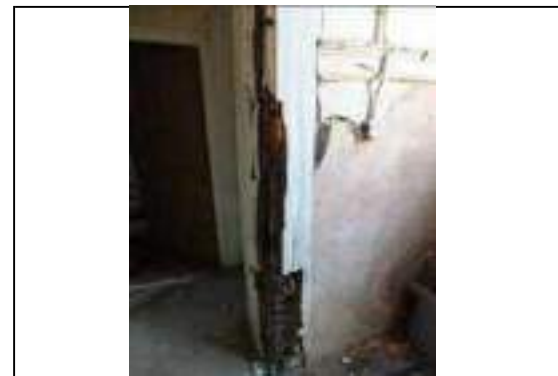
Photo 21 - Architrave destroyed by dry rot in RF.40.

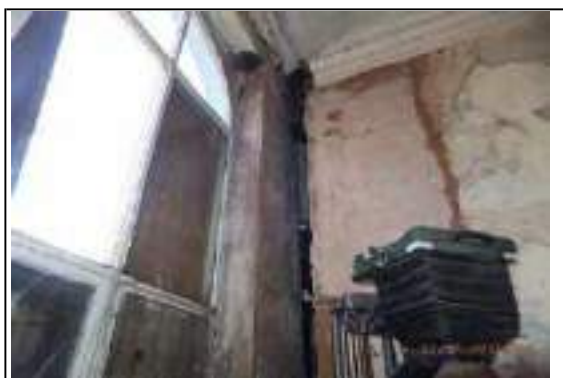
Photo 22 - Plaster & brickwork has been broken out to allow access to internal downpipe in RF.40.

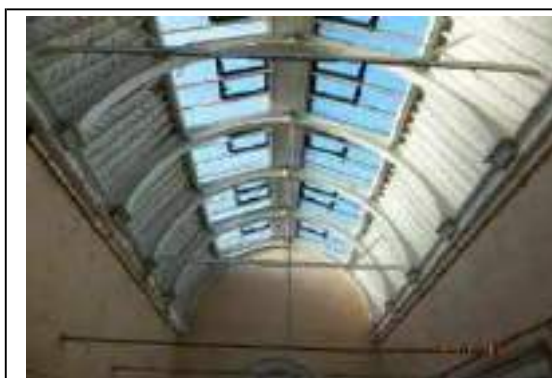
Photo 23 - Glazed rooflight over RF.23. Believed to have been repaired externally in 2017.

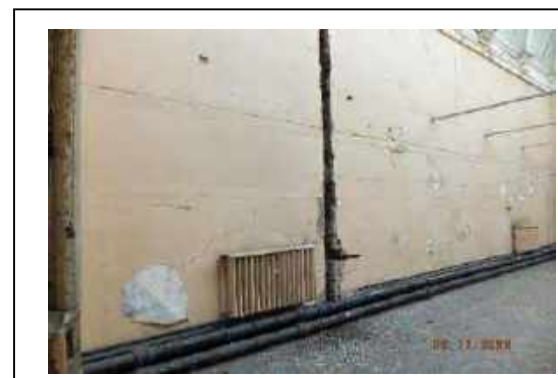
Photo 24 - exposed internal downpipe to RF.23.

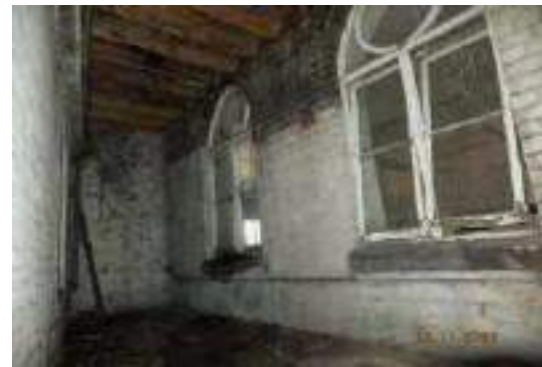
Photo 26 - Previously external lightwell now roofed over adjacent to RF.28.

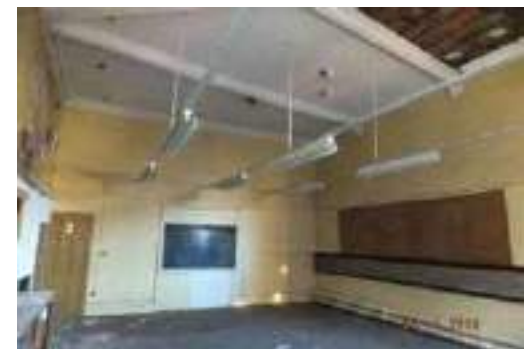
Photo 27 - RF.24 (workshop). Water damage to lath & plaster shown top left, assumed to be historic leak pre-2016 roof repair.

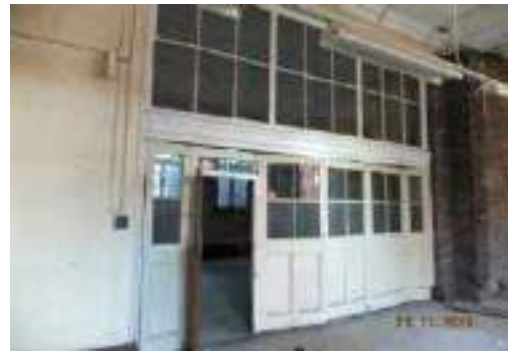
Photo 29 - Folding shutter partition between RF.25 & RF.26 workshops. Note missing/ damaged brickwork to structural pillar on RHS.

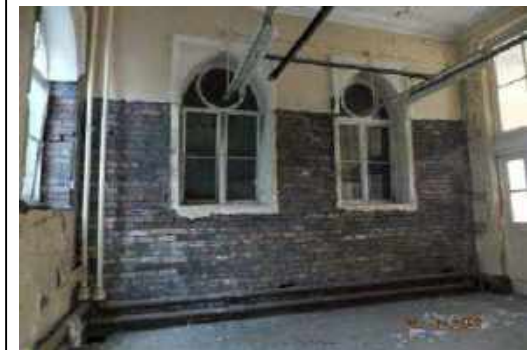
Photo 30 - View of 'external' wall & windows to North side of RF.26. Evidence of previous dry rot or waterproofing injection treatment to lightwell walls.

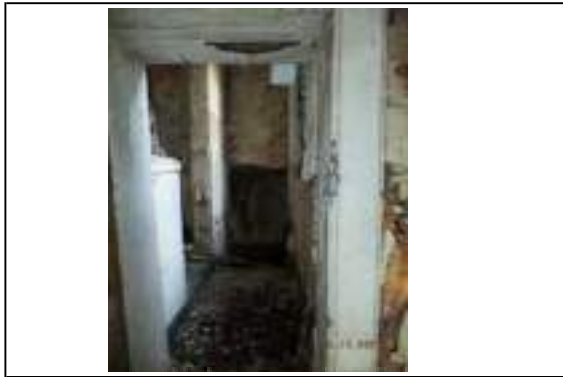
Photo 31 - View through to stairwell from RF.26 (no further safe access). Decayed & failed lintel, extensive damage to woodwork and plaster. Pigeons freely using the space.

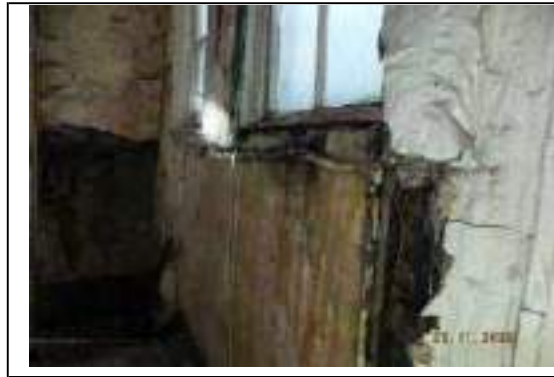
Photo 32 - Severe decay to woodwork and wall finishes beyond RF.26.

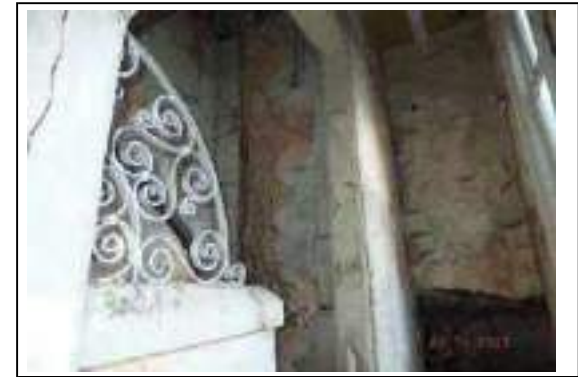
Photo 33 - Root growth observed down internal first floor wall of rear stairwell.

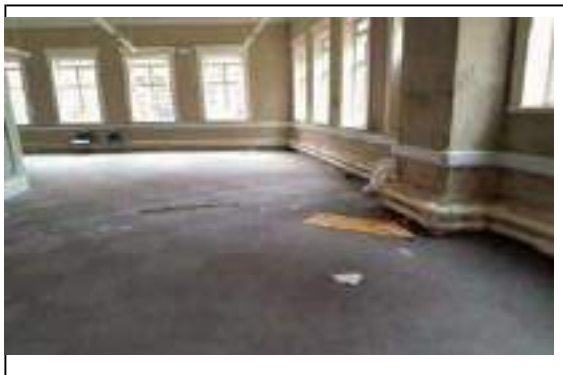
Photo 34 - Heating pipework running the entire perimeter of the building.

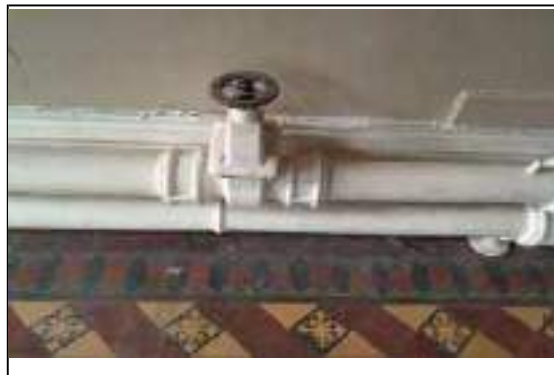
Photo 35 - Heating pipework gate valve

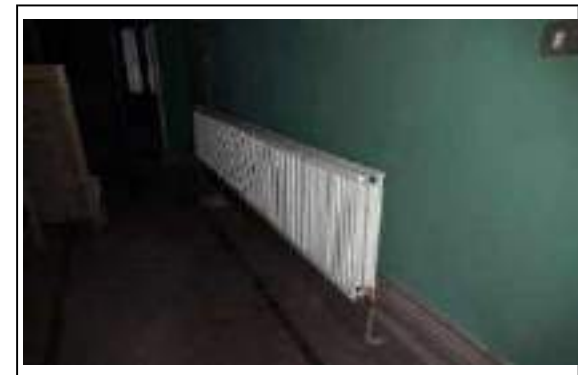
Photo 36 - Standard radiator

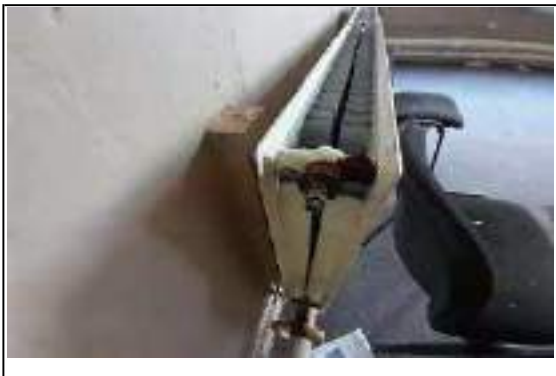
Photo 37 - Radiator showing signs of corrosion

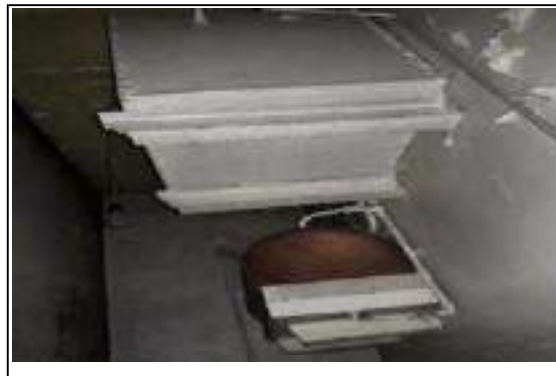
Photo 38 - Cold water storage tank and hot water cylinder

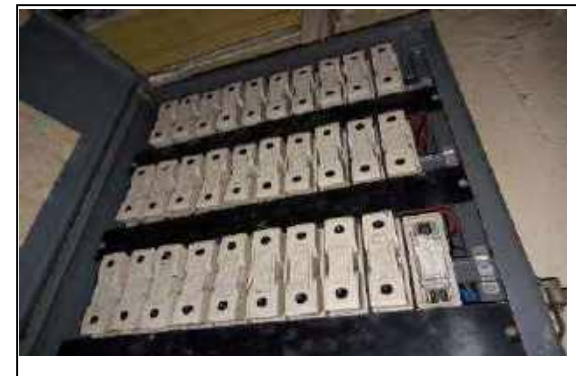
Photo 39 - Fuse board

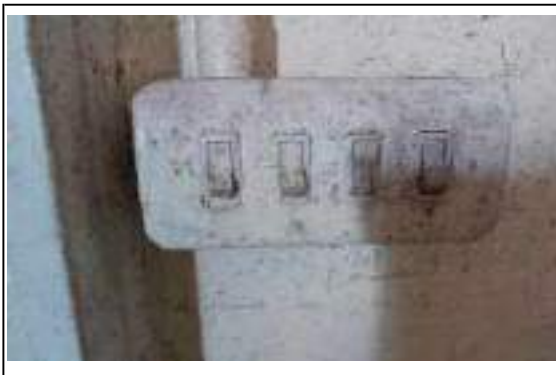
Photo 40 - Light switch that has been painted over

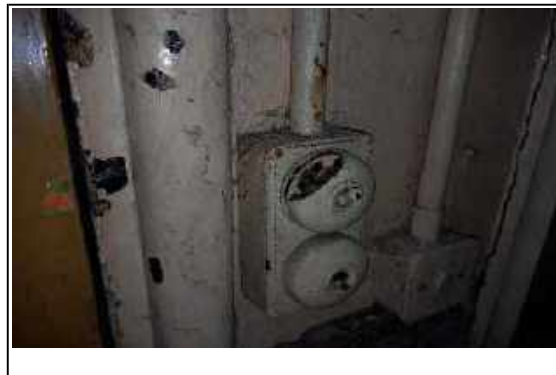
Photo 41 - Damaged period light switch

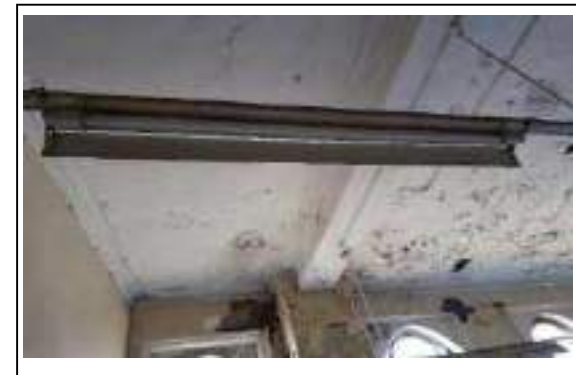
Photo 42 - Typical luminaire

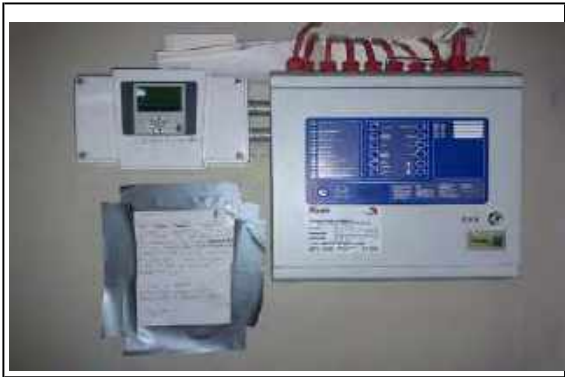
Photo 43 - Fire Alarm Panel

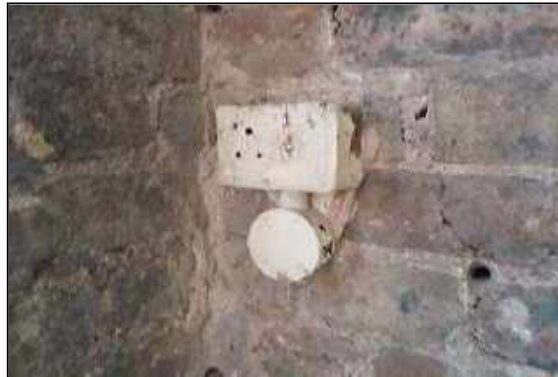
Photo 44 - Socket outlet 50+ years and defective

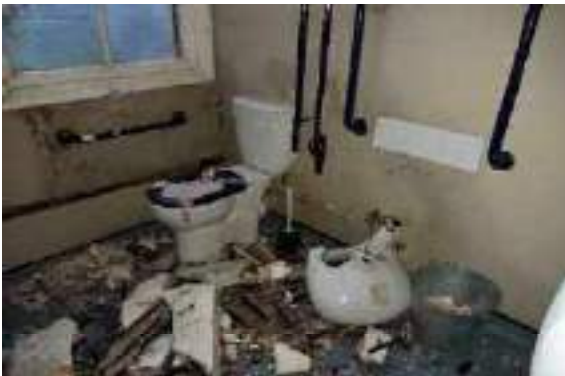
Photo 46 - Defective sanitaryware

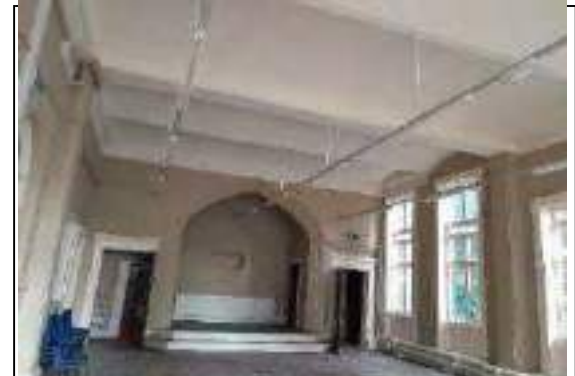
Photo 48 - Fluorescent luminaires with trunking wiring containment

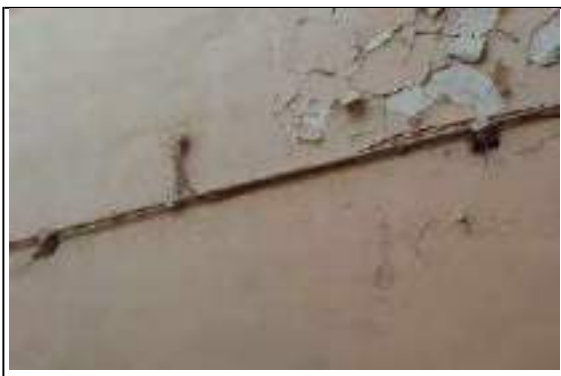
Photo 49 - Single core cables not fully intact.

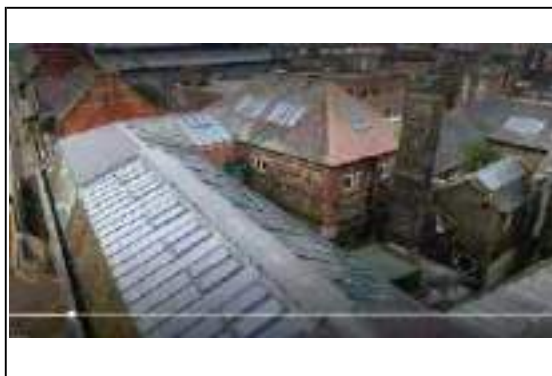
Photo 50 - General roof view (drone footage) of front range and technical school extension.

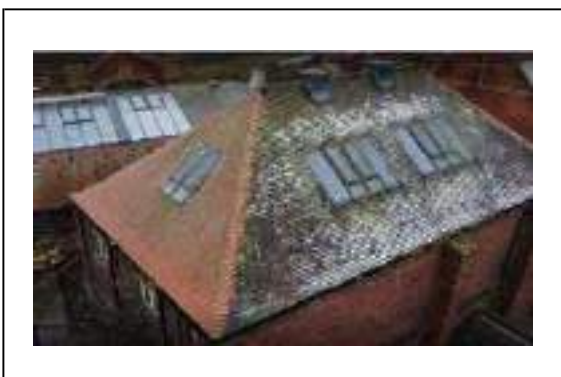
Photo 52 - Technical school roof (drone footage).

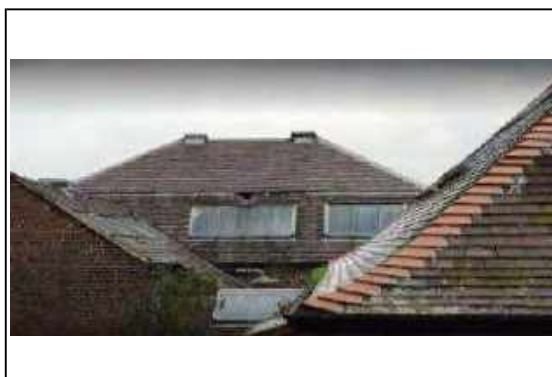
Photo 53 - View of roof failure to North East workshop extension (drone footage from West)

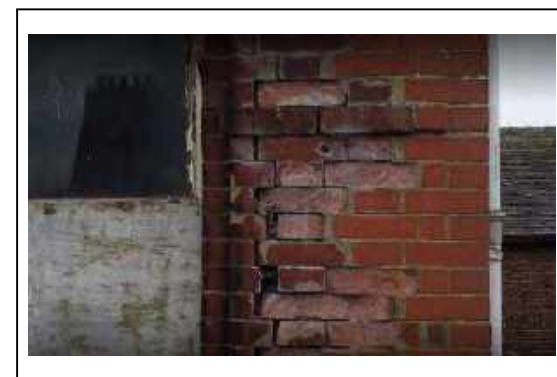
Photo 54 - Displaced brickwork due to previous shrub growth in wall (drone footage).
